Re: *Re-Opened Record (Tree Felling Permit)*
Applicant: Springfield Utility Board
City File No. 811-19-000016-TYP 2
Project Name: SUB Glenwood Substation and Transmission Line Tree
Felling Permit
Our File No.: 13538/12953

RE: REVIEW OF FEI 7/24/19 SUBMISSION, SUB POWER LINE, E 22ND AVENUE.

RE: SLOPE STABILITY CONCERNS, SUB POWER LINE, VICINITY OF E 22ND AVENUE

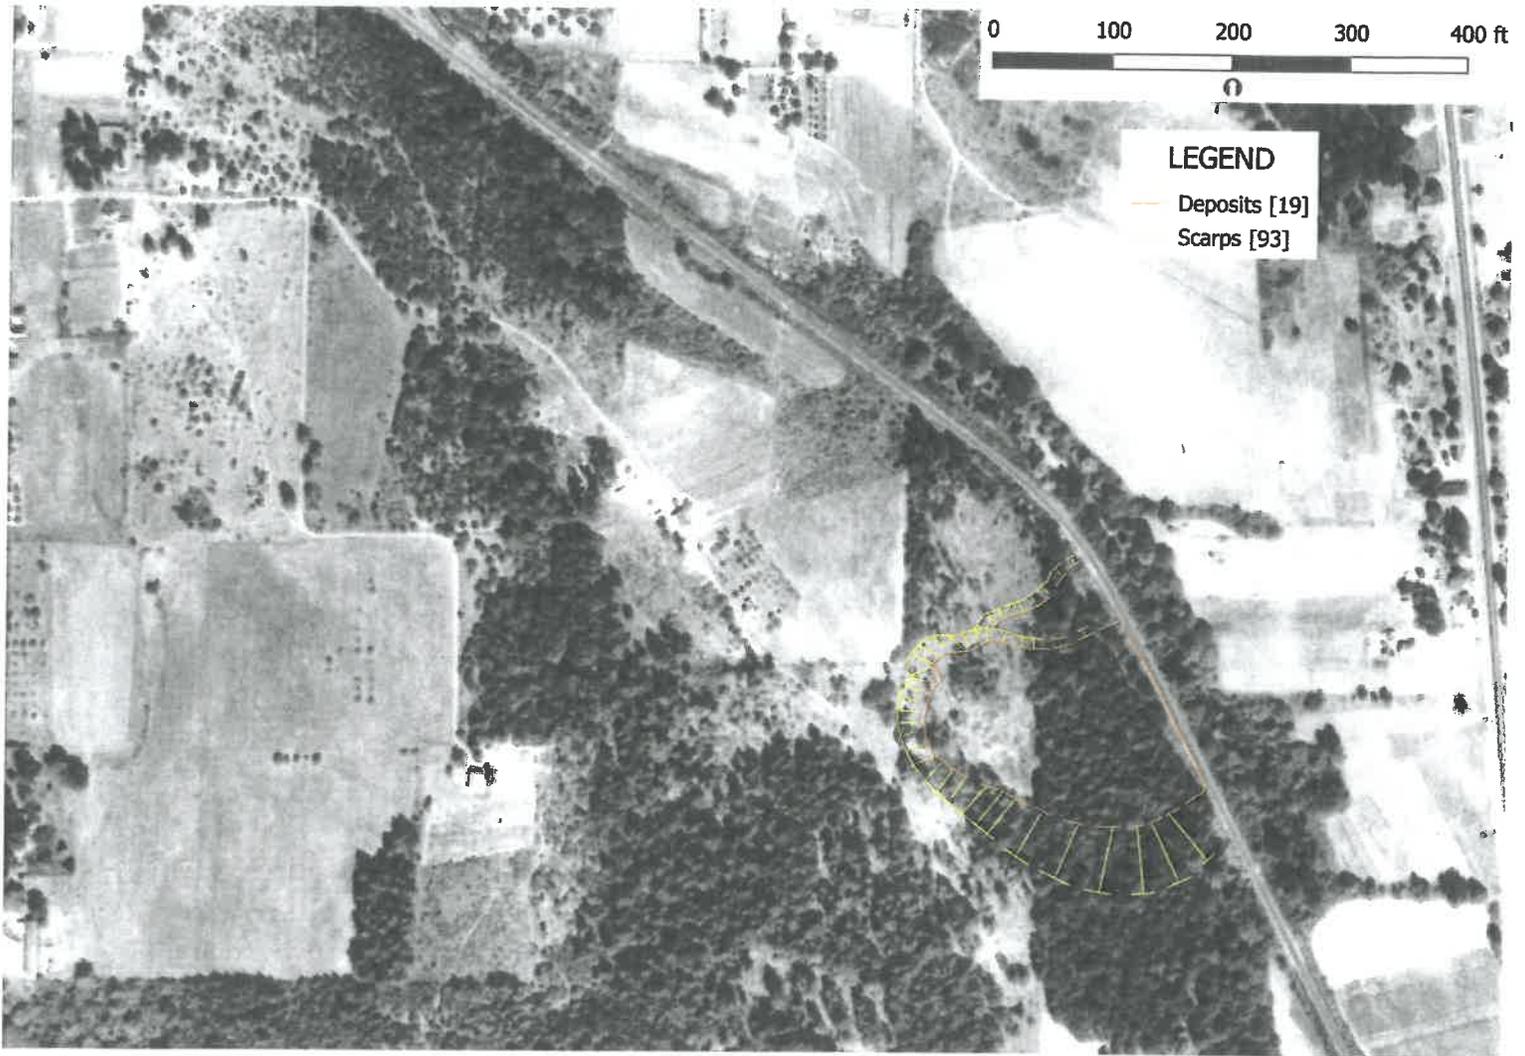
SUB E. 22nd Avenue Substation Project Slope Stability Review
Figure 4b: Portion of 1936 Aerial Photo Showing Probable Landslide Feature
Base from 1936 Willamette Valley Project, Photo 3888.

Soil disturbance is evident along the central (westernmost) upper edges of the amphitheater-shaped slope which is proposed to be clear-cut and then traversed by the southern portion of the power line (Figure 4b). Two further lines of soil disturbance extend from that area towards the east-northeast. Apparent raveling of the cut bank on the west side of the railroad tracks is discernible where these lines of soil disturbance would “exit” the toe of the slope. Tree cover obscures much of the ground in the southern and eastern portion of the area of interest and the area upslope (W) from the current location of I-5.

These observations show that the concave, amphitheater-shaped slope in the southern portion of the proposed project is a natural feature, as opposed to having a man-made origin. Given the geomorphology of this feature, with an arcuate steeper slope segment as its upslope boundary, lacking a well-defined creek channel, and having a gently sloping depressed central area is typical of deep-seated slope movements in this area.

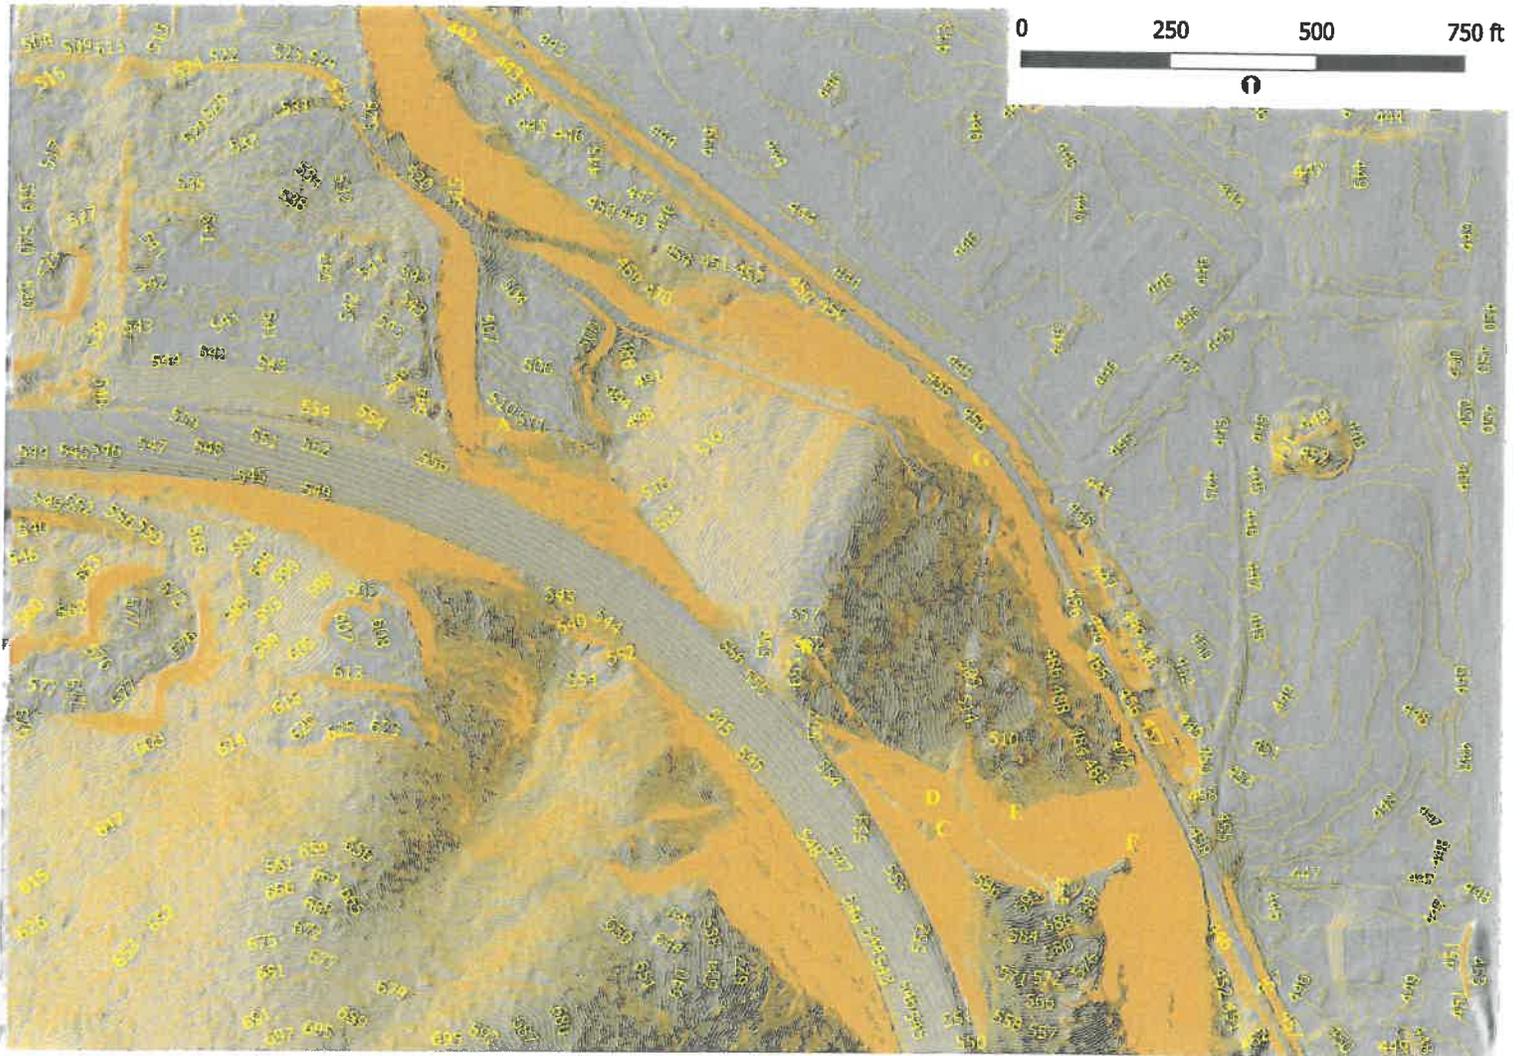
SUB E. 22nd Avenue Substation Project Slope Stability Review
Figure 7: LiDAR Hillshade Image with 1-ft. Contour Lines
Base from DOGAMI DEM and QGIS

The hillshade image shows a significant cut which has been made a short distance east of the currently proposed substation pad. The contour map indicates that the cut bank is up to 35 feet tall. To the east of the cut bank is a relatively gently sloping area approximately 150 to 200' wide (E-W) and 200 to 300' long (N-S). The east margin of this pad consists of a steeper (approximately 2H : 1V) slope ranging from 5 to 12' tall. This slope extends to the channel of a small creek. The southeastern side of the creek consists of a relatively uniform, gentle slope (around 15 to 20%) extending approximately 370' to a broad ridge trending SSW to NNE.

On the other side (SE) of the ridge, a broad, roughly semi-circular, concave or amphitheater-shaped topographic feature is present, which is open to the valley below. I-5 is tangential to the central portion of the up-slope margin of the feature. The southern border of this feature consists of a NE- to N-facing slope which is 100 to 120' tall at an overall slope of up to 100% (45°).

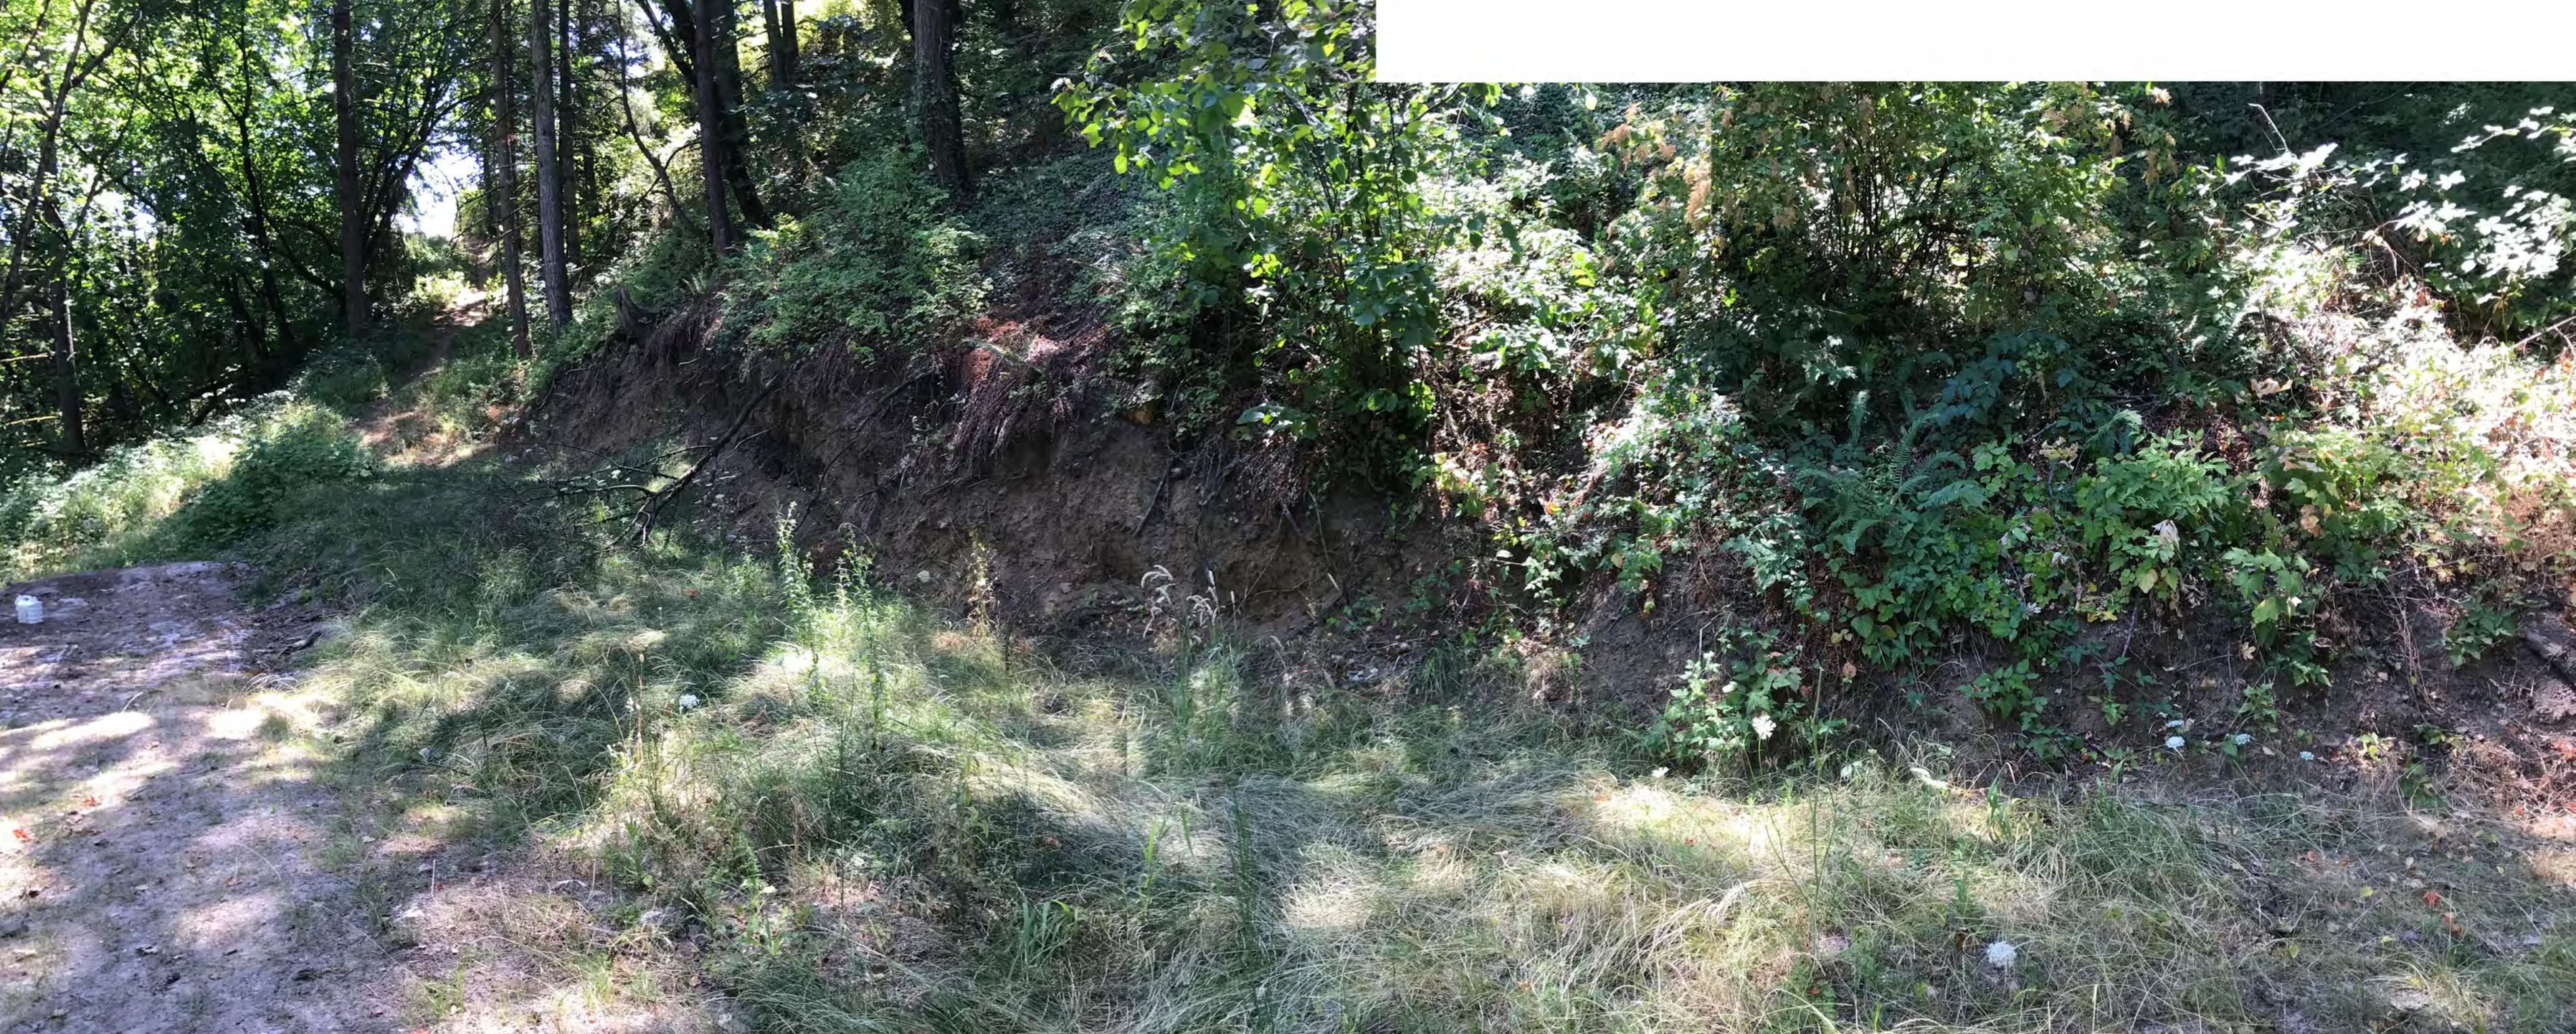
The presence of a long-active deep-seated slope movement in that area is further supported by the observations in the cut bank at location C. The stratigraphy found in the road cut at the site indicates that clayey SU-C, derived from weathering of sandstone, has covered what is either an older road bed, or, more likely, talus generated from collapse of a cliff underlain by highly competent rock ("basalt"?). A non-slope-movement origin of the observed stratigraphy is essentially impossible to imagine. A clayey soil with sedimentary rock fragments covers a pile of near-fresh state (unweathered) igneous rock fragments and a thick forest soil has developed over the whole deposit.

Cut in likely slope movement at Location C. View S to W.

In order to effectively assess the impact of the probable slope movement on the Interstate Highway, it would be necessary to conduct subsurface exploration in the area where the probable headscarp is located close to the highway. In particular, it would be important to determine the subsurface conditions (including groundwater pore pressures) in the vicinity of the exposure of the igneous rock fragments beneath the clayey soil deposit. Additional investigation is also warranted in the more gently sloping presumed slide deposit located in the central portion of the amphitheater-shaped feature. The conditions there are likely to have import for not only the rail line but also for the viability of the proposed access road which will need to be passable during inclement weather.

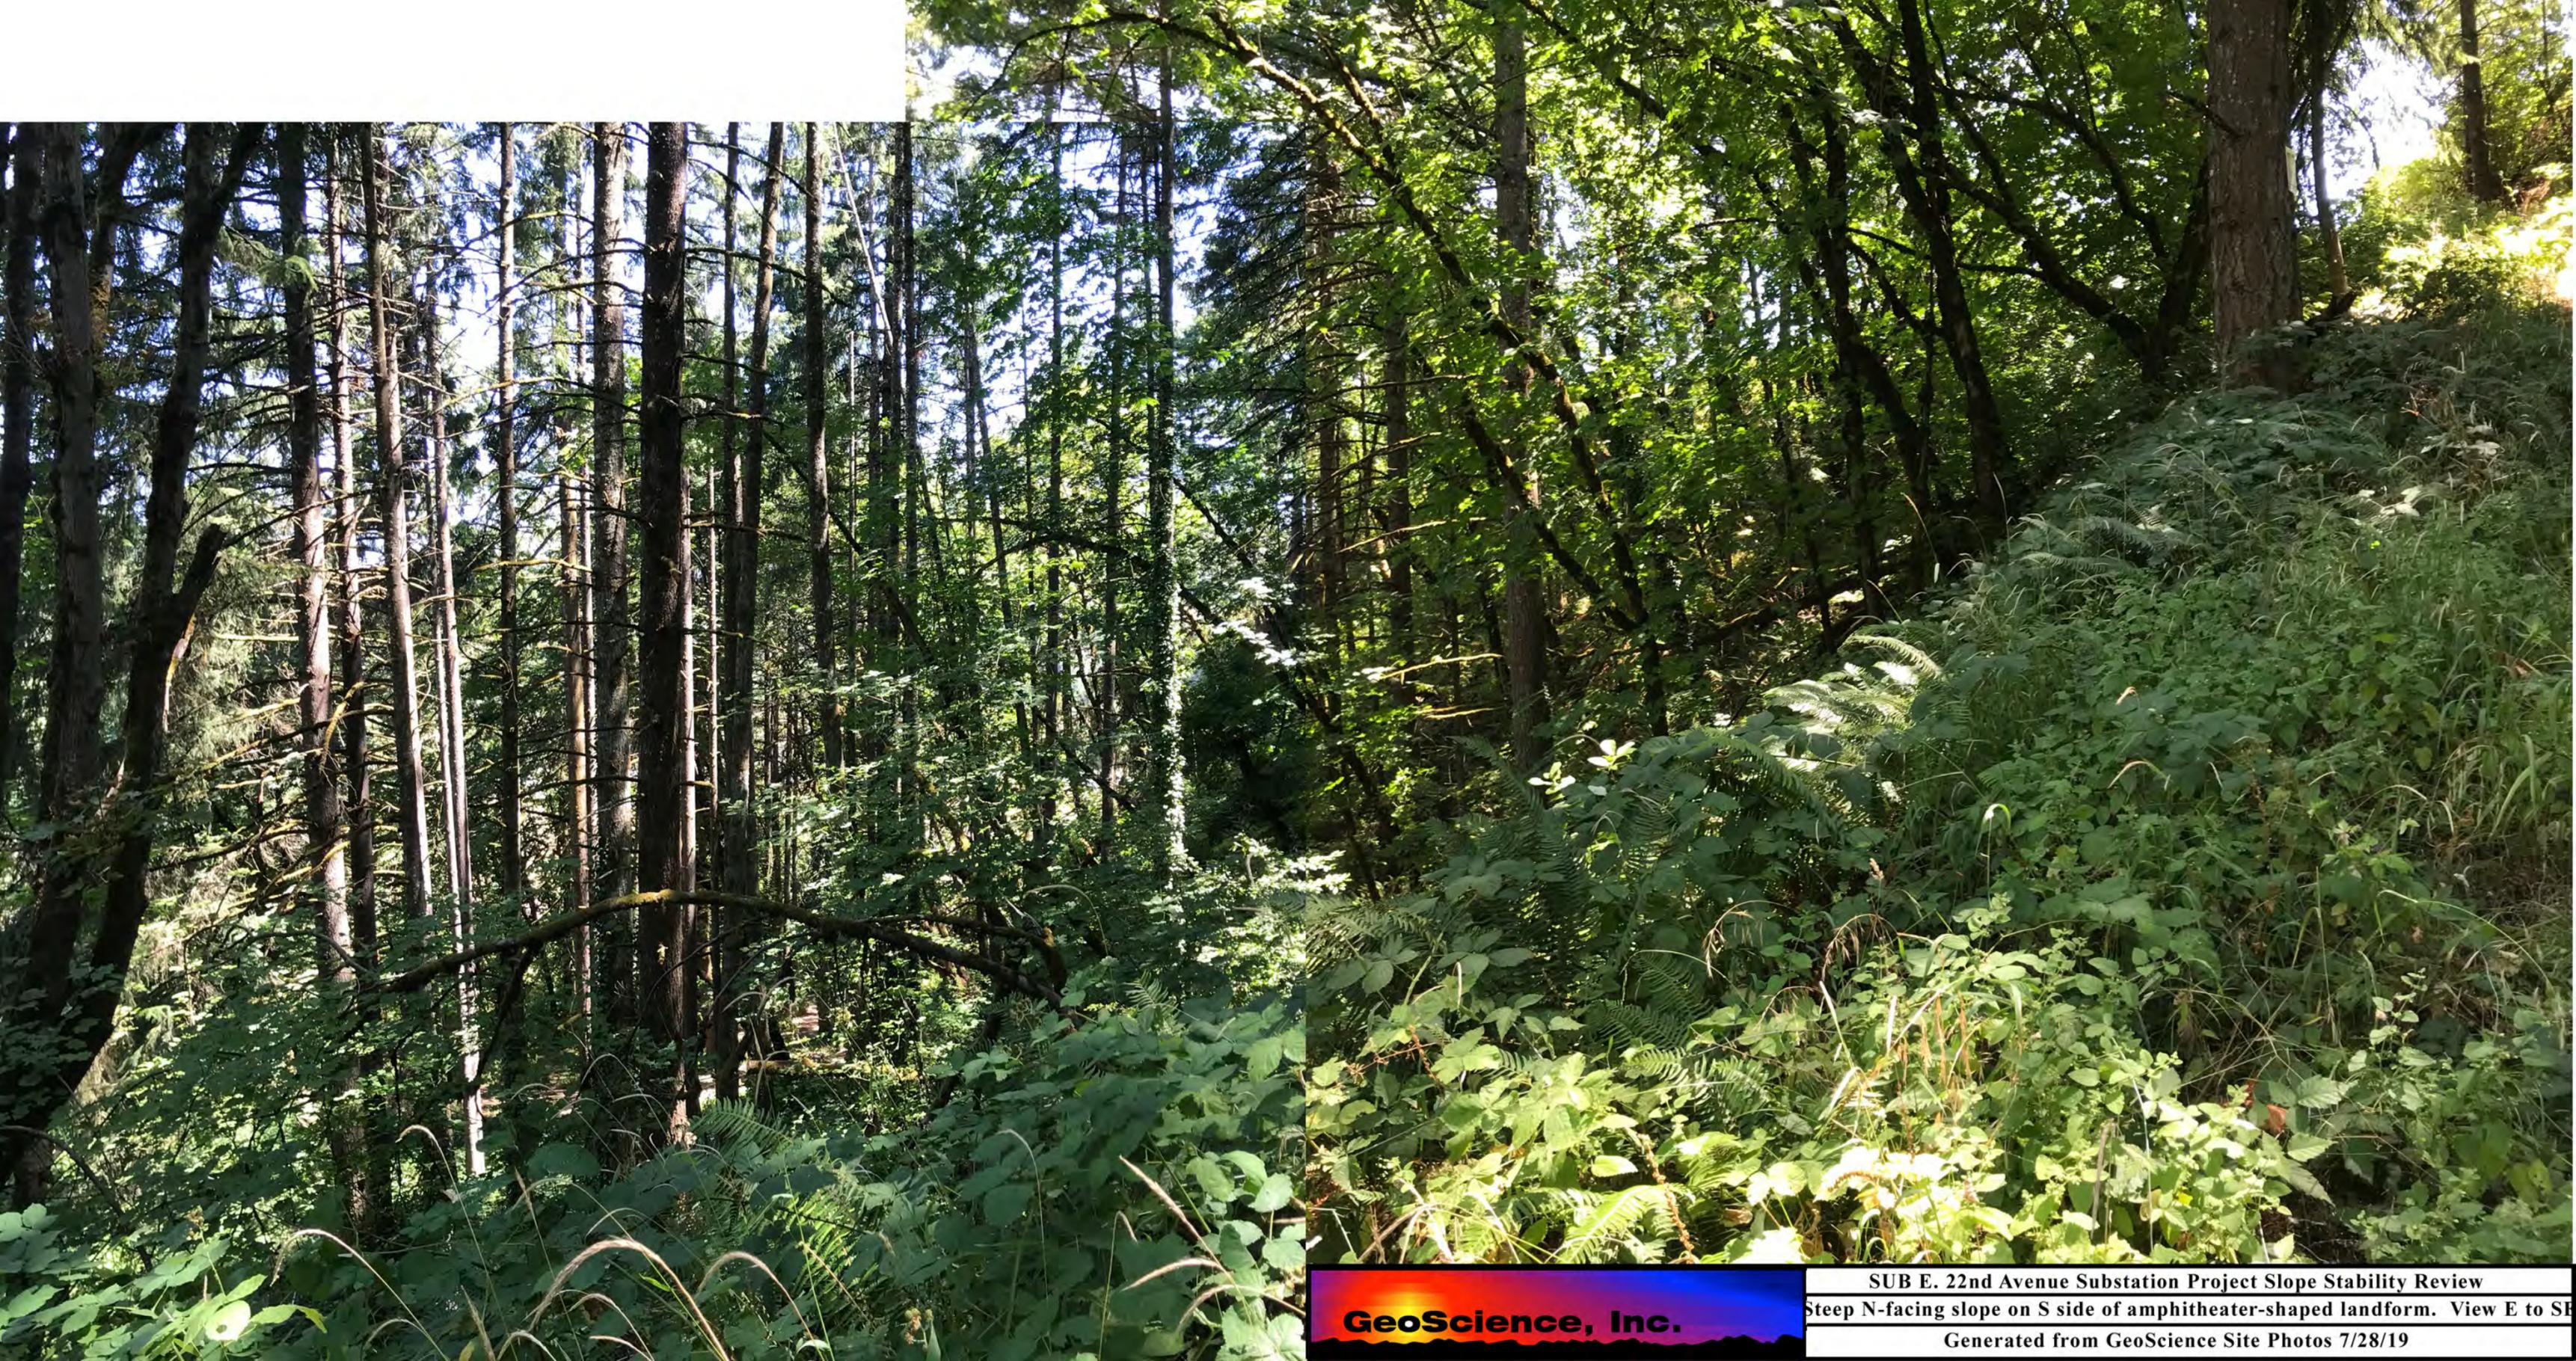
There is no indication that FEI conducted any assessment for evidence of previous debris flow activity on the steep slope. Such activity might require investigation (possibly including subsurface exploration) of the deposits downslope from the steep face in the cut bank for the railroad line and likely extending into the shallow subsurface of the deposits east of the rail line. If deposits consistent with debris flow origin are found during such an investigation, it may be prudent to reconsider the timber harvest plans (“tree felling”) in light of the new evidence.

SUB E. 22nd Avenue Substation Project Slope Stability Review
Steep N-facing slope on S side of amphitheater-shaped landform. View E to S
Generated from GeoScience Site Photos 7/28/19

In addition, it is recommended to examine both the cut bank for the railroad and the valley floor east of the railroad grade downslope from the steep north-facing slope in the south portion of the amphitheater-shaped land form for geologic evidence of the past occurrence of debris flows. If such evidence is found, it may be prudent to re-consider the planned removal of numerous trees from the steep slope or determine how to mitigate the risk of such occurrences to both the railroad and other downslope properties.
