**Glenwood
Natural Resource
Wildlife Habitat Assessment
2010**

Report and field sheets
City of Springfield
Environmental Services Division
Water Resource Section

Glenwood Wildlife Assessment February 2010

February 10, 2010
Sunny Washburn
Meghan Murphy

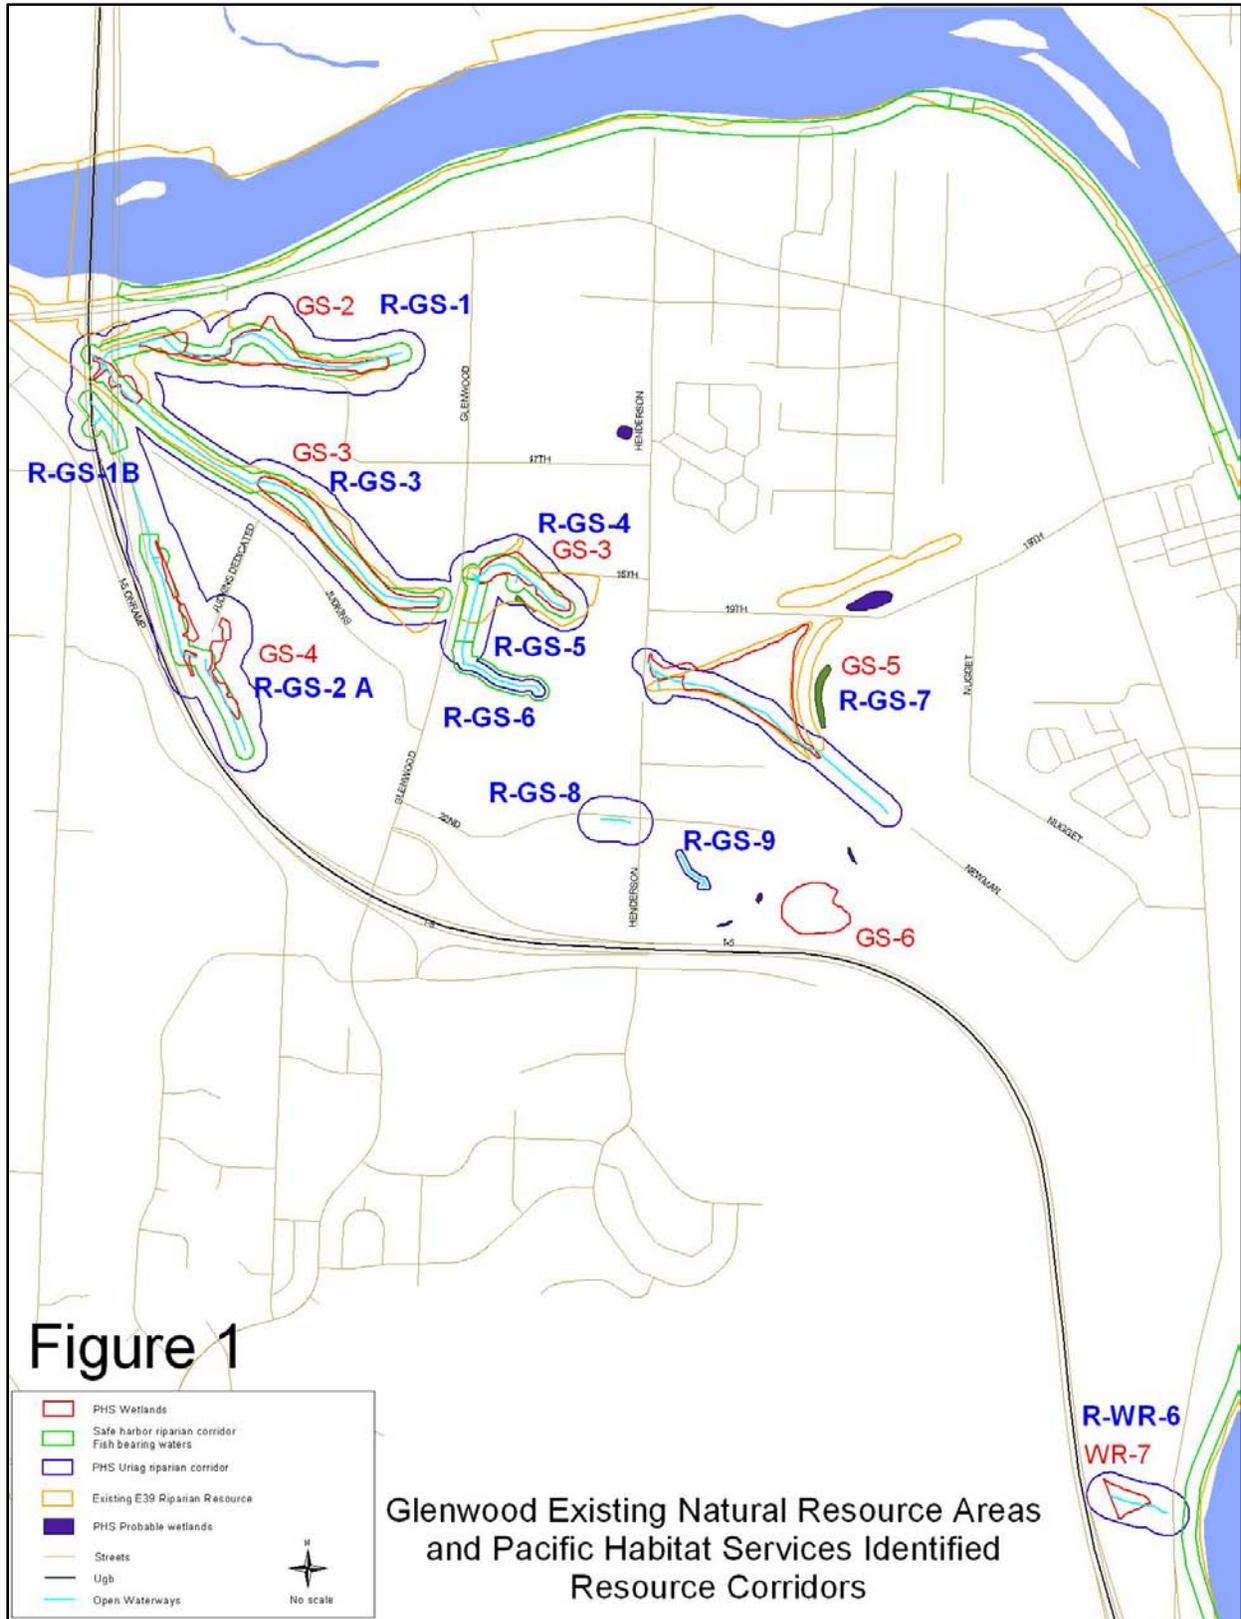
Figure 1 - Identified sites

In order for the City to incorporate the PHS riparian areas identified into the Cities existing Natural Resource Inventory (NRI) it was determined that an additional assessment method was required since the NRI is an adopted inventory by Council. See Figure 1 for identified sites.

Six sites met the criteria of Tier1. See Table 1 – Tier1 Significance Criteria Evaluation Table for results. See Figure 1 for identified sites.

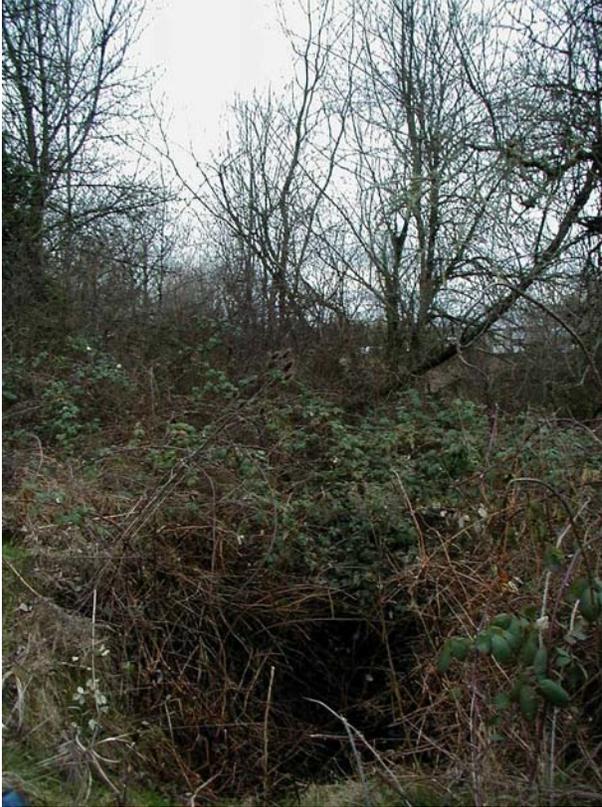
RGS-1 eastern upper reach facing north

General topography: Flat upper banks with slight slope to wetlands.

Water features (pond, lake, stream stagnant, etc.): Upper east end is 2 small streams feeding into the wetlands (Spfld. WQLW designations). Both appear to be storm system fed. Wetlands are ponded with a flowing channel.

Major structures, roads: 2 stormwater outfall pipes on the upper east end, parking lot and pavement on 2 sides, commercial back yard on the north side and wetlands on the west.

Mostly non native vegetation along top of banks and around asphalt. Lower lying areas and wetland edge have a more native vegetation base of emergent wetland community to palustrine forested. Canopy layer can be improved as blackberries and willows are the co-dominant species.

There is low habitat layering at this upper end; cottonwoods are dominant tree species with willows and blackberries as co-dominant. Large and small woody debris throughout the area with a large duff layer of leaves and twigs. Water system seems to be storm fed and seasonal with the wetland area staying damp; currently ponded with a stream flow thru the edge.

This area is surrounded by commercial land and uses with a parking lot and asphalt on 2 sides and a back yard of a commercial business on the north side. Lots of garbage in the water, along banks and throughout the riparian area. Heavy noise from large garbage trucks and equipment moving metal dumpsters. There are two stormwater outfalls in this small area; one from a parking lot swale not currently flowing and the other is a permitted (DEQ permit holder) industrial stormwater discharge outfall from the Sanipac site with discharge water currently flowing.

This area can be easily incorporated into the existing E39 boundaries. The E39 boundary is very close to the end of the upper reach and the WQLW boundary. This area has a lot of potential for enhancement thru invasive species removal and garbage control. The industrial discharger may also be able to provide enhancements to the stream channel that they discharge to as a water treatment area (Water Quality Facility – swale).

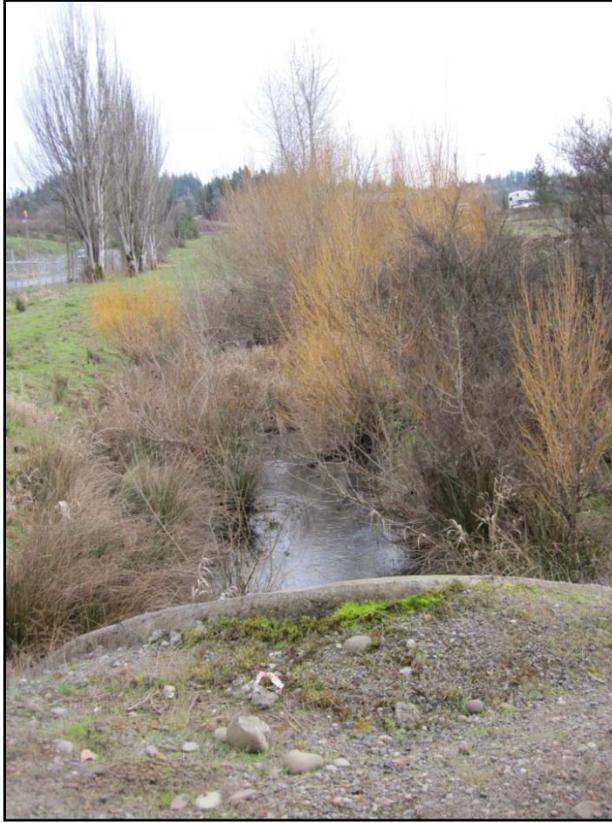
RGS-2A facing south at fish culvert

Water features (pond, lake, stream stagnant, etc.): Wetland channels are braided and come from underground springs that are also braided. The main watercourse is a narrow stream that starts out meandering and becomes channelized as it flows north. Added flows from storm system culverts and industry. A large fish friendly culvert separates the system into two sections of open water with riparian corridors.

Major structures, roads: I5 along the west top of bank on part of the system. Culverts and outfall structures. A section of this system was recently piped with a large fish friendly culvert separating it from the lower waterway section under the bridges.

A dominant canopy is missing in the wetlands with scattered Hawthorn trees and a small stretch with conifers bordering parts of the wetlands. The main watercourse has a dominant canopy of willows mixed with hawthorns.

There is low habitat layering along the watercourse with willows and hawthorn dominant. The wetlands are open and mowed.

This area is surrounded by commercial land and ROW. There is a lot of noise from traffic on I5. There are boot worn trails in the wetland area from foot traffic. ODOT currently has the area marked for bridge work they are doing to the north. Signs of culvert work are becoming over grown with blackberries and willows.

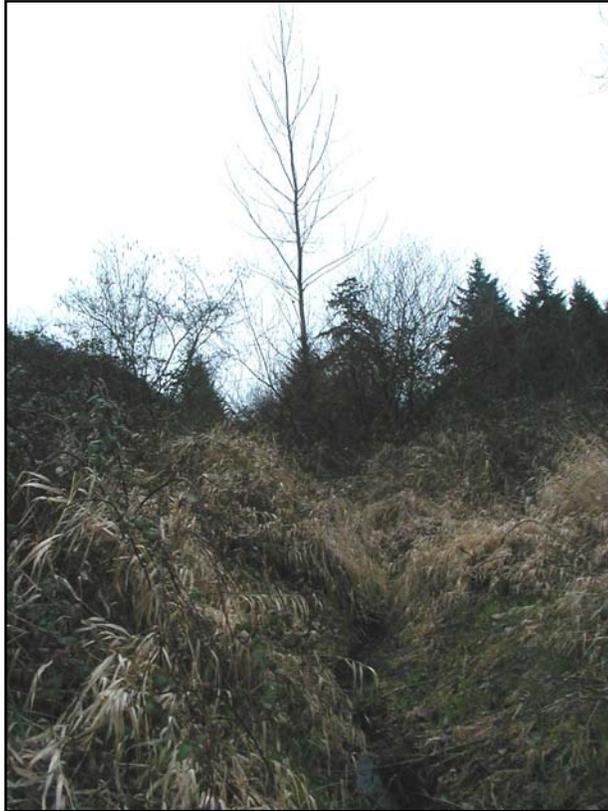
RGS-5 facing the north taken from the southern end

There is a nice snag that is currently being used by birds; it has wood pecker holes in it and signs of nesting.

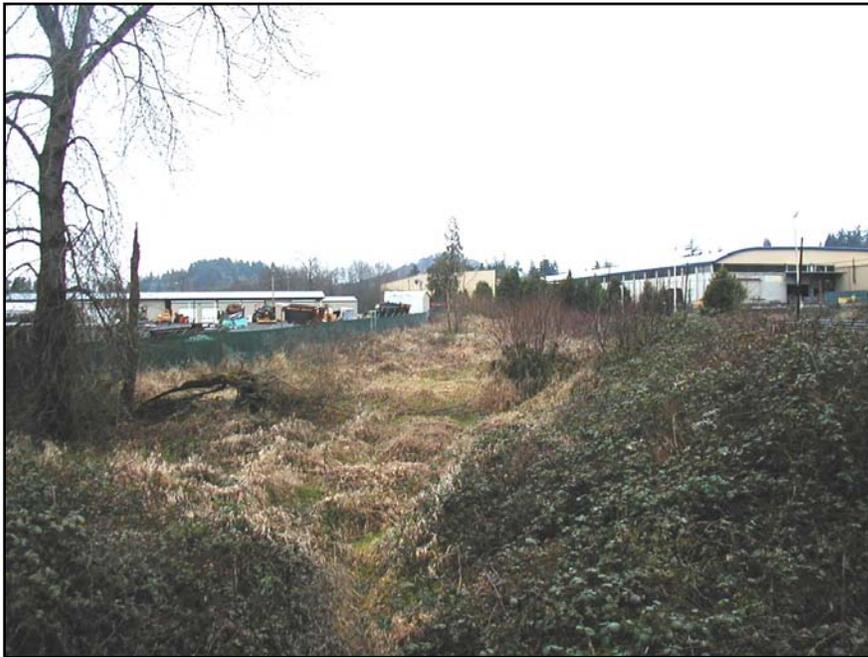
RGS-6 facing east taken from the west end

Mostly non native vegetation throughout the reach as Reed Canary grass has taken over the area. A dominant canopy is missing with scattered willows, maples and a couple fir trees present. The waterway is being choked by Reed canary grass. A large cottonwood is on the west end with a dead snag that birds are using. Signs of wood pecker holes and nesting in snag.

There is a nice snag that is currently being used by birds; it has wood pecker holes in it and signs of nesting.

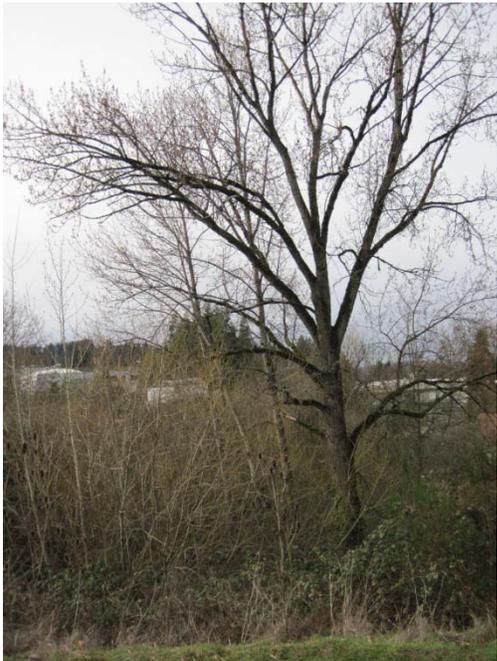
R-GS-9 facing northwest from top

potential for erosion and bank failure. This site could potentially be used as a water quality facility to treat water coming into Springfield from under the freeway.
