Re: *Re-Opened Record (Tree Felling Permit)*
Applicant: Springfield Utility Board
City File No. 811-19-000016-TYP 2
Project Name: SUB Glenwood Substation and Transmission Line Tree
Felling Permit
Our File No.: 13538/12953

RE: REVIEW OF FEI 7/24/19 SUBMISSION, SUB POWER LINE, E 22ND AVENUE.

RE: SLOPE STABILITY CONCERNS, SUB POWER LINE, VICINITY OF E 22ND AVENUE

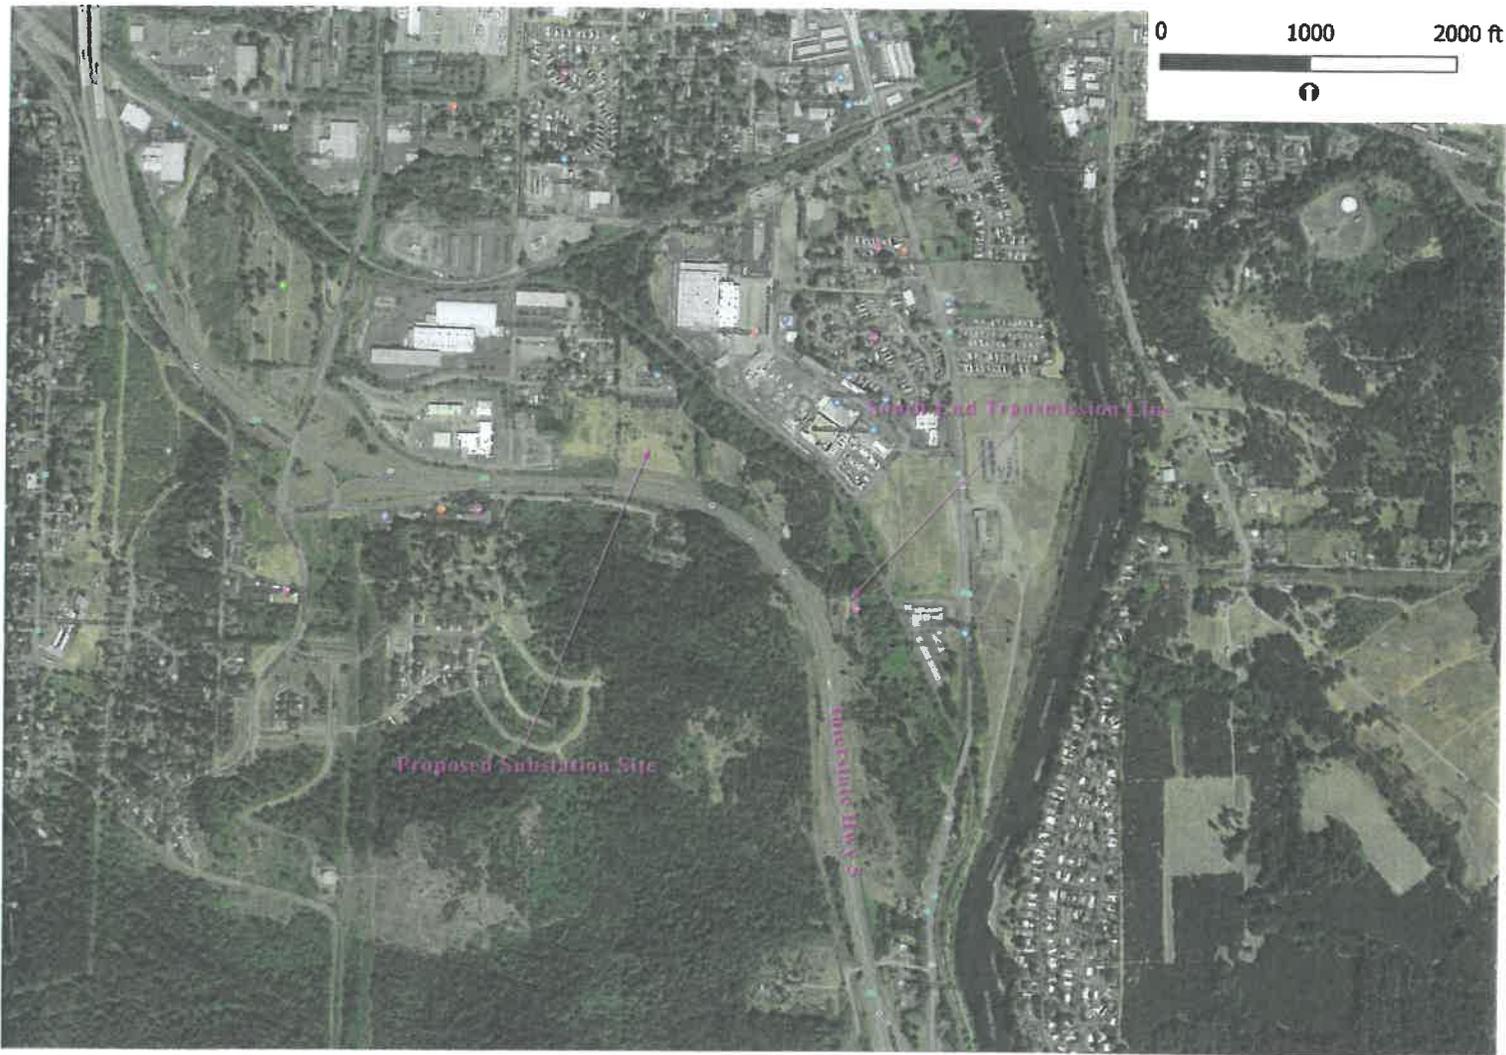
SUB E. 22nd Avenue Substation Project Slope Stability Review
Figure 1: Project Location
Base from Google Earth and QGIS

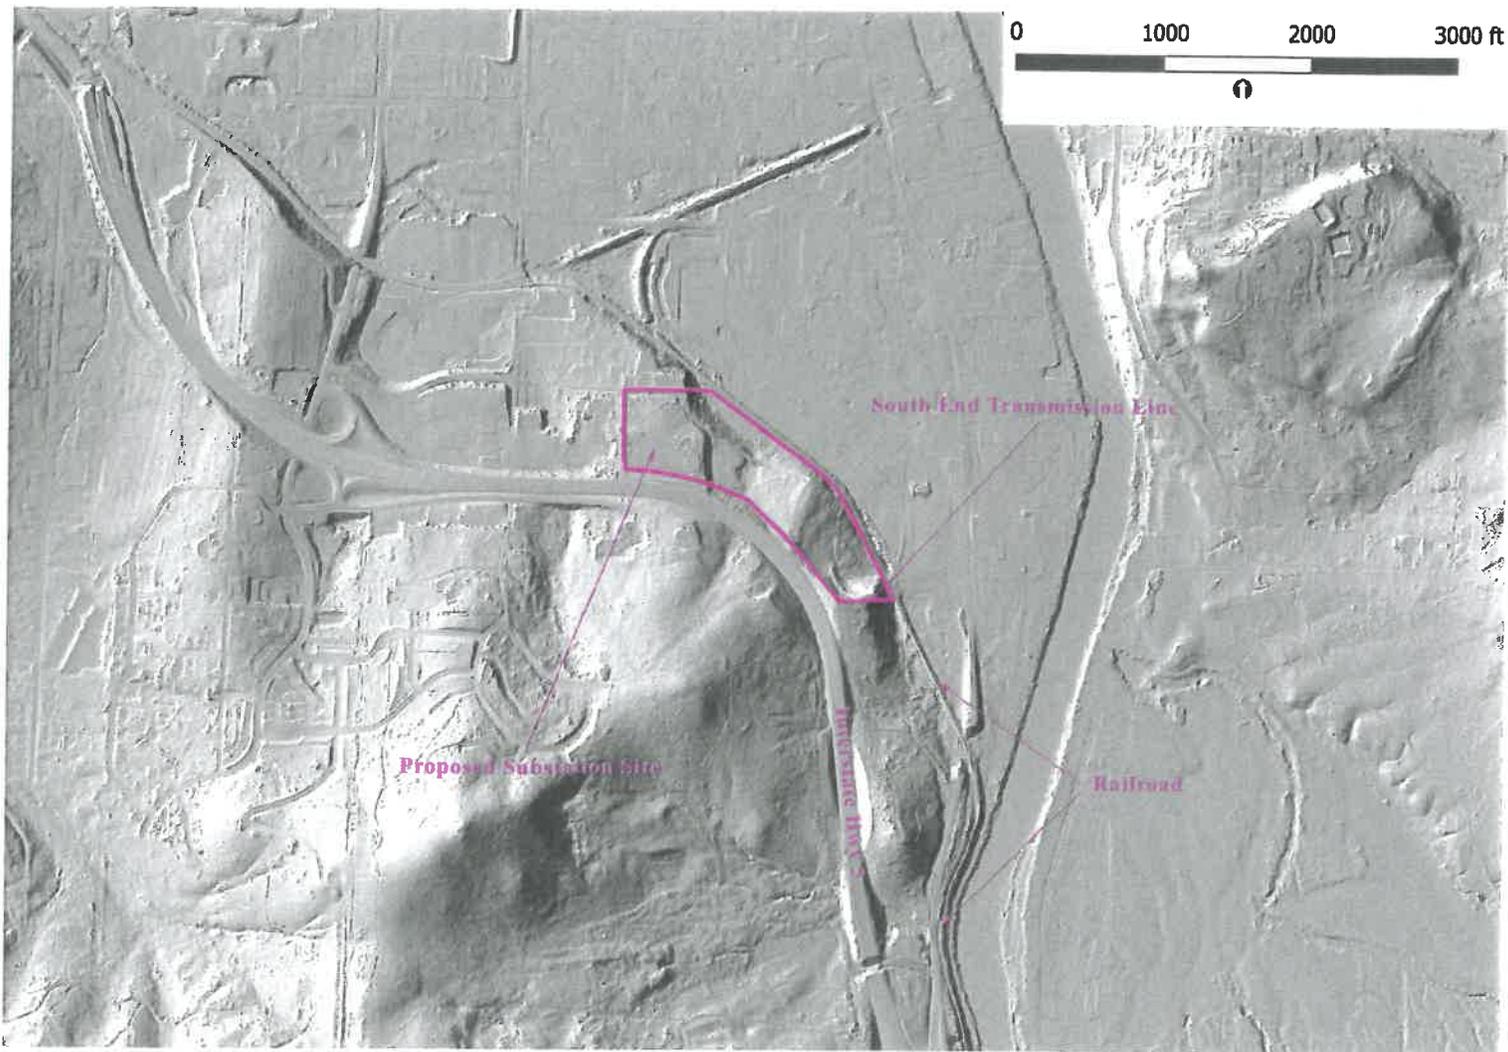
SUB E. 22nd Avenue Substation Project Slope Stability Review
Figure 2: Project Location on LiDAR Hillshade Image
Base from DOGAMI and QGIS

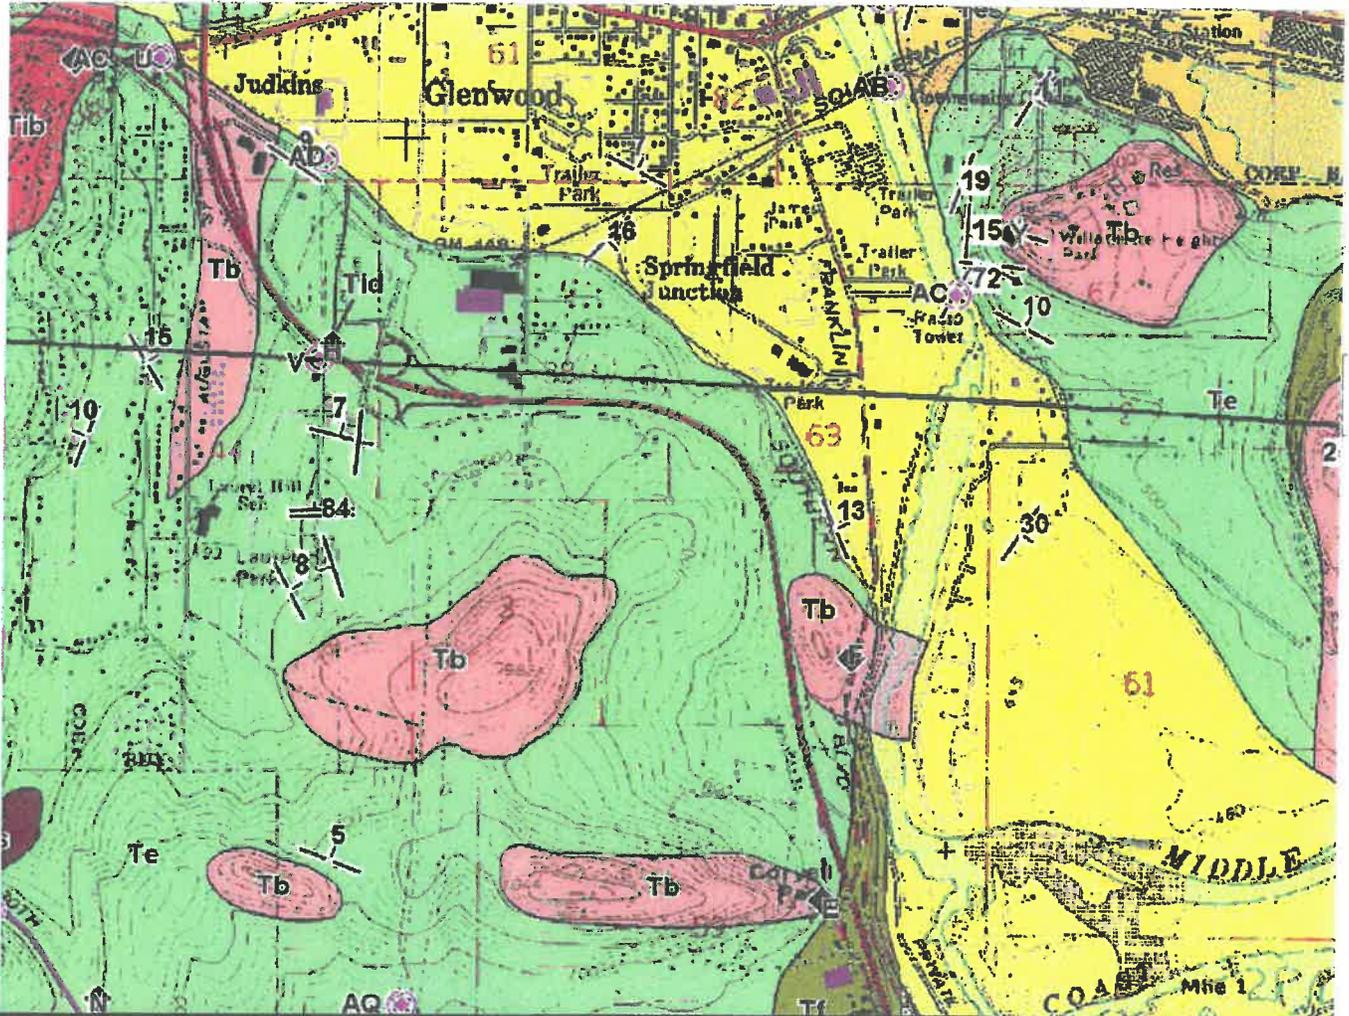
The *Preliminary Geologic Map of the Eugene East and West Quadrangles, Lane County, Oregon* (Madin and Murray, DOGAMI, 2005) indicates that the area is underlain by the late Eocene - early Oligocene *Eugene Formation*, which consists of shallow marine sandstone and siltstone with local/minor conglomerate beds. In the vicinity of the site, the map shows generally northeasterly to southeasterly dips ranging from 9 to 15° with a dip of 13° to the ENE directly at the site (Figure 3). A basalt body is shown to be present not far south of the project area.

SUB E. 22nd Avenue Substation Project Slope Stability Review
Figure 3: Portion of Eugene East and West Quadrangles Geologic Map
 Base from Madin and Murray, DOGAMI, 2005.

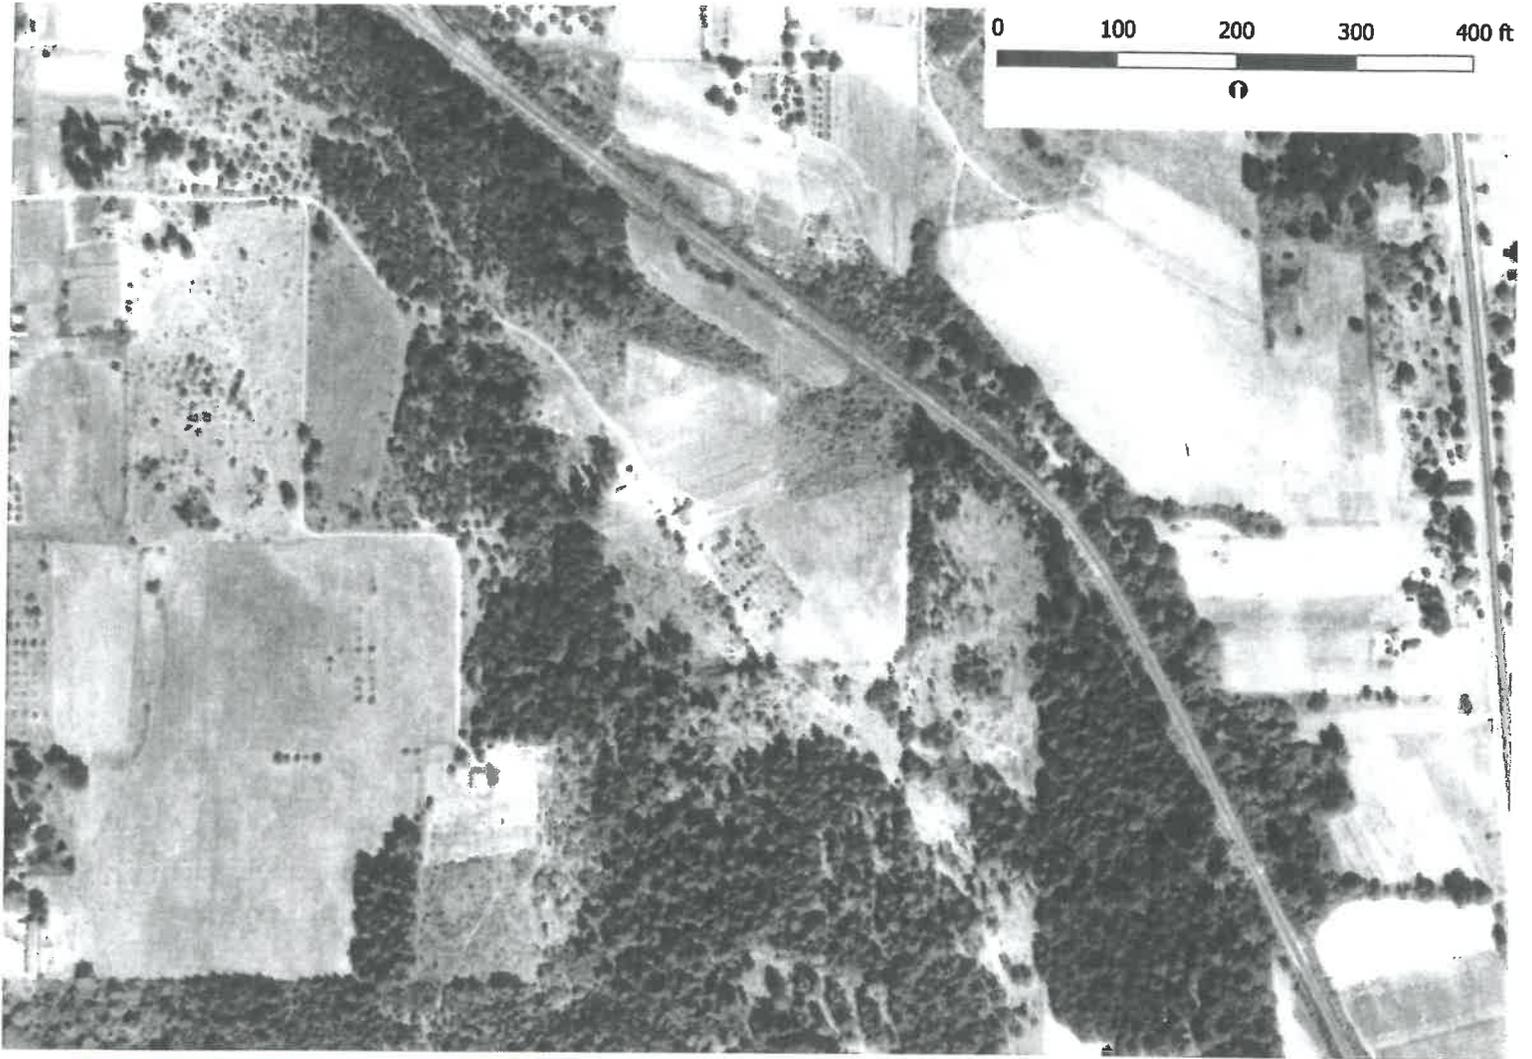
At the time, the entire northern portion of the project site was without tree cover, and appears to have been used to grow hay or grain (Figure 4a). The western portion of the southern extension of the power line had been recently logged. A relatively dense fir forest covered the lower slopes of the amphitheater-shaped slope in the southern portion, and the hill on which the EWEB power line has now been constructed.

SUB E. 22nd Avenue Substation Project Slope Stability Review
Figure 4: 1936 Air Photo w/o Annotations
Base from 1936 Willamette Valley Project, Photo 3888.

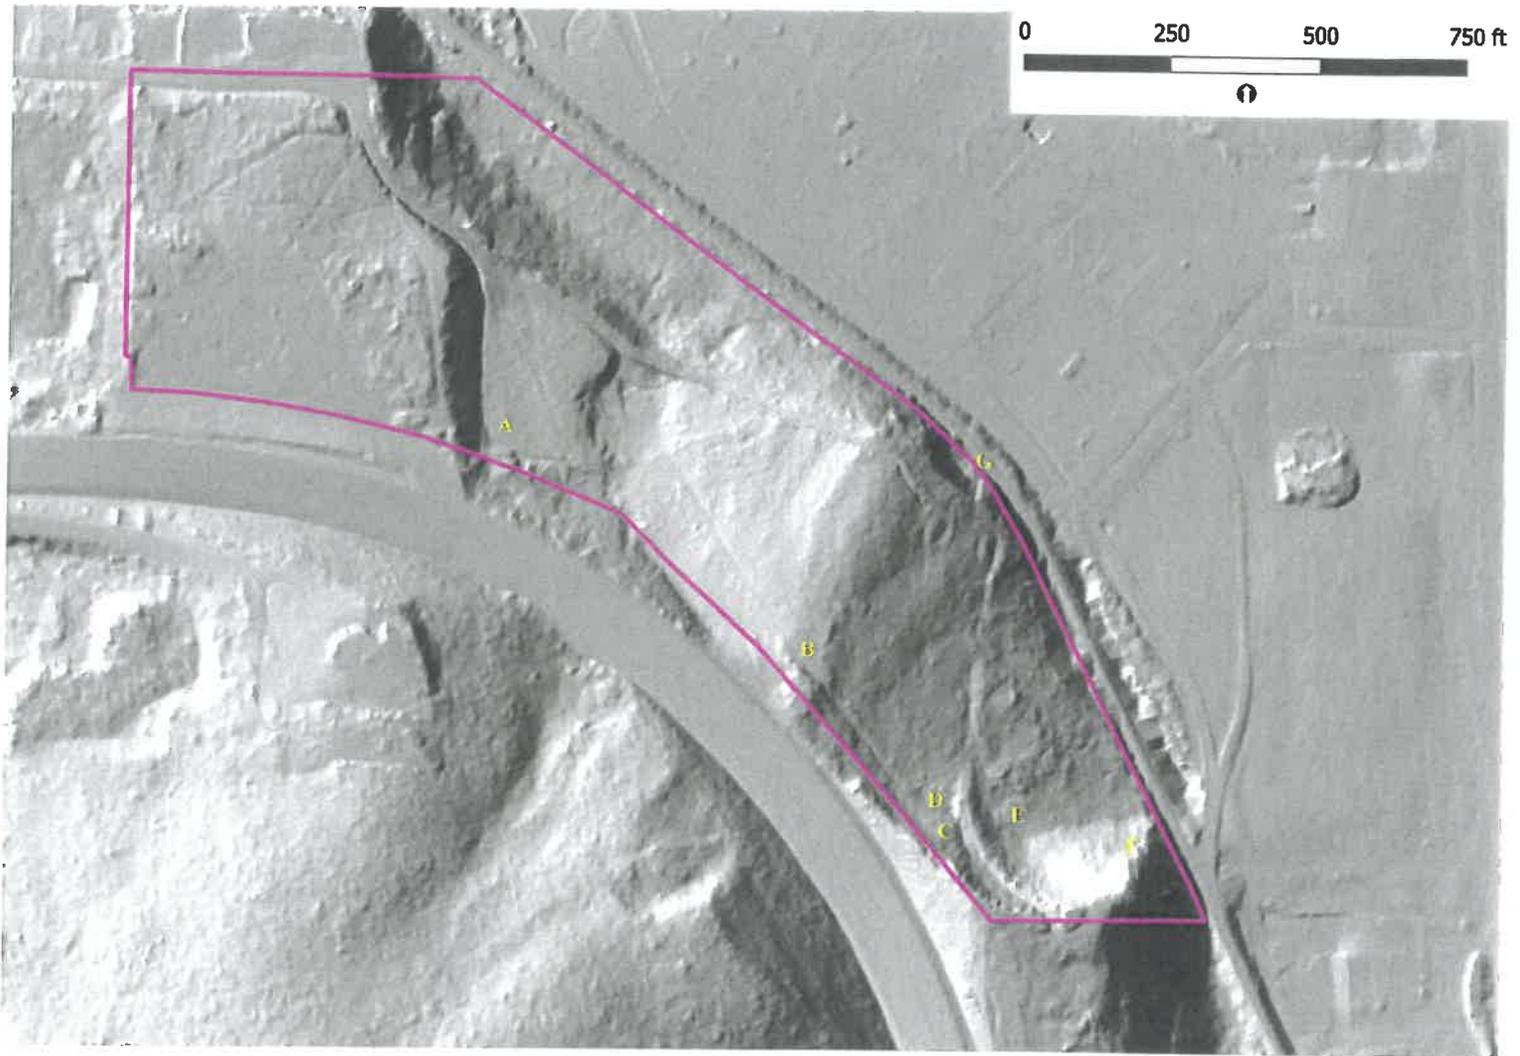
The LiDAR (Light Detection and Ranging) DEM (Digital Elevation Model) for the area was downloaded from the DOGAMI website. A hill-shade image of the site was created with the virtual illumination placed at an azimuth of 300° and an inclination of 30°. The resulting image is shown on Figure 5. For orientation, the same area is shown on a Google Earth image on Figure 6. A contour map derived from the LiDAR DEM is shown on Figure 7.

SUB E. 22nd Avenue Substation Project Slope Stability Review
Figure 5: LiDAR Hillshade Image of Project Area w/Feature Location Points
Base from DOGAMI DEM and QGIS

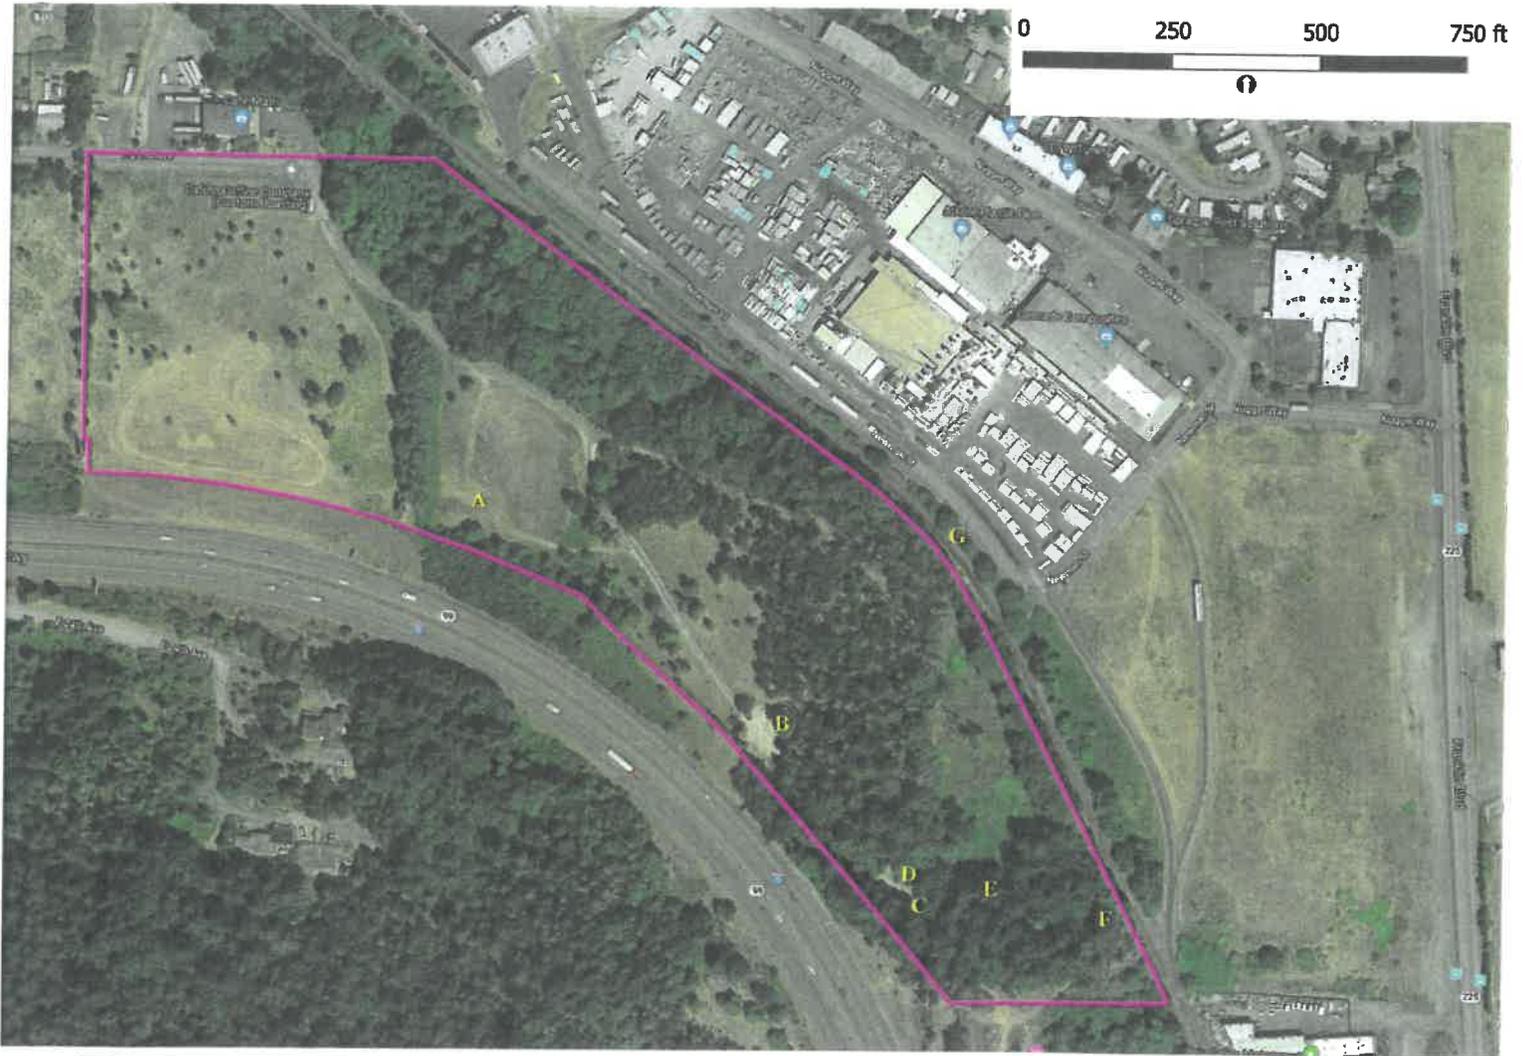
SUB E. 22nd Avenue Substation Project Slope Stability Review
Figure 6: Aerial Photo with feature Locations
Base from Google Earth and QGIS

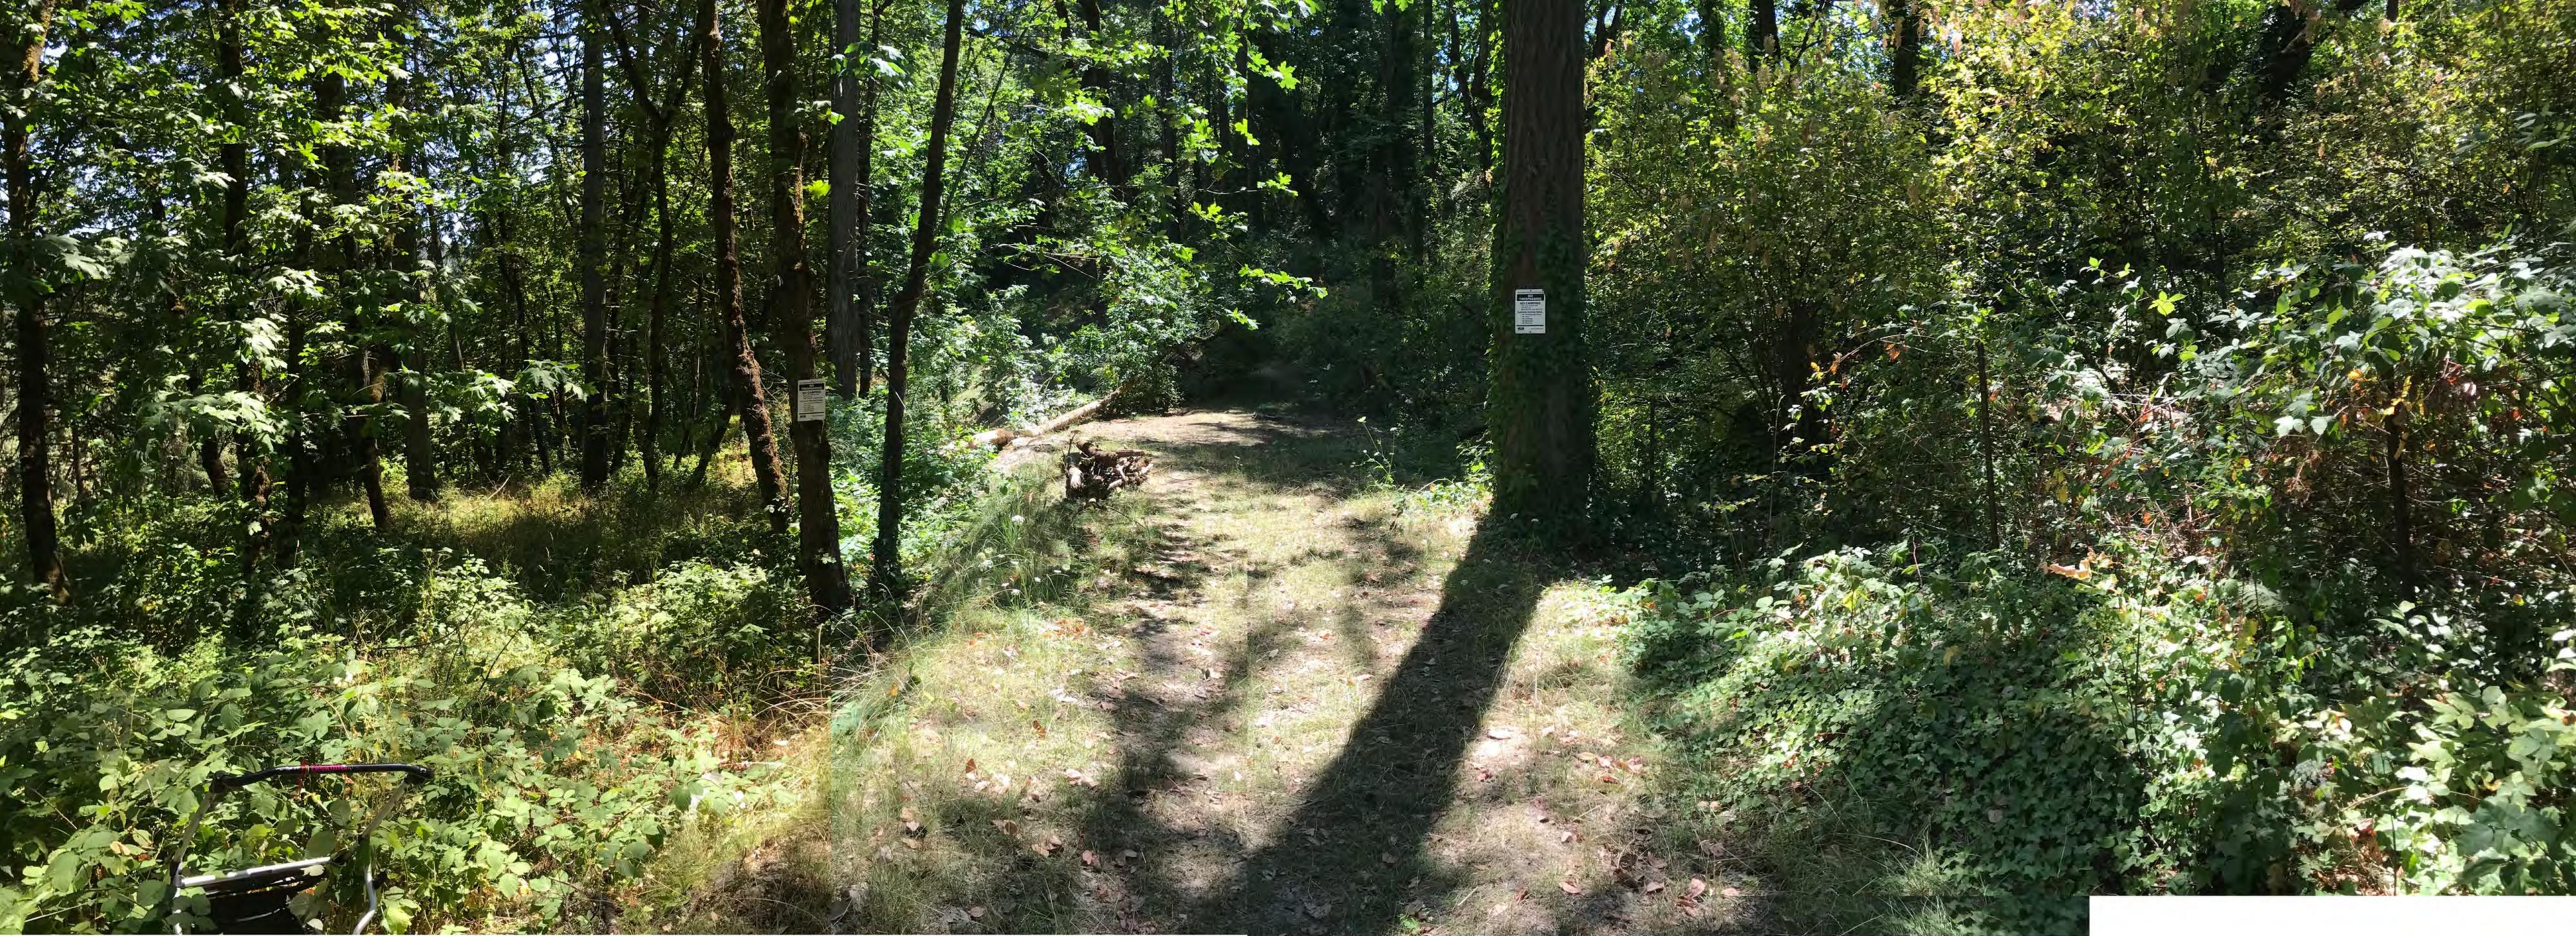
Cut in likely slope movement at Location C. View S to W.

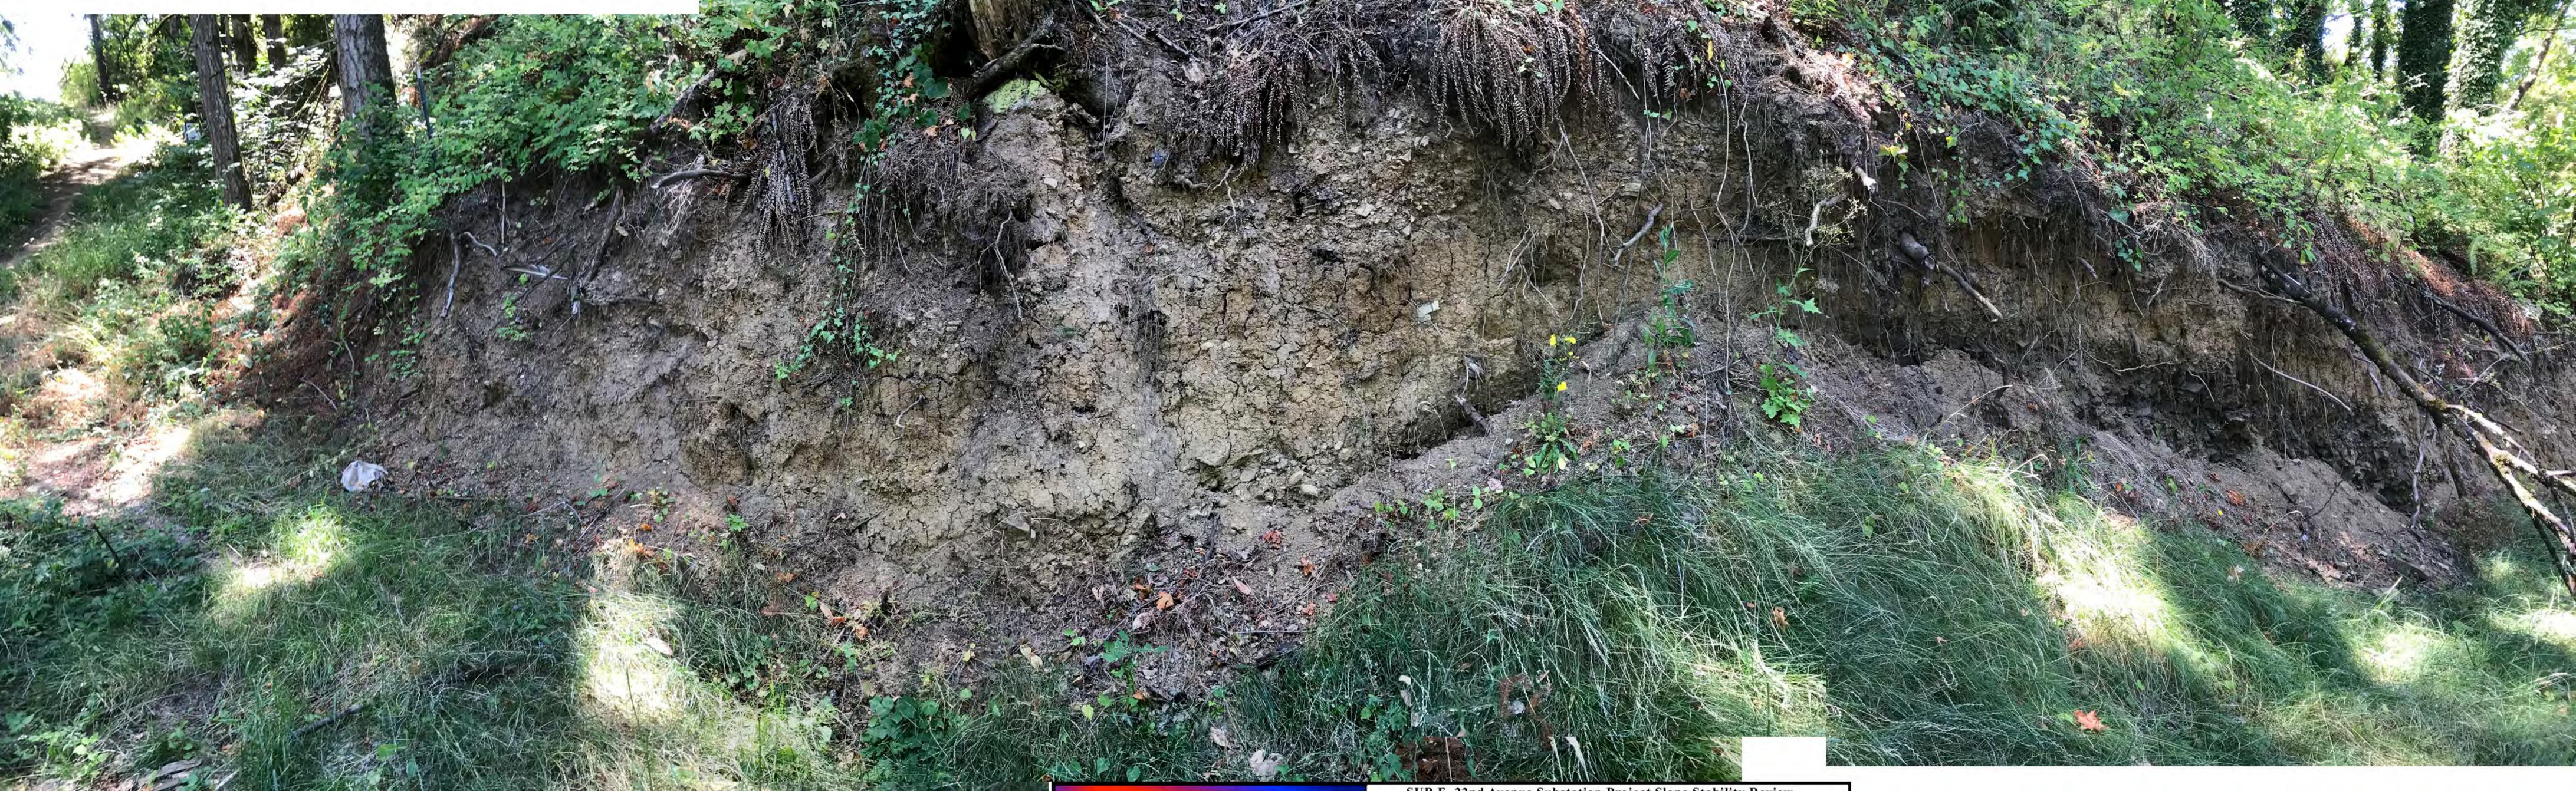
SUB E. 22nd Avenue Substation Project Slope Stability Review
Steep N-facing slope on S side of amphitheater-shaped landform. View E to S
Generated from GeoScience Site Photos 7/28/19
