Inventory and Channel Assessment Report For Springfield Waterways

Q St Floodway
Concrete Control Structure

August 2004

Environmental Services, Water Resources

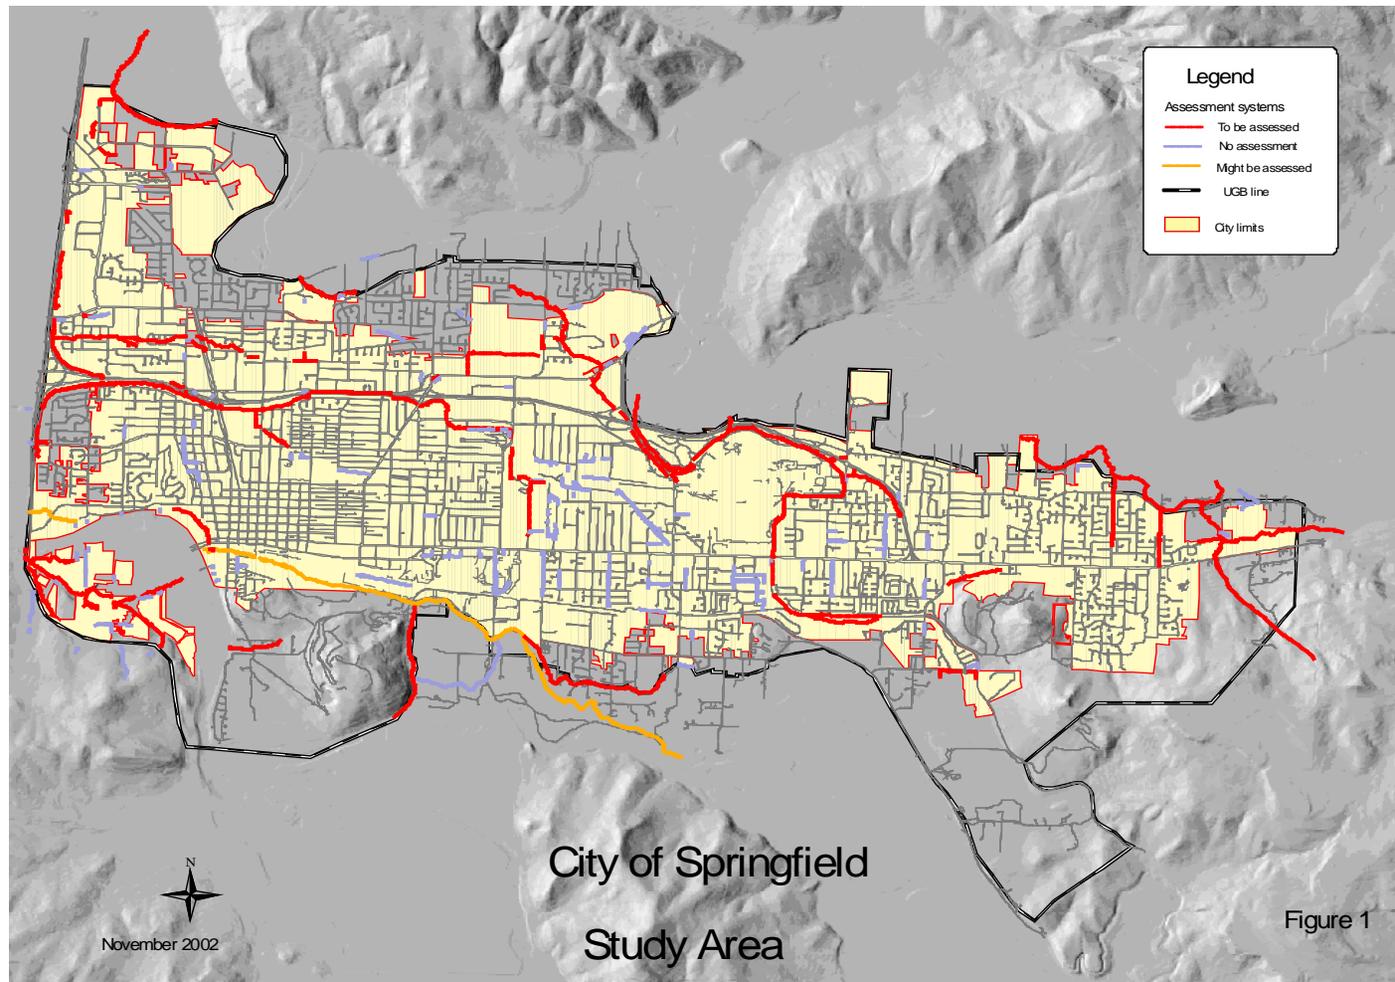
In June 2002, the Water Resources section of the Environmental Services Division for the City conducted a city-wide inventory and assessment of all surface drainage stream and channel systems that discharge to the Willamette and McKenzie Rivers. At the time of this assessment 44 stream systems within the Urban Growth Boundary (UGB) had been identified for the assessment study area. See figure 1, study map.

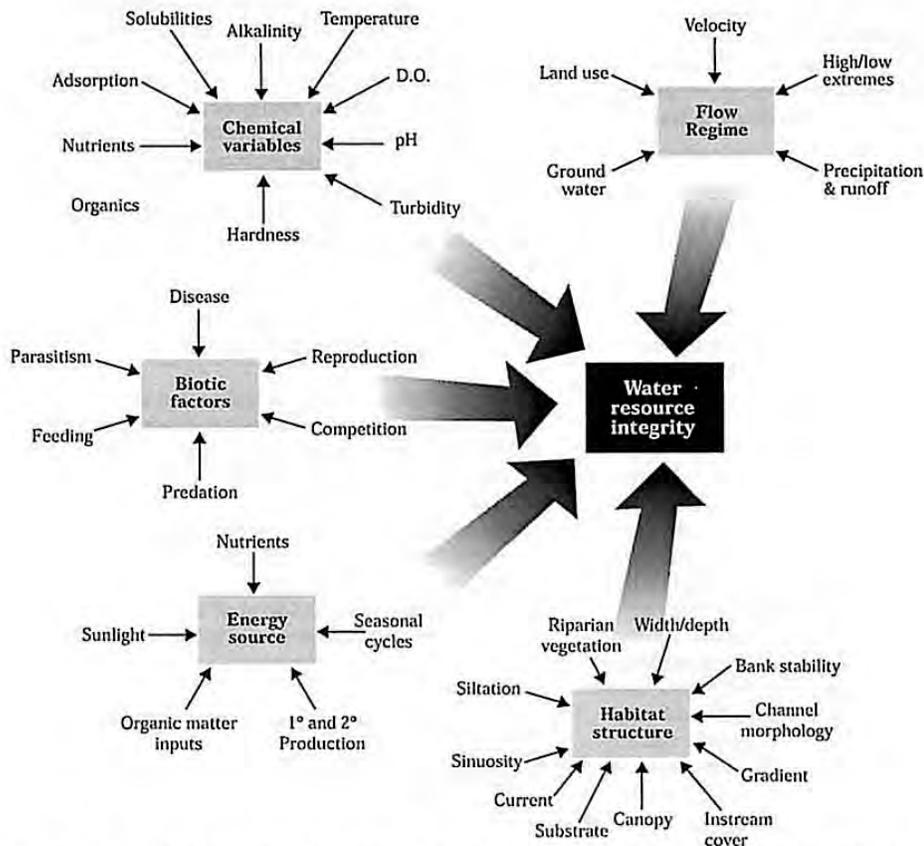
Figure 2 Factors that influence the integrity of streams (modified from Karr 1986)

A stream is a complex ecosystem in which several biological, physical, and chemical processes interact. Changes in any one characteristic or process have cascading affects throughout the system (see figure 2). Due to the complexity and changing nature of these variables not all influences in the chart could be investigated. However, this scoring and rating methodology attempts to record the most critical elements of a stream system.

The scoring of each reach was then totaled and divided by the number of categories scored. This returned an overall health rating. The overall health ratings are based on the functional value of a stream or channel system. Functional values are benefits provided by resources (see figure 2). The ratings return a value that is interpreted as poor (<6.0), fair (6.1 - 7.4), good (7.5 - 8.9), and excellent (>9.0), this numeric value represents the “Functional Value” of the system or reach. The functional value can be used as a general statement about the “state of the environment”, or over a period of time as an indicator of “trends” in the conditions, or as a baseline study to characterize health.

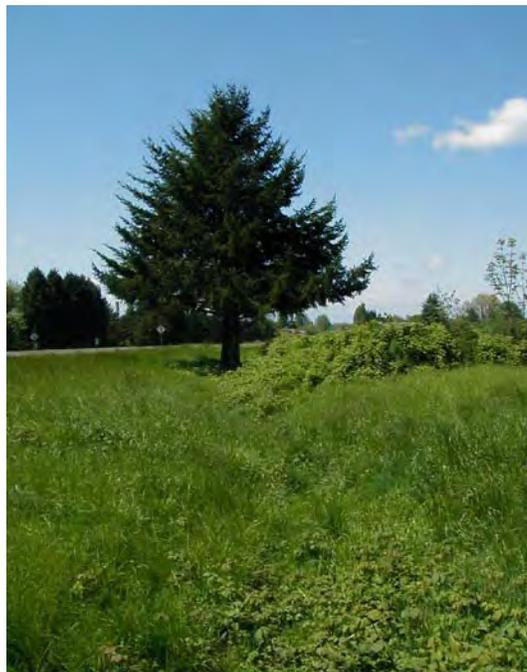
48th & Highbanks Channel looking west

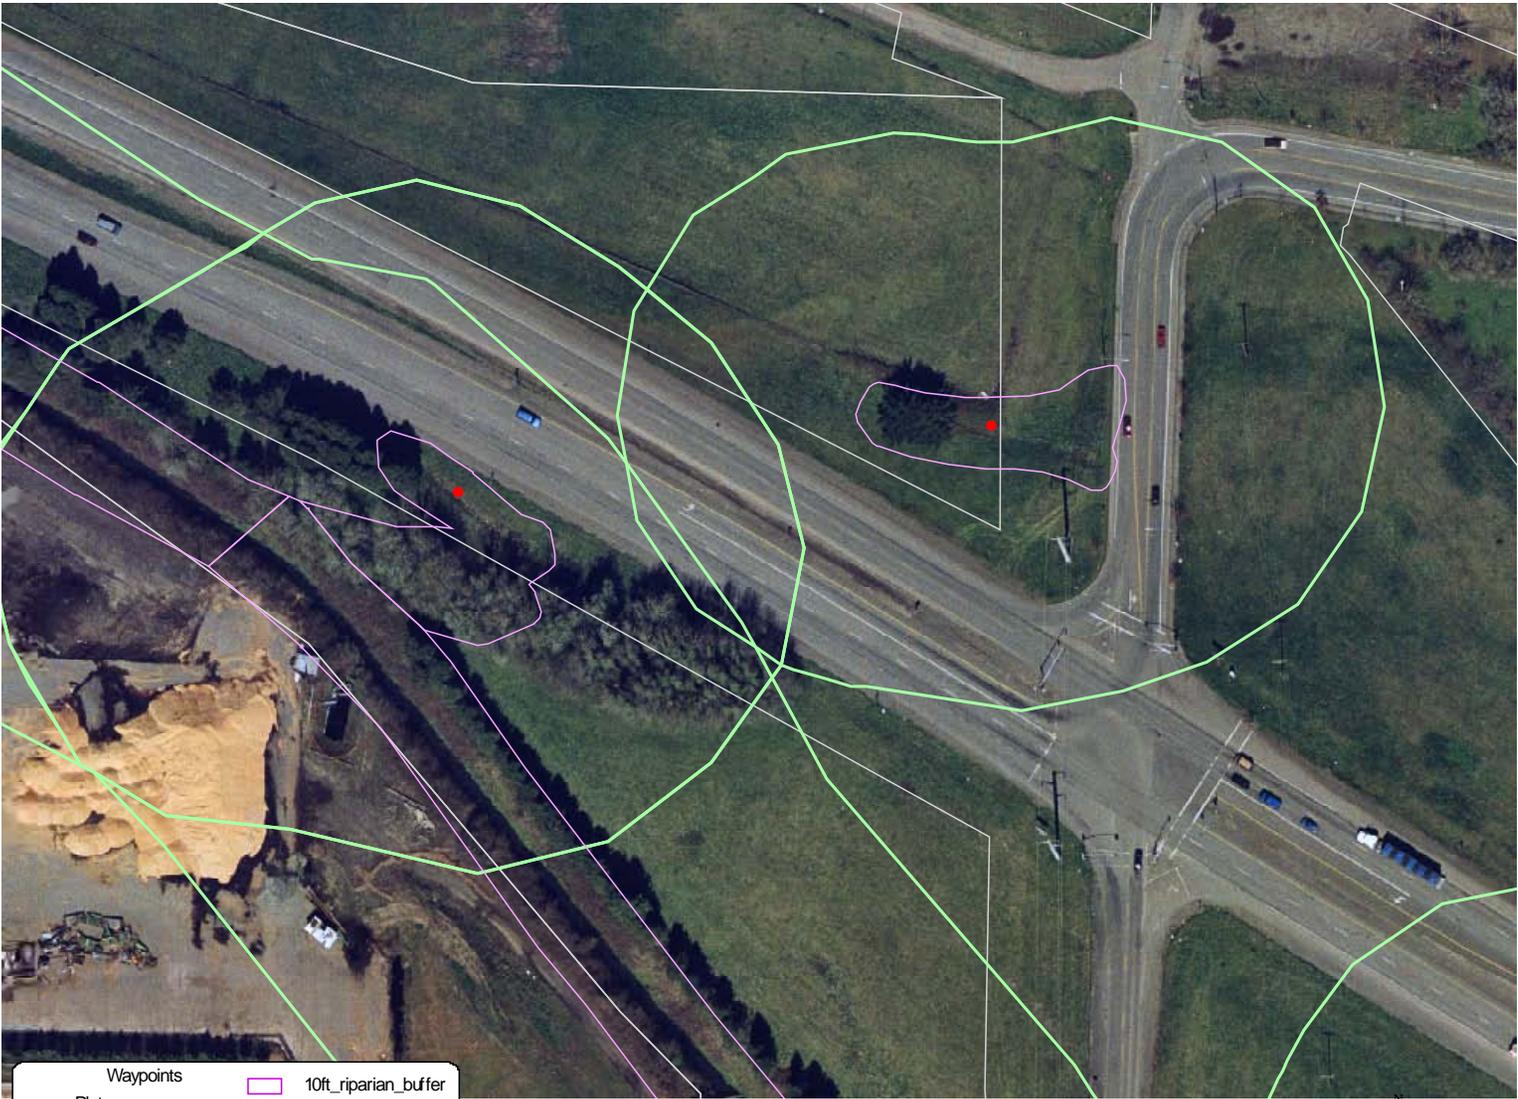
48th & Highbanks Channel

Waypoints	
● Plot	10ft_riparian_buffer
● Seed Collection Site	200ft_landuse_buffer
● In Channel Structure	tax lots

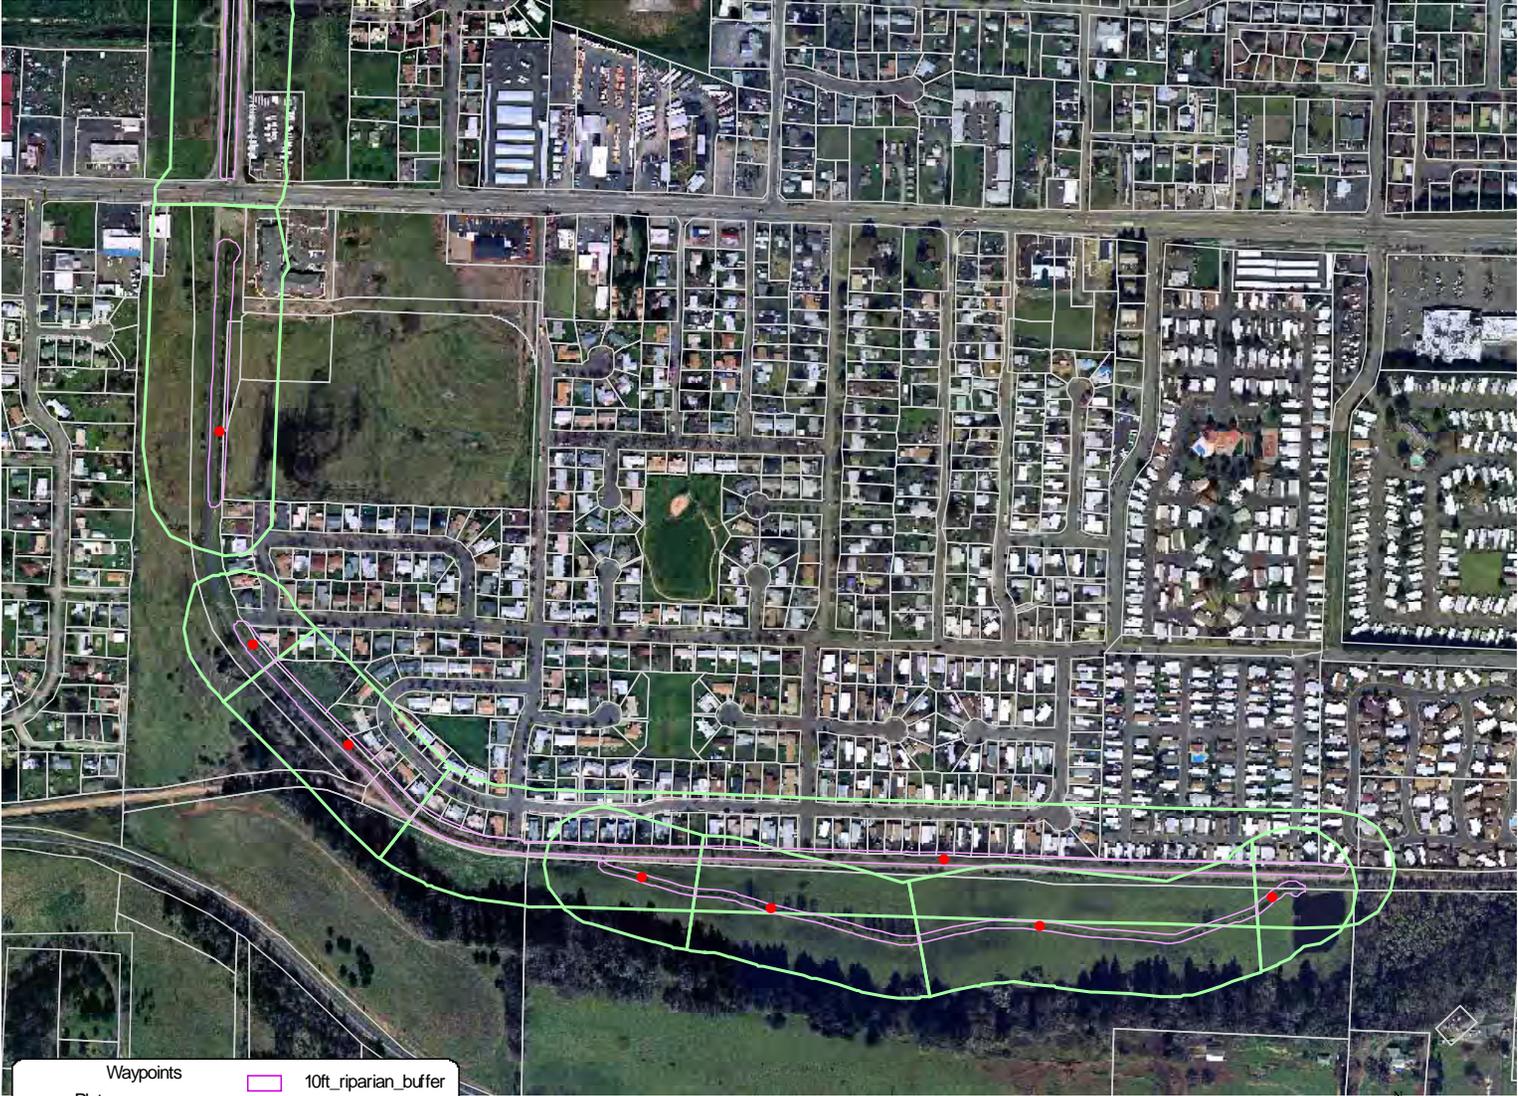
48th St. Channel - South of Main St.

Waypoints	10ft_riparian_buffer
Plot	200ft_landuse_buffer
Seed Collection Site	tax lots
In Channel Structure

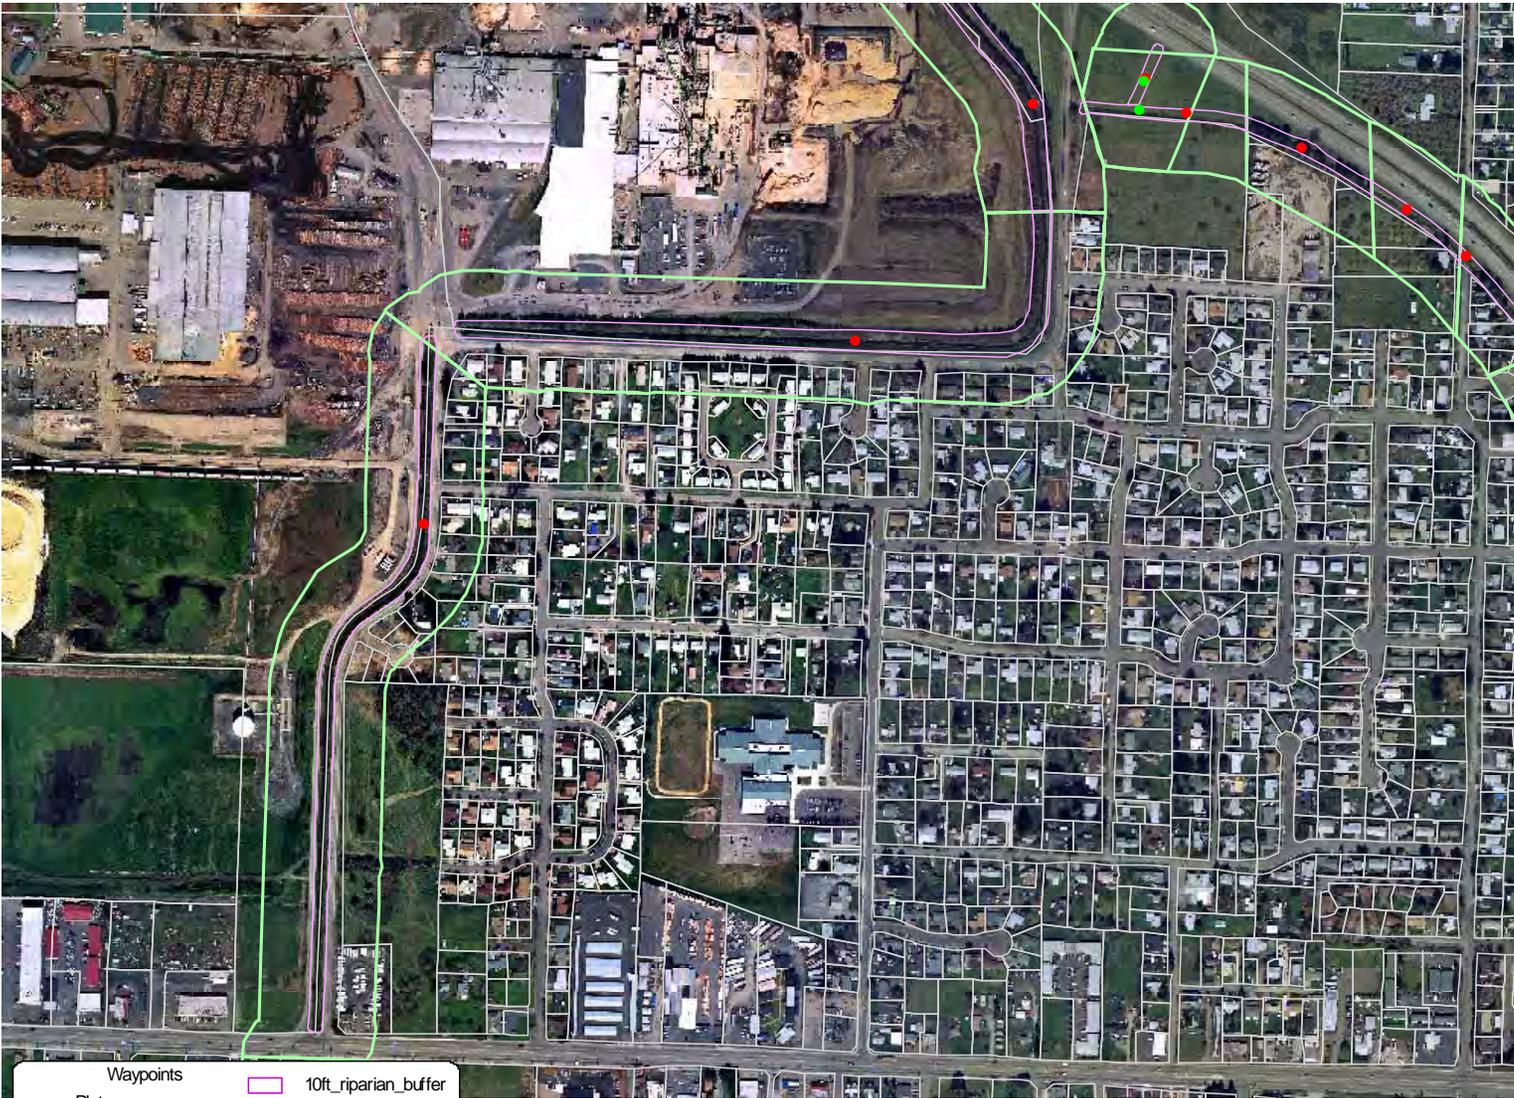
48th St. Channel - North of Main St - middle section

Waypoints	10ft_riparian_buffer
Plot	200ft_landuse_buffer
Seed Collection Site	tax lots
In Channel Structure

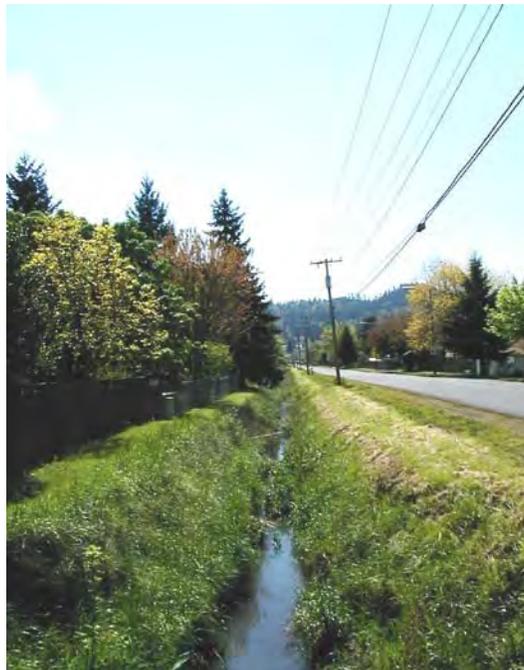
69th St Channel facing south

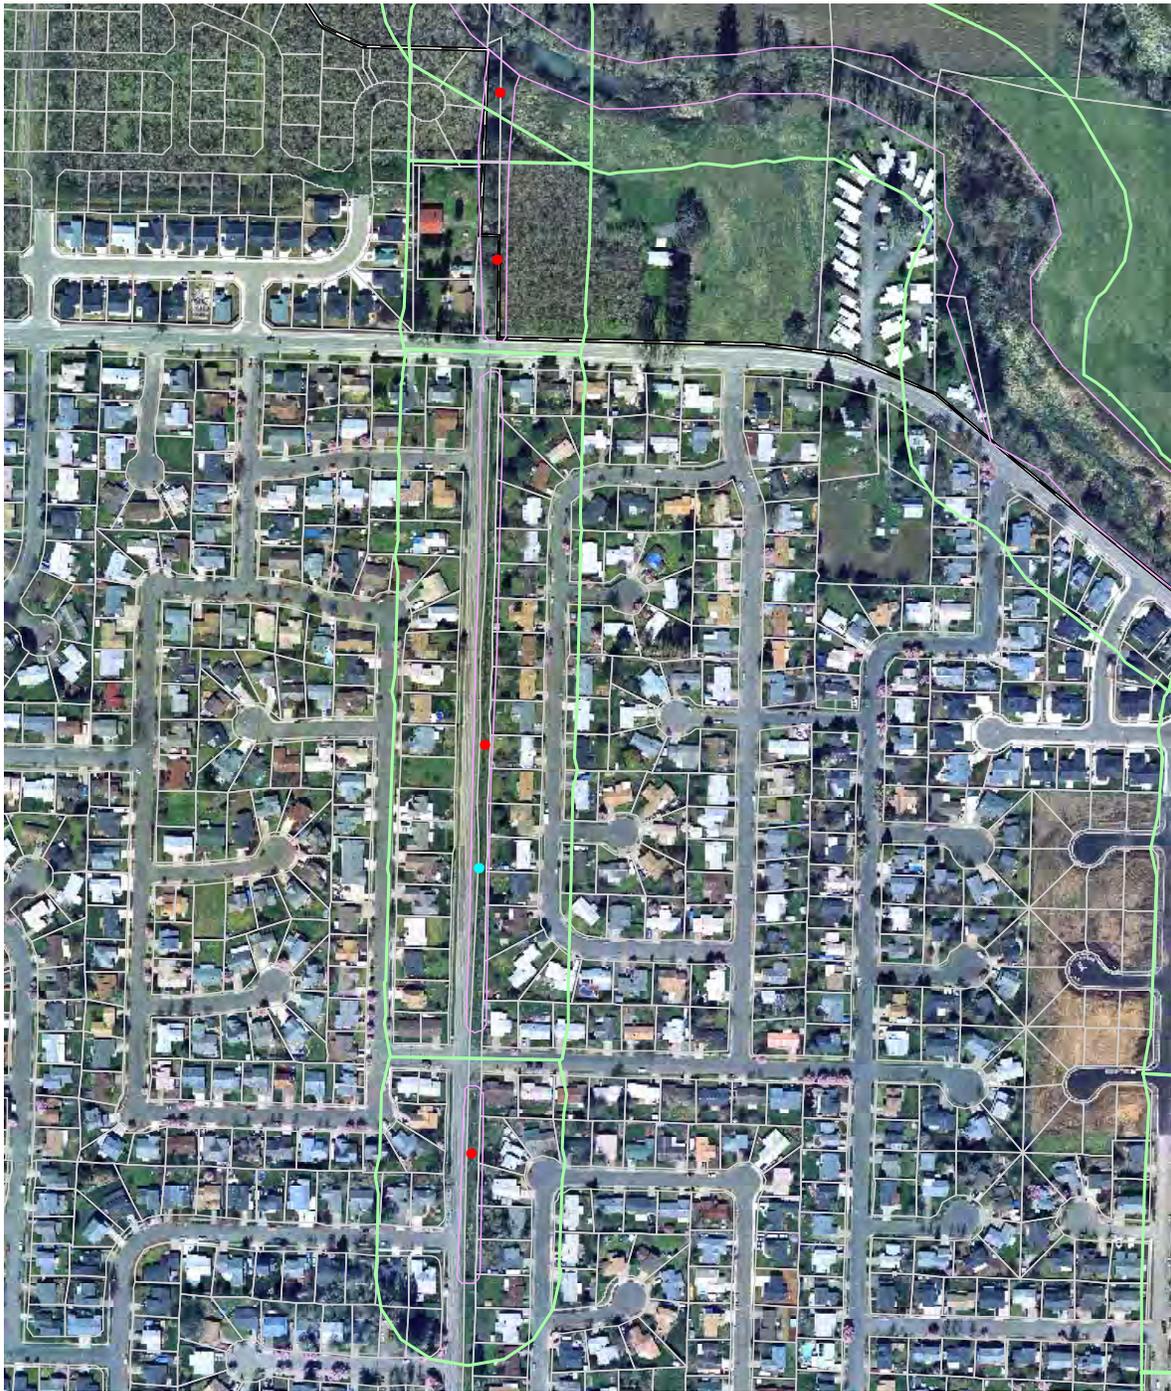
69th St Channel

Waypoints		10ft_riparian_buffer
	Plot	200ft_landuse_buffer
	Seed Collection Site	tax lots
	In Channel Structure

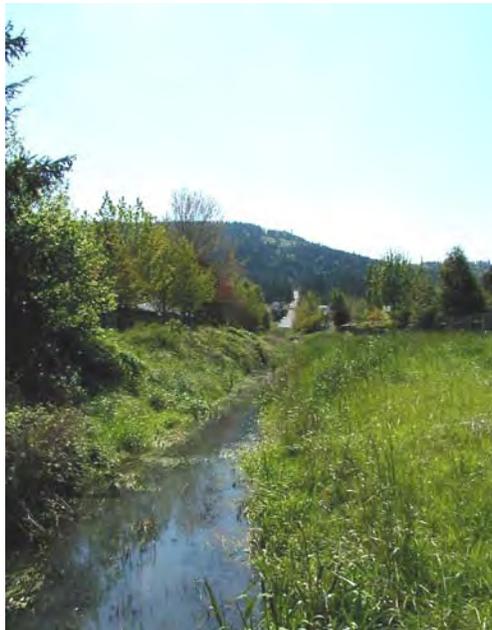
72nd St Channel facing south

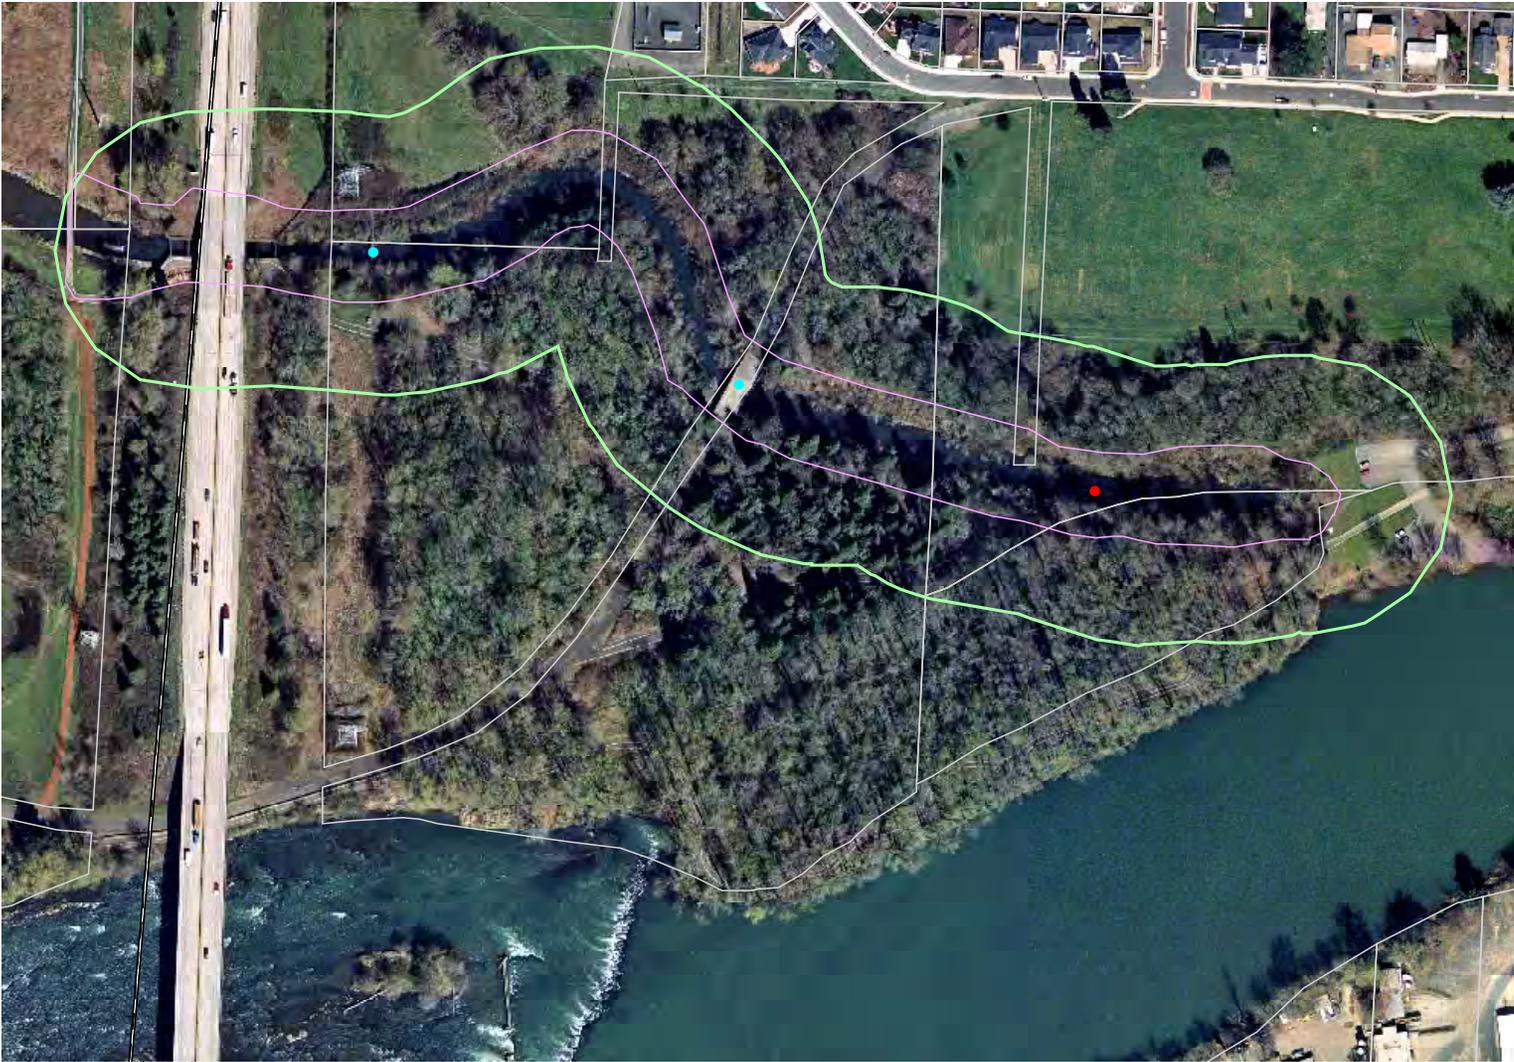
Alton Baker Canoe Canal

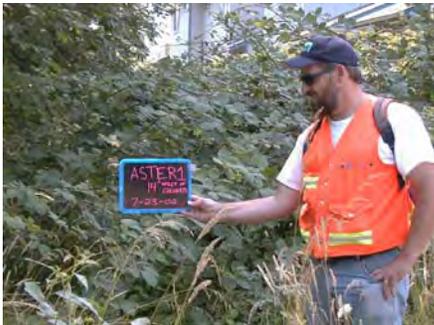
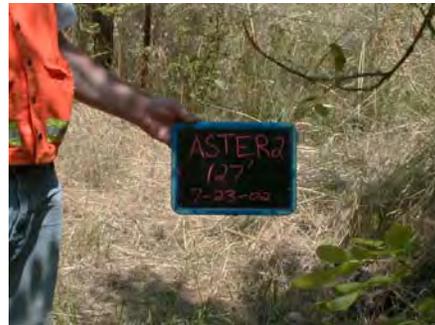
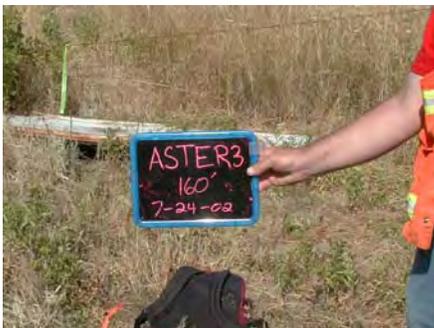
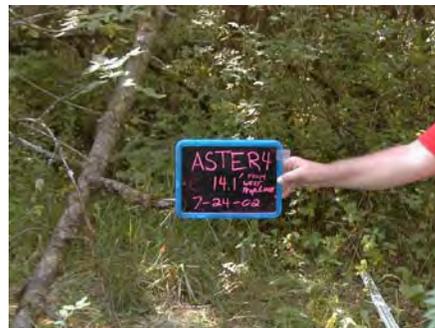
Aster Channel starts south of Main St. and west of South 63rd St. It flows southwest to a piped system east of South 58th St.

It receives flow from stormwater runoff and is fed by wetlands. This system is a broad, shallow chain of wetlands and wetland conditions and is listed on the Local Wetlands Inventory. Portions of the channel itself do not sustain flow year-round. The channel is approximately 0.34 miles long.

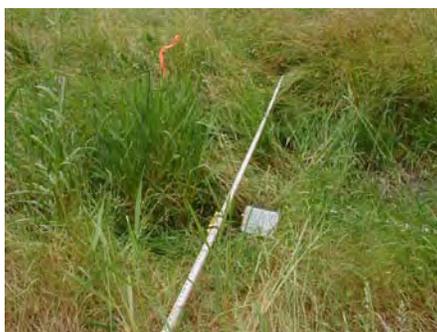
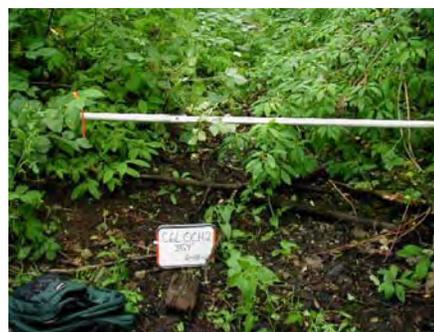
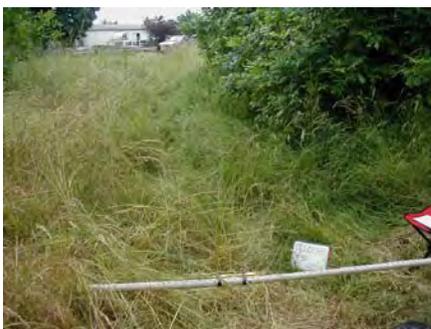
Channel 6 – Lochaven Channel is a tributary to Channel 6. It starts west of Clearvue Lane, south of Channel 6 and north of Lochaven Ave. It flows northwest to intersect with Channel 6, behind Guy Lee School.

It receives flow from stormwater runoff and flows through a wetland. This system is considered wetlands and is listed on the Local Wetlands Inventory. The channel is approximately 0.14 miles long.

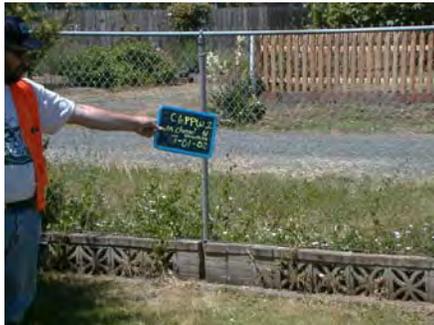
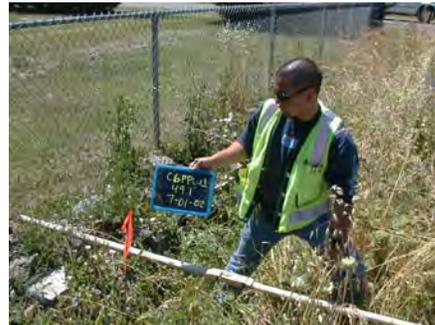
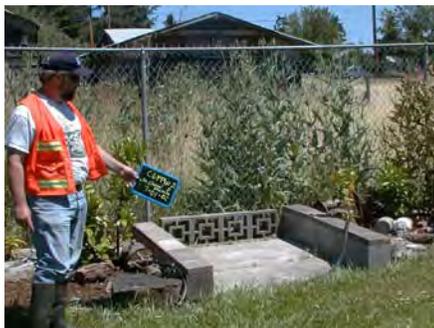
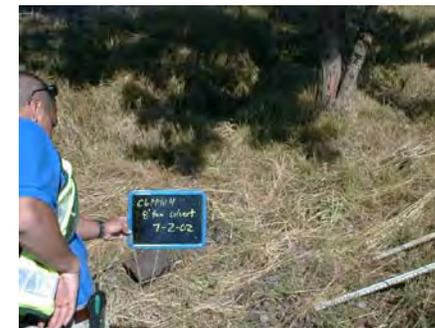
Channel 6 – PPW Channel is a tributary to Channel 6. It starts between Pioneer Parkway East and West, south of Channel 6 and south of Hayden Bridge Rd. It flows northwest to a piped system off Laura St, then into Channel 6.

It receives flow from stormwater runoff. The channel is approximately 0.14 miles long.

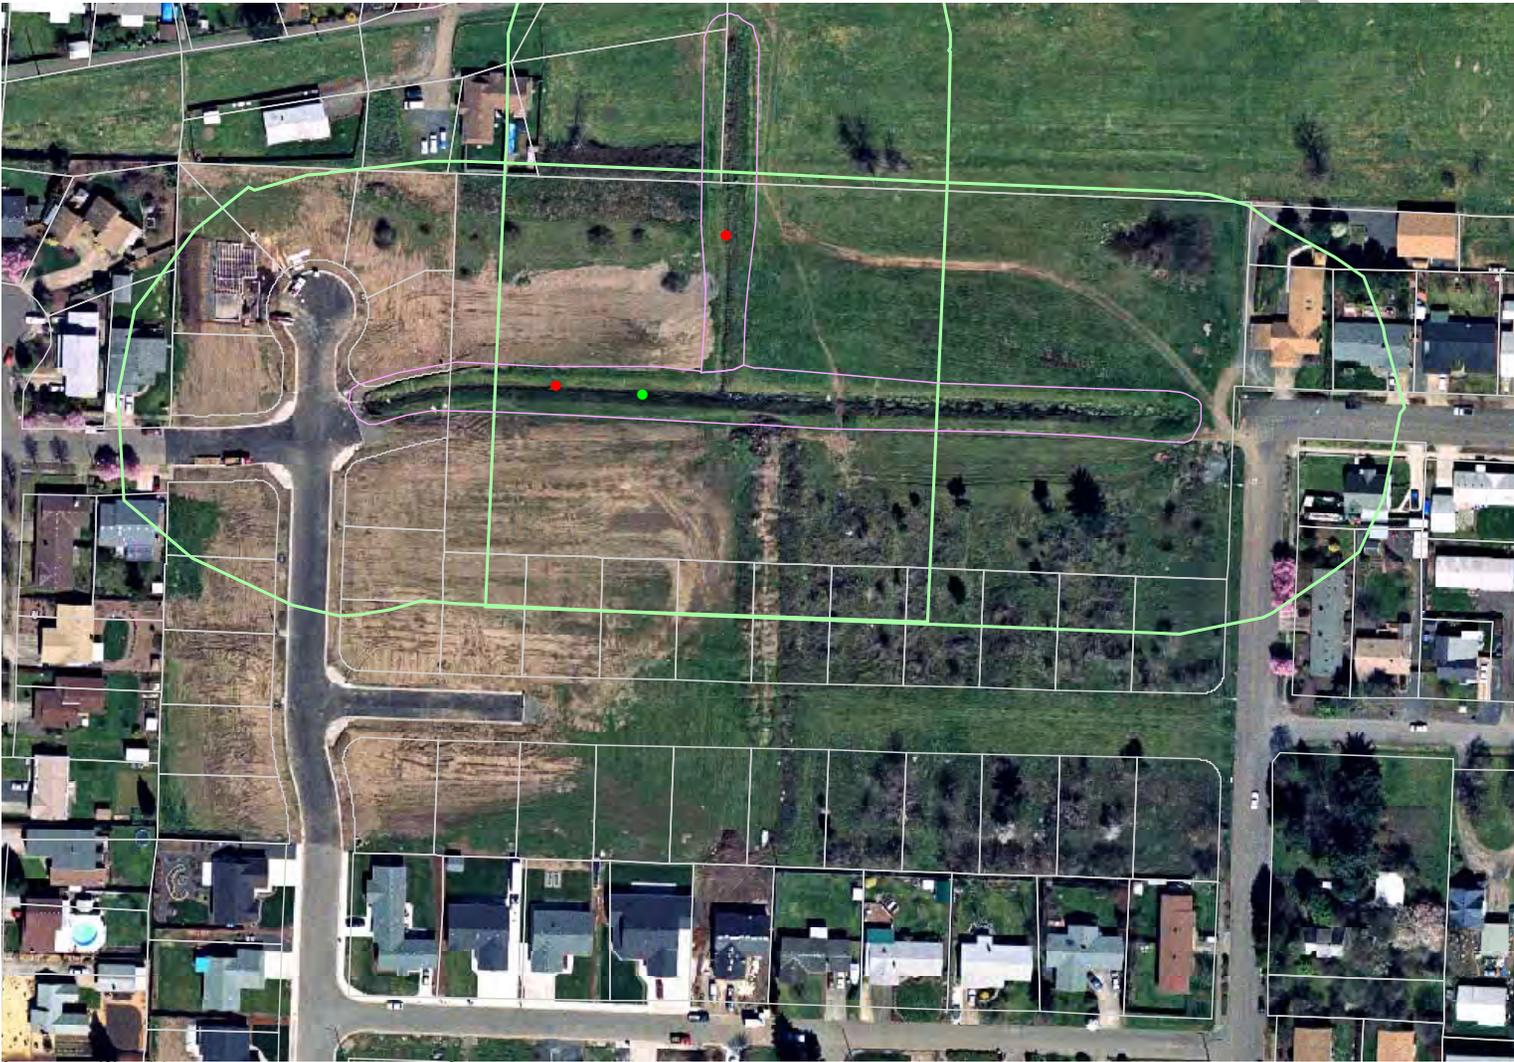
Channel 6 - T St Channel

Waterway Removed 2004

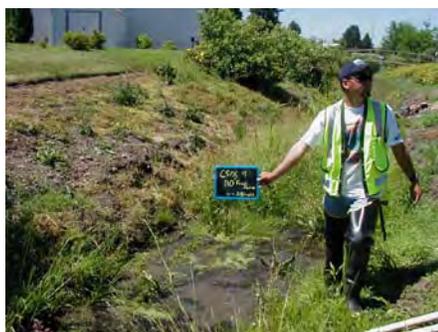
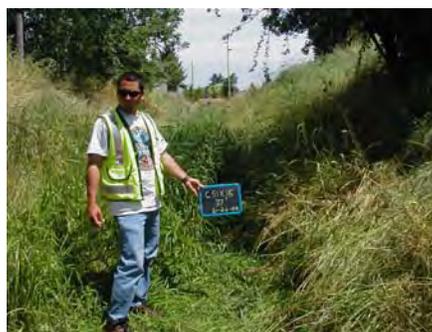
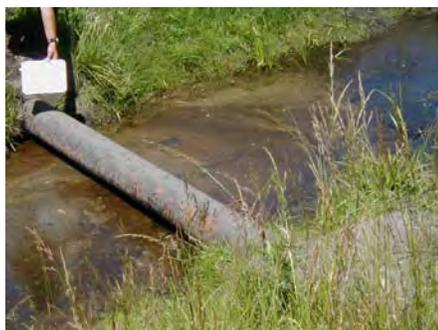
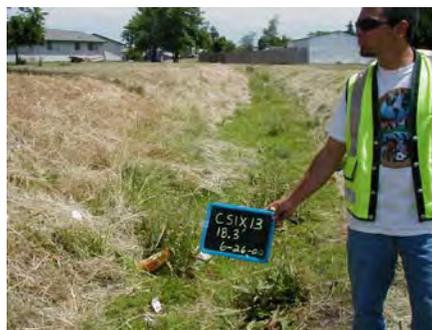
Channel 6 is a tributary to the I-5 Gateway Channel. It starts west of 5th St, south of T St. It flows northwest to intersect with the I-5 Gateway Channel east of interstate 5 and south of Kenray Loop.

It receives flow from stormwater runoff and flows from a wetland. This system is considered wetlands and is listed on the Local Wetlands Inventory. The channel is approximately 1.13 miles long.

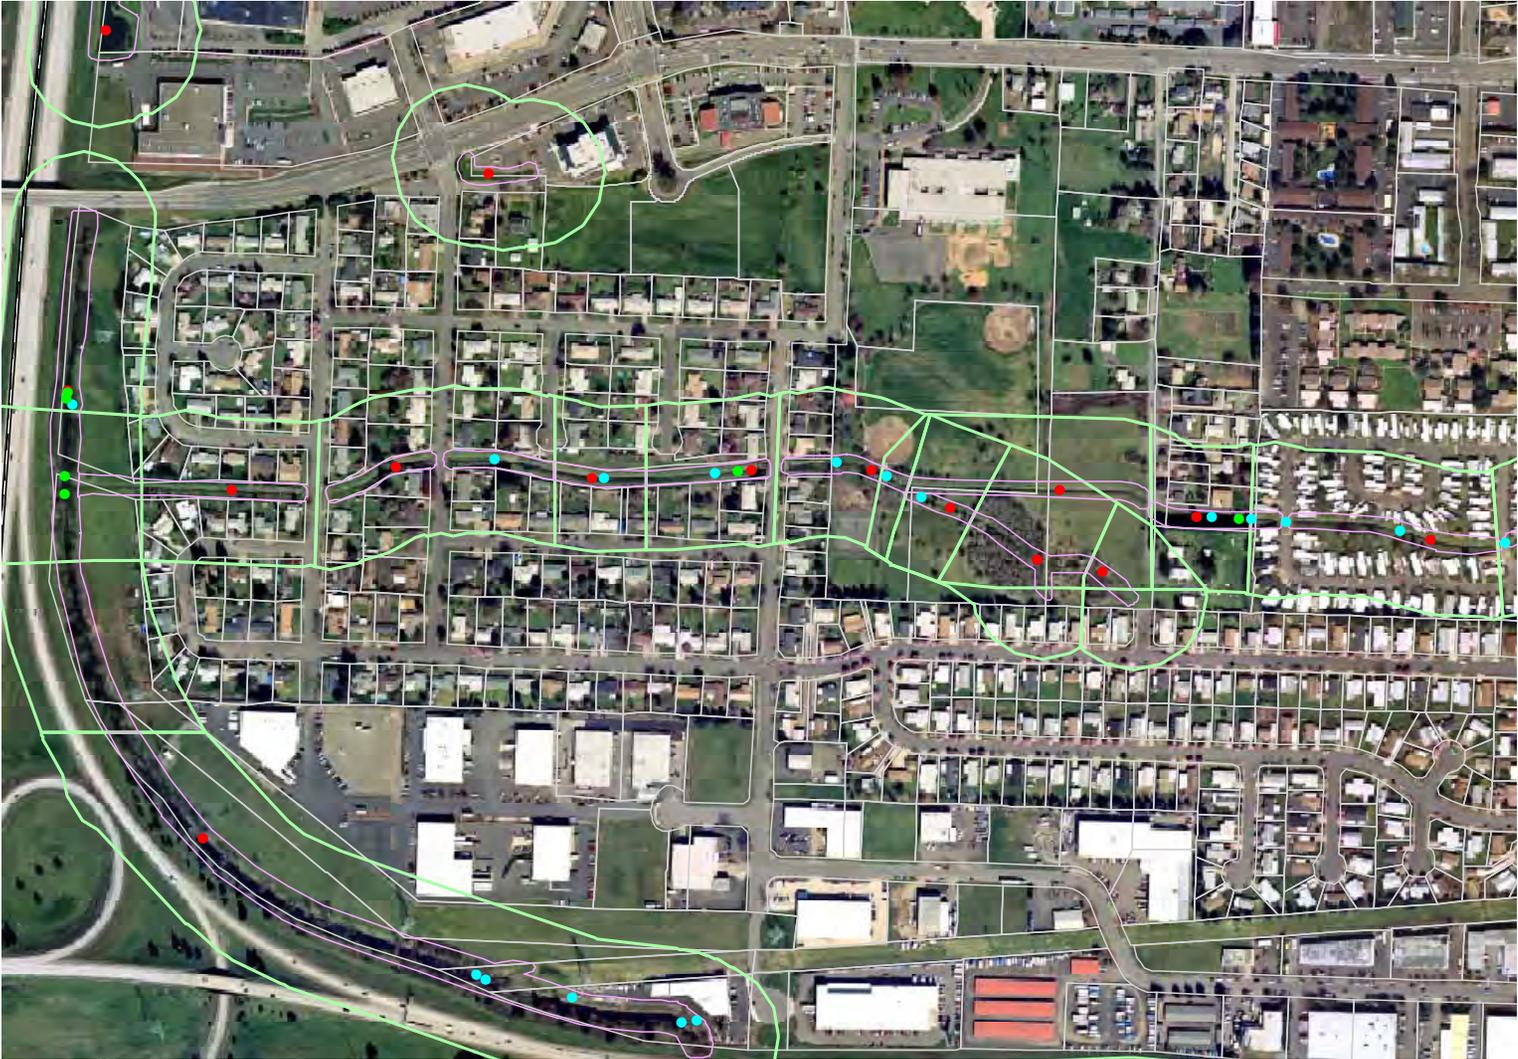
Channel 6 - Western Section

Waypoints	
●	Plot
●	Seed Collection Site
●	In Channel Structure
	10ft_riparian_buffer
	200ft_landuse_buffer
	tax lots

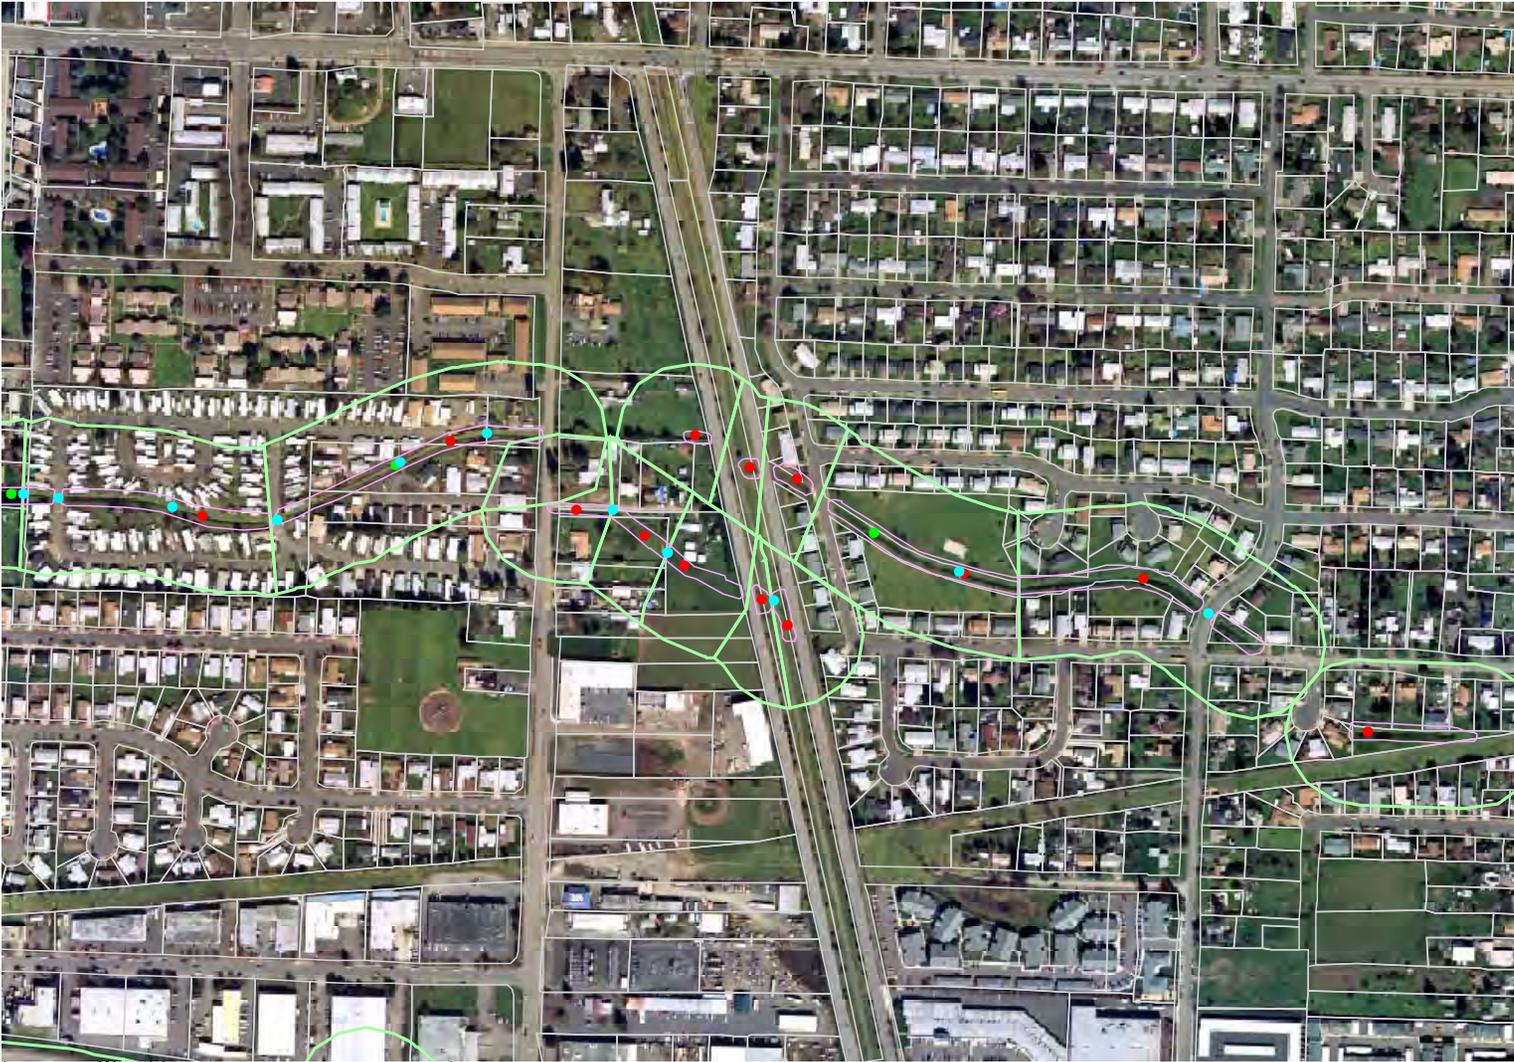
Channel 6 - Eastern Section

Waypoints	
● Plot	10ft_riparian_buffer
● Seed Collection Site	200ft_landuse_buffer
● In Channel Structure	tax lots

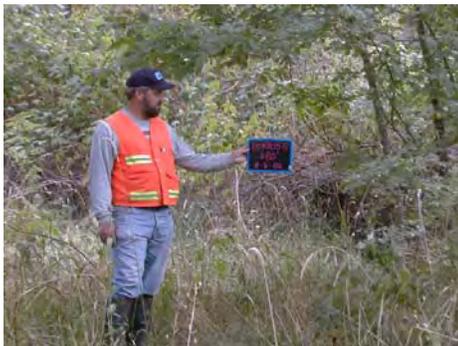
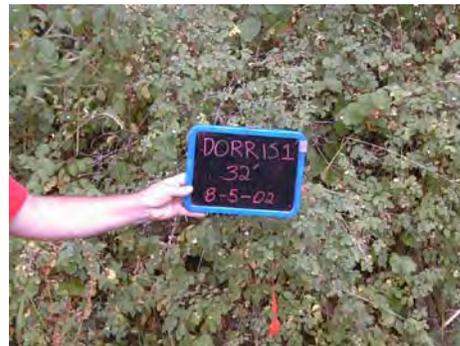
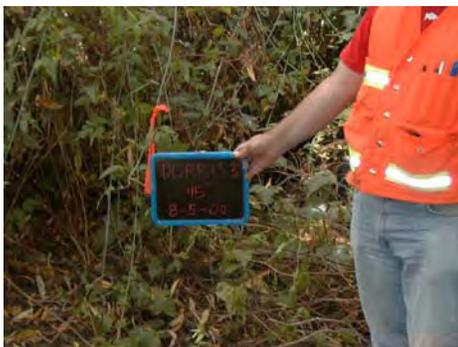
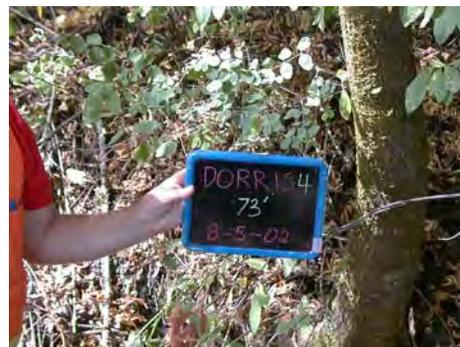
Dorris creek is a tributary to the Willamette River. The section that has been mapped starts east of South 2nd St and north of Dorris St. It flows southwest to the Willamette River.

It receives flow from stormwater runoff, ground water and springs. Sections of this system are wetlands and are listed on the Local Wetlands Inventory. Approximately 0.36 miles of the creek has been mapped.

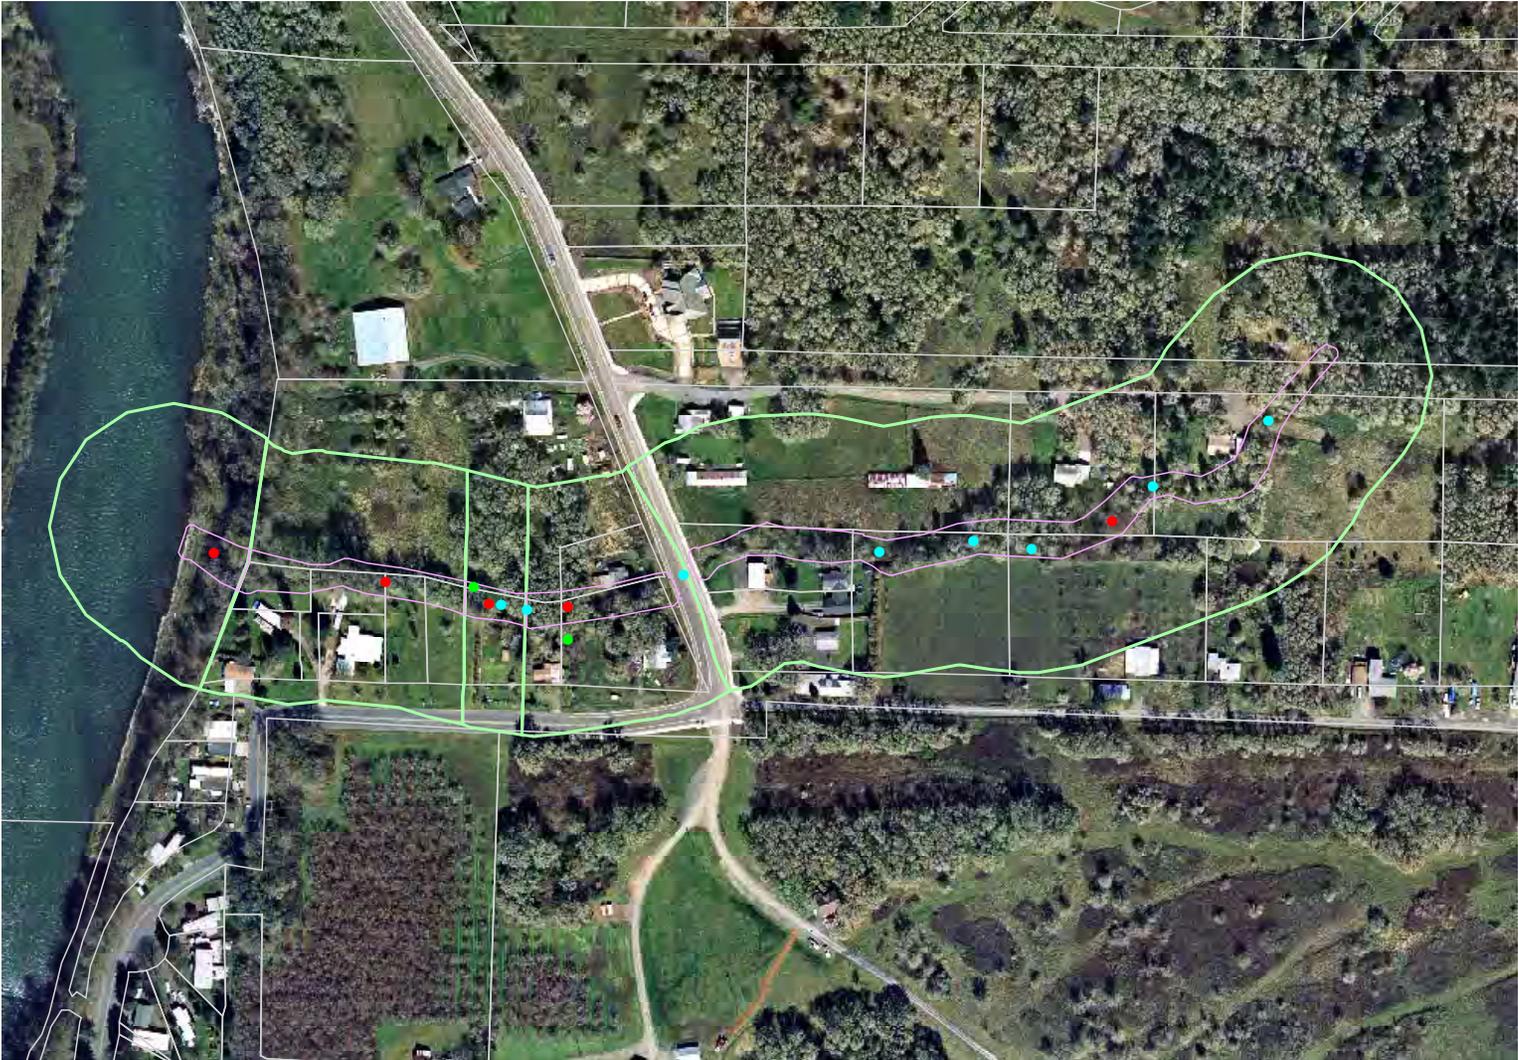
Dorris Creek

Waypoints	
● Plot	10ft_riparian_buffer
● Seed Collection Site	200ft_landuse_buffer
● In Channel Structure	tax lots

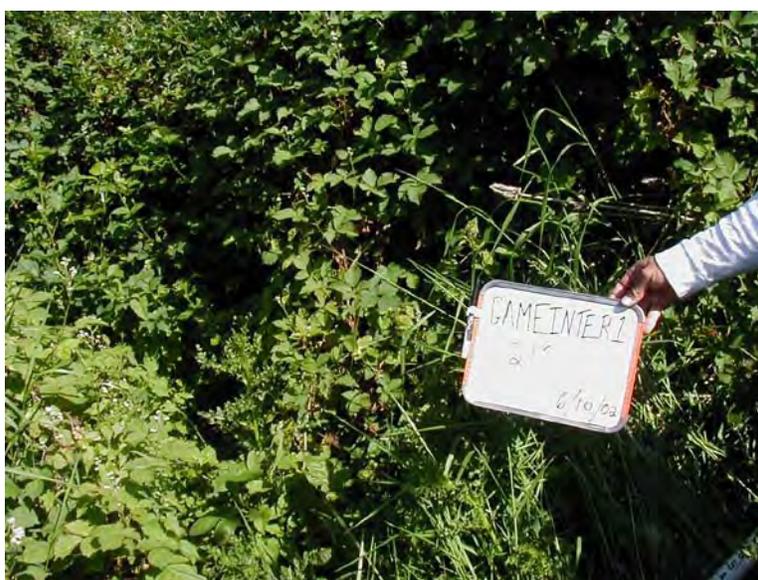
Game Farm International Channel starts south of International Way and south of Sports Way. It flows northwest to a piped section then into the northern section of the Sports Way Channel which in turn flows to Maple Island Slough. This system is typically absorbed into the ground before it flows to Maple Island Slough, except in very high water conditions.

It receives flow from stormwater runoff and industry. The channel is approximately 0.13 miles long.
