Inventory and Channel Assessment Report For Springfield Waterways

Q St Floodway
Concrete Control Structure

August 2004

Environmental Services, Water Resources

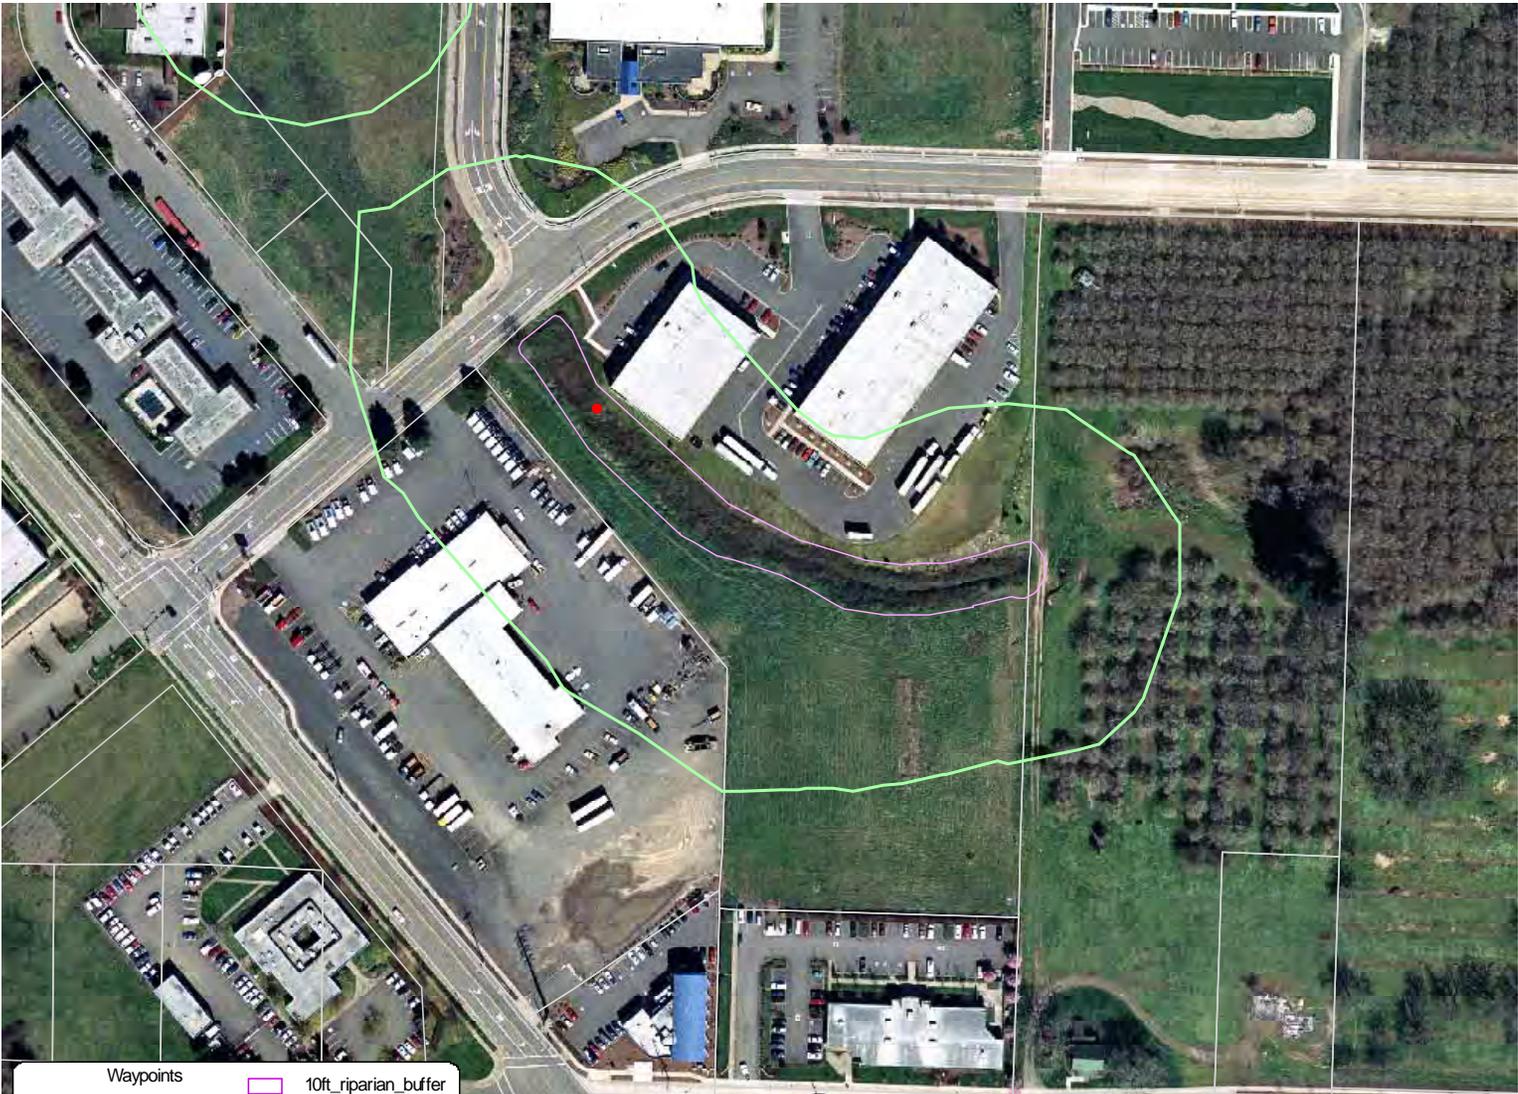
Game Farm International Channel

- | Waypoints | |

| ● Plot | 10ft_riparian_buffer |

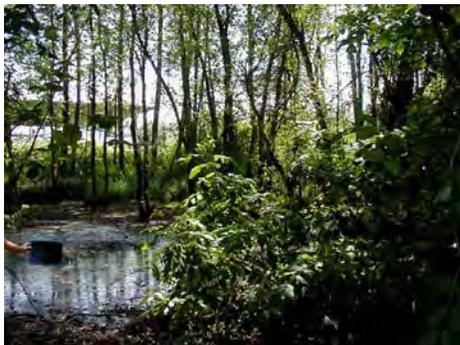
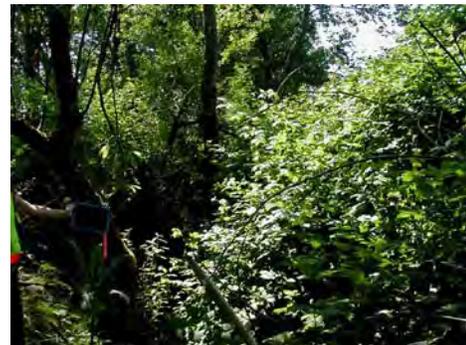
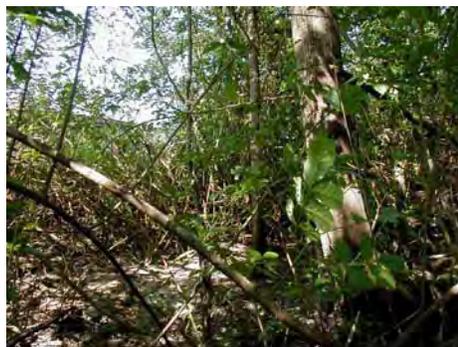
The Glenwood North Channel starts west of Glenwood Blvd. at the north Sanipac office parking area. It flows west to the Glenwood Slough.

It receives flow from stormwater runoff, industrial and commercial runoff. The channel is approximately 0.29 miles long.

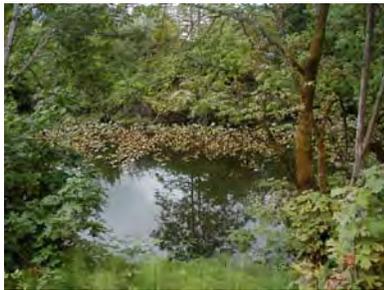
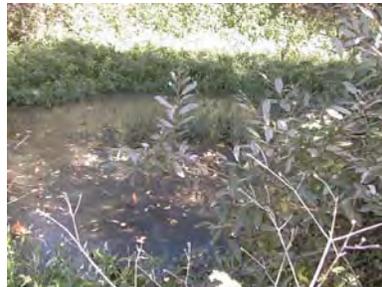
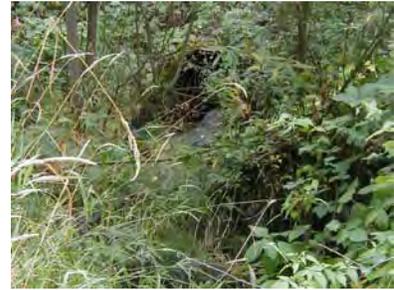
The Glenwood Slough is a tributary to the Willamette River. It is believed that the system starts in Eugene and flows through a culvert under I-5 and into Glenwood. The box culvert had not been located at the time of this assessment and the waterways starting point has not been identified, due to extremely heavy brush and blackberries in the area and a lack of accurate records. The clearest point that can be assumed as a starting point is located on the north side of the railroad tracks southwest of Nugget Way next to the site currently occupied by PW Pipe on Wildish land. It flows northwest going under a series of railroad tracks and through culverts until it gets to the Willamette River under Franklin Blvd. Parts of this system are wetlands and are recorded on the local wetland inventory.

It receives flow from industrial and commercial stormwater runoff and is a wetland. It is also fed by runoff from Eugene. The channel is approximately 1.19 miles long.

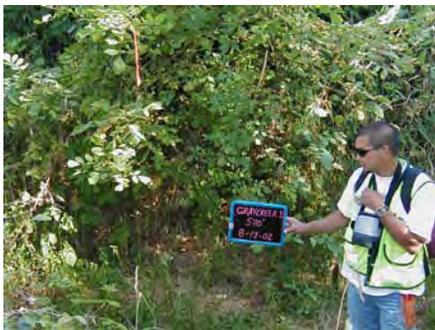
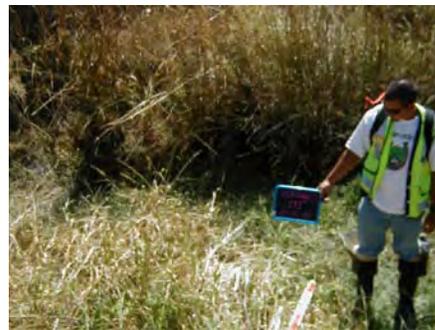
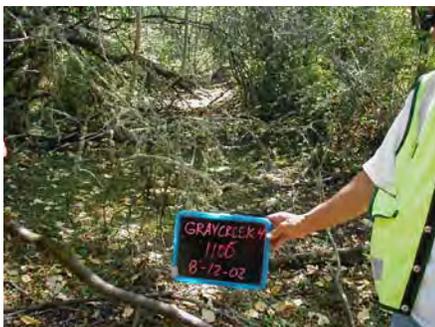
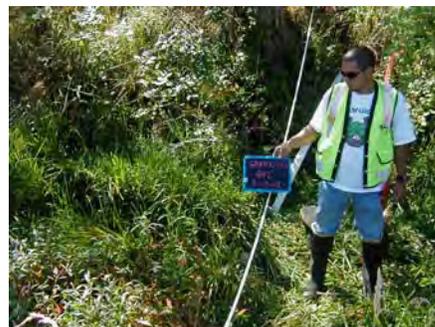
Gray Creek has been mapped from just west (inside) of the UGB. It starts by receiving small side creek flows from Cedar Creek. It flows west to intersect with 75th St Creek where some flow goes north into 75th St Creek and the rest of the flow continues west to a piped system that drains to 72nd St Channel.

It receives flow from stormwater runoff, groundwater and wetlands. The mapped section of the channel is approximately 1mile long.

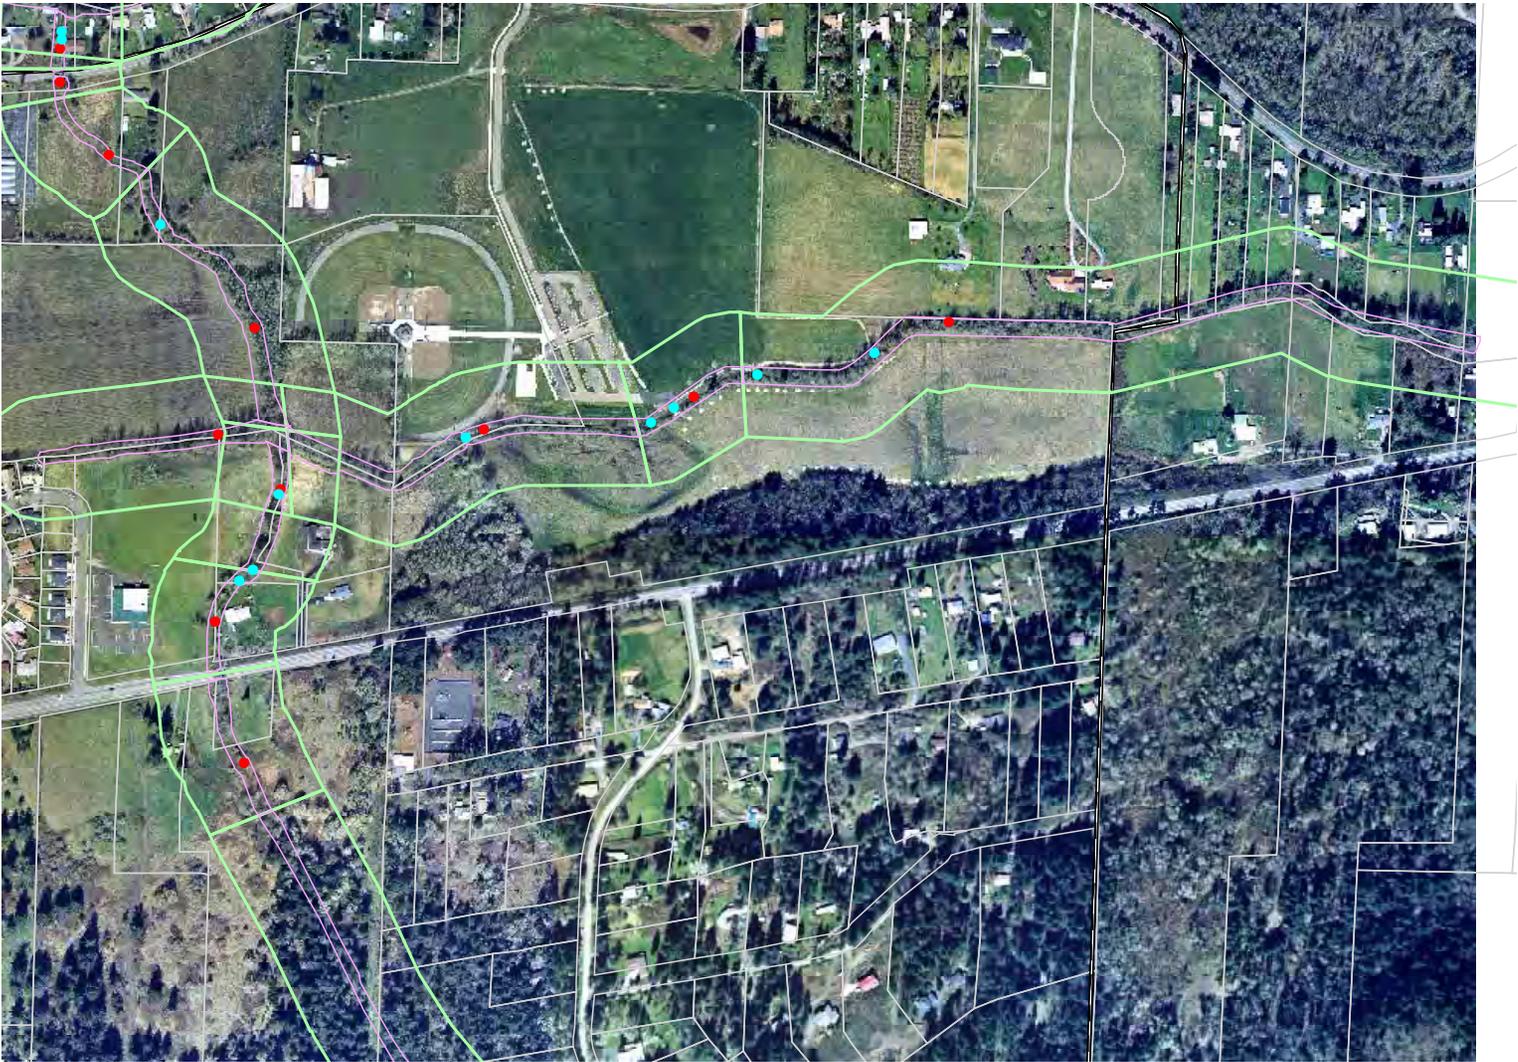
Gray Creek

Waypoints	
● Plot	10ft_riparian_buffer
● Seed Collection Site	200ft_landuse_buffer
● In Channel Structure	tax lots

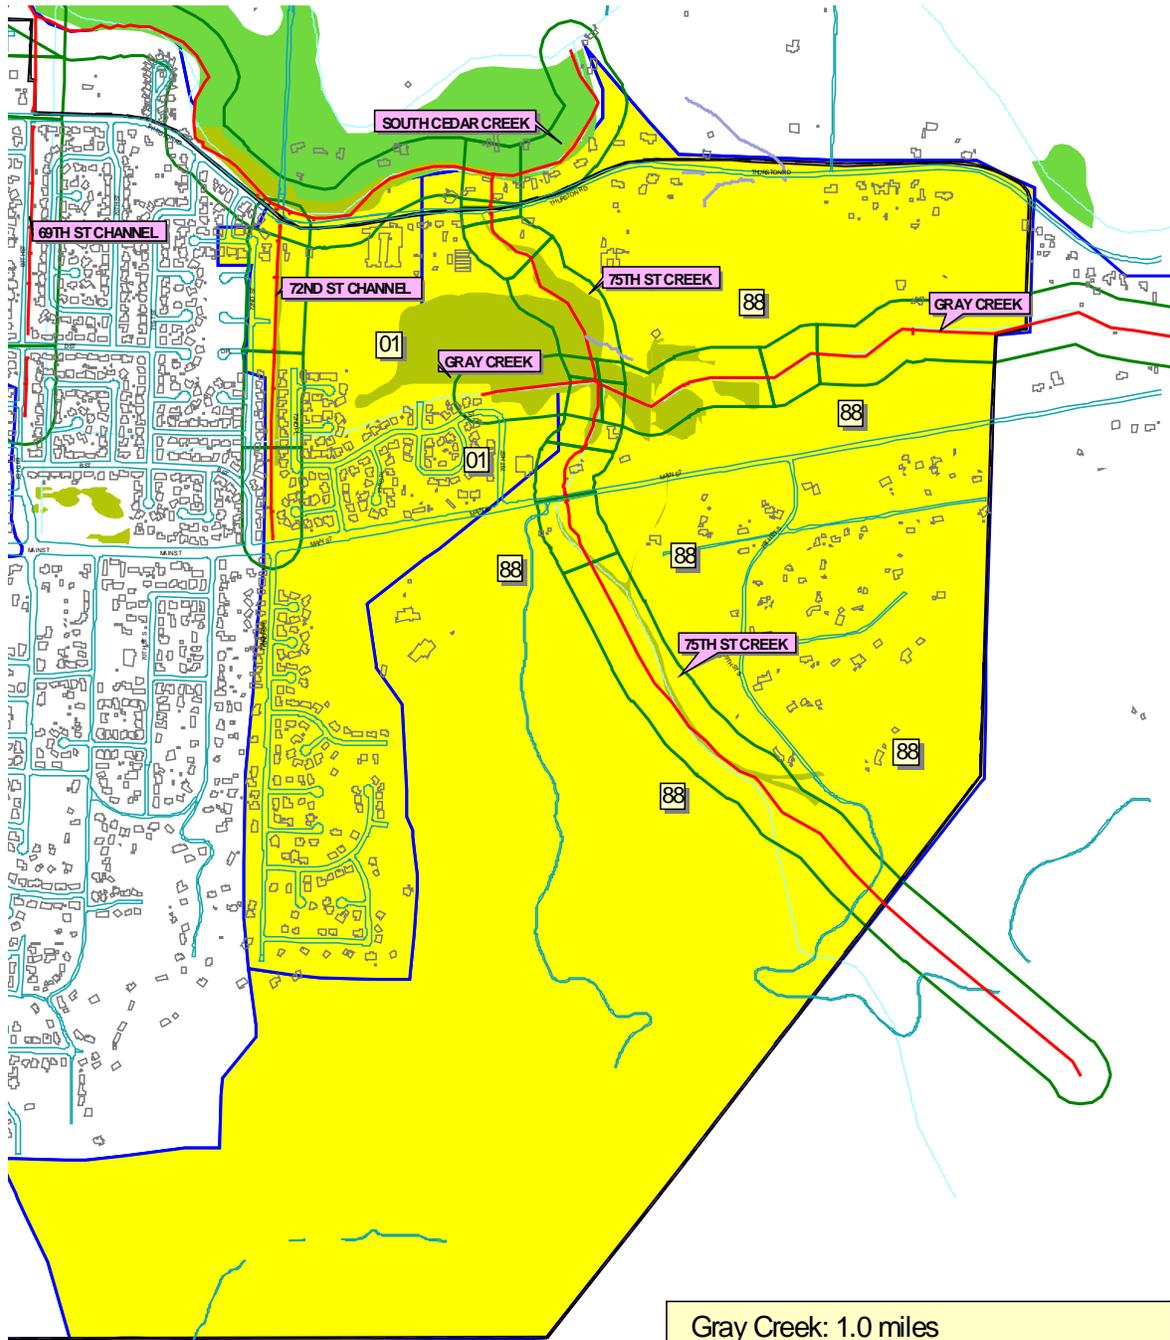
Gray Creek: 1.0 miles
 Sub Basins: 01, 88
 Major Basins: South Cedar Creek Basin
 Sub Basin 01 Acres: 157.51
 Sub Basin 88 Acres: 683.19
 Sub Basin 01 Percent imperv.: 31.64%
 Sub Basin 88 Percent imperv.: 9.09%

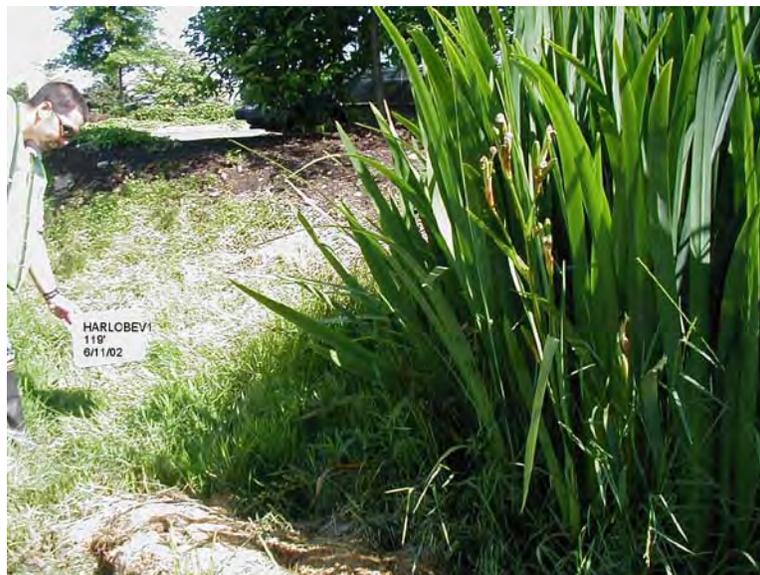
The Harlow – Beverly Channel is southeast of the Harlow Rd. – Beverly St. intersection. It starts east of Beverly St. and flows northwest into a piped system. It has been redesigned as a series of swales.

It receives flow from stormwater runoff. The channel is approximately 0.04 miles long.

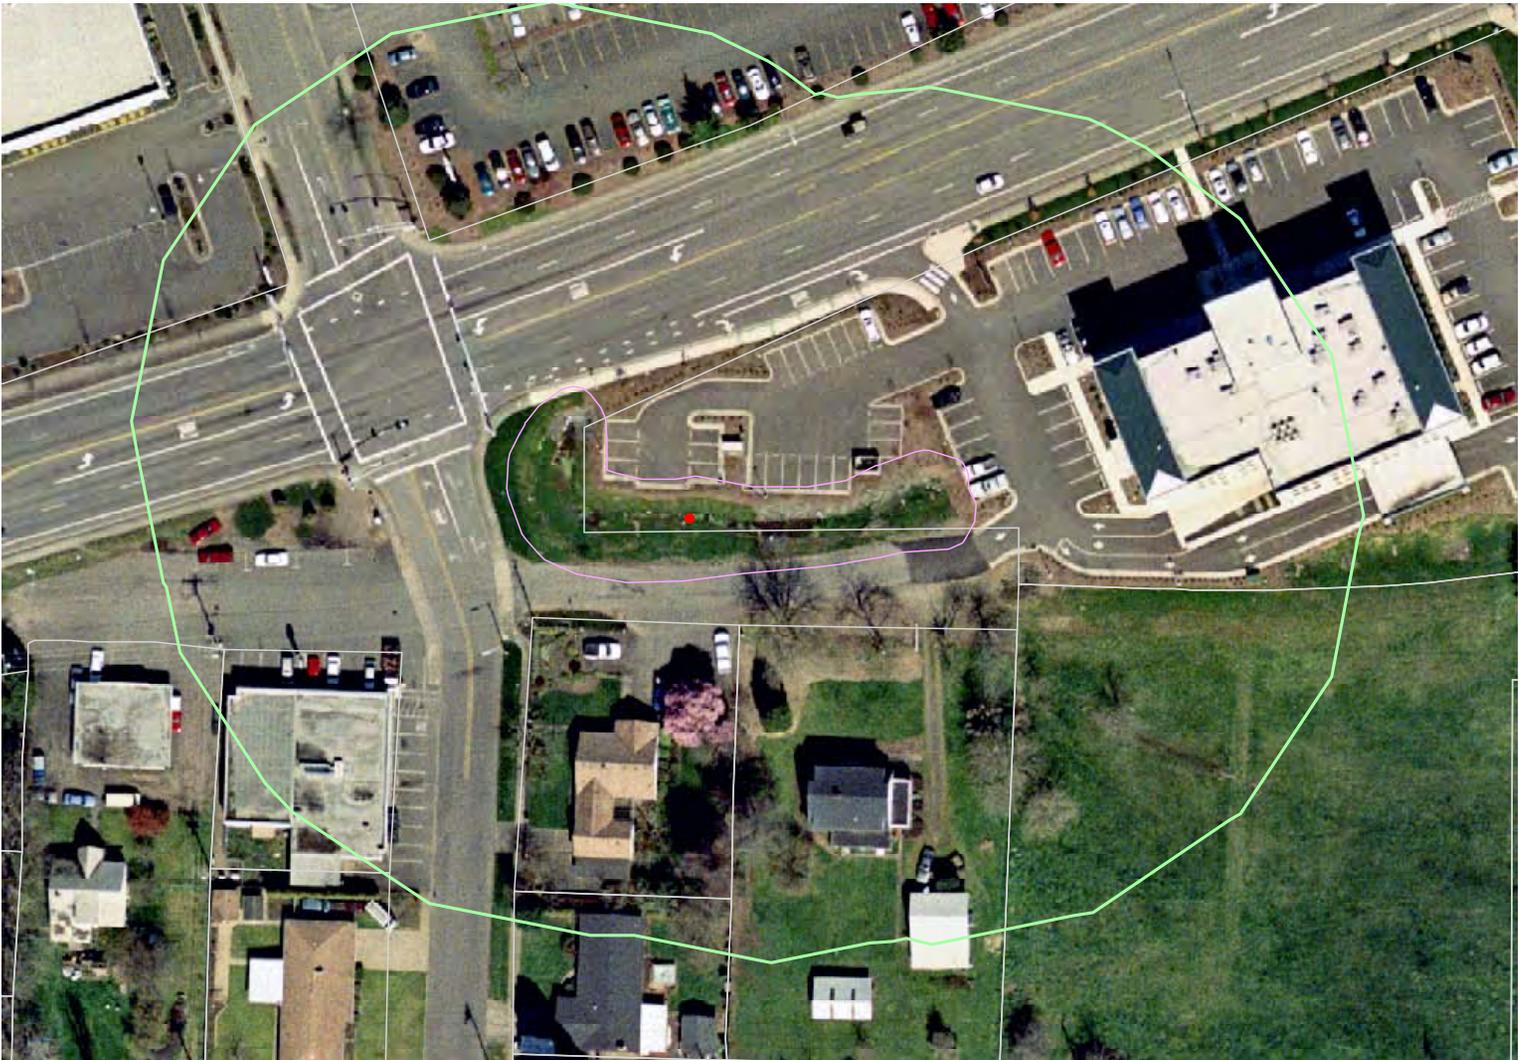
Harlow - Beverly Channel

Waypoints	
● Plot	10ft_riparian_buffer
● Seed Collection Site	200ft_landuse_buffer
● In Channel Structure	tax lots

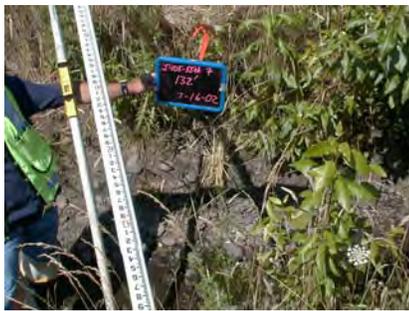
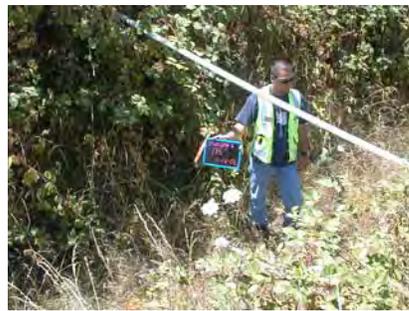
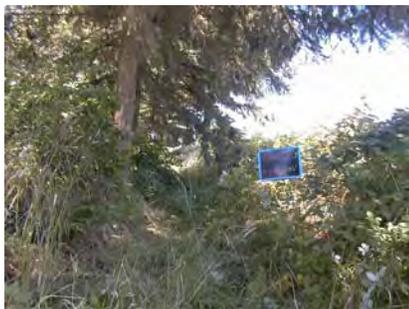
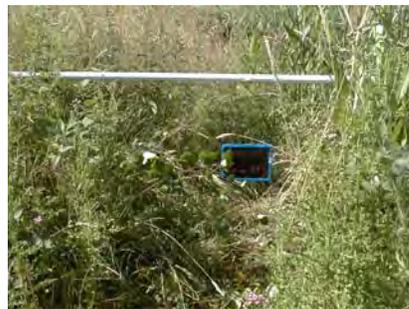
I-105 – 55th St Channel is a tributary to the 48th St Channel. It starts west of I-105 (also known as Hwy 126 east bound), north of Main St, and west of 55th St. The channel parallels the freeway along the west and south side to the 52nd St exit. It flows northwest to a culvert, then into the 48th St Channel.

It receives flow from stormwater runoff. The channel is approximately 0.58 miles long.

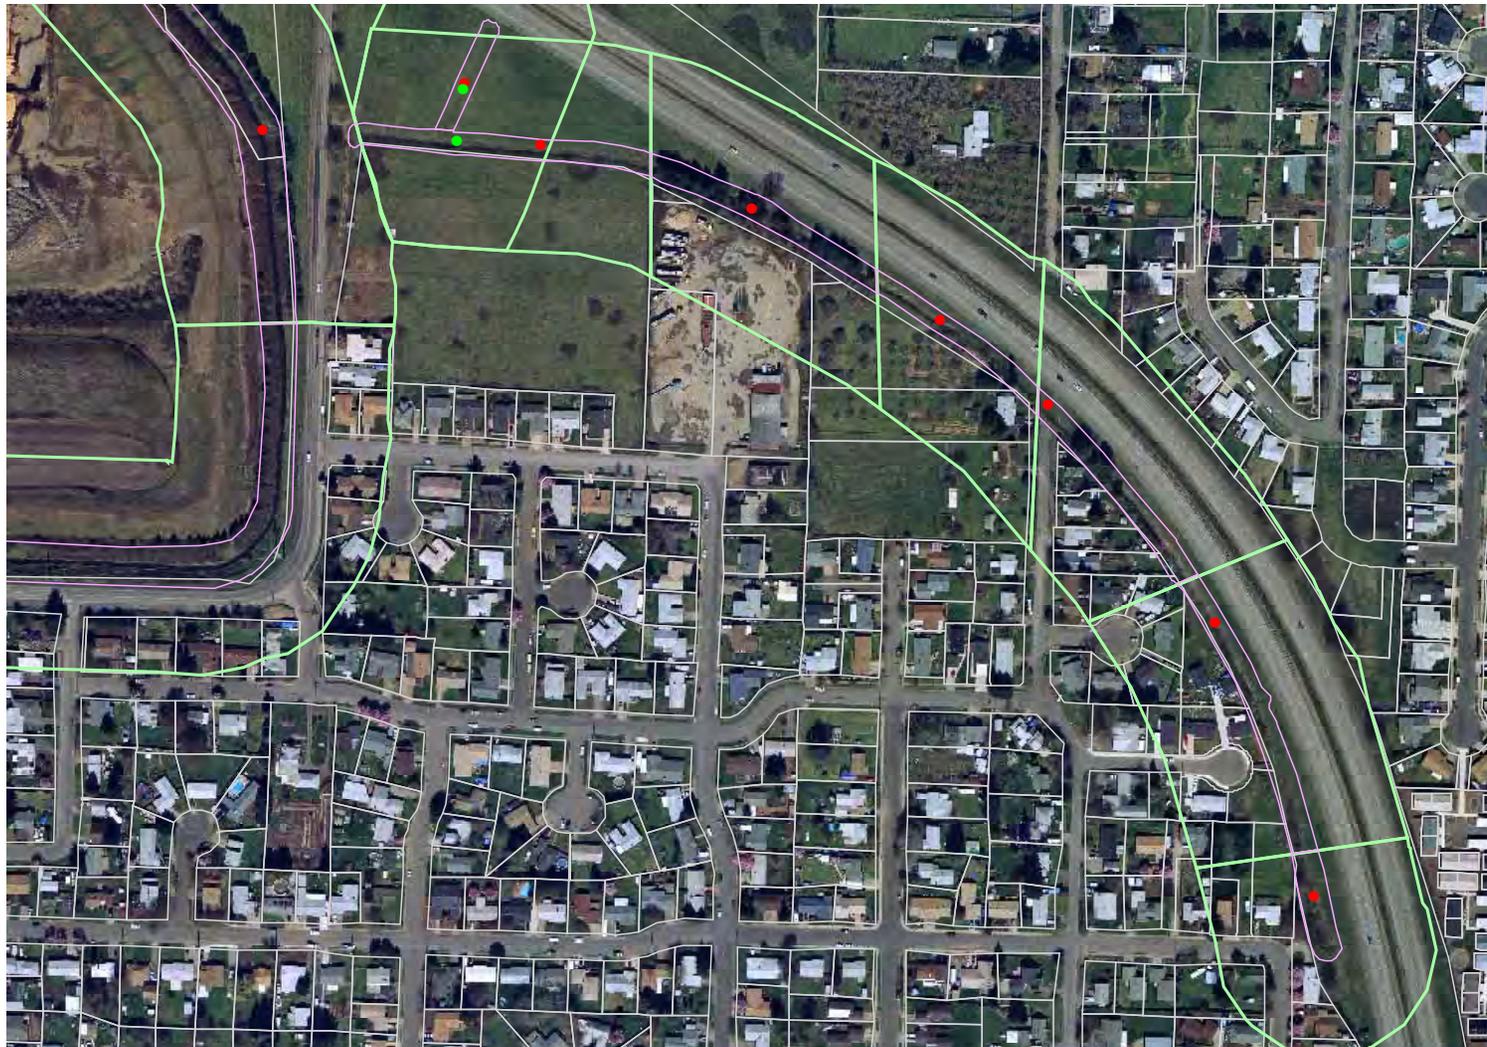
I-105 - 55th St Channel

Waypoints	
● Plot	10ft_riparian_buffer
● Seed Collection Site	200ft_landuse_buffer
● In Channel Structure	tax lots

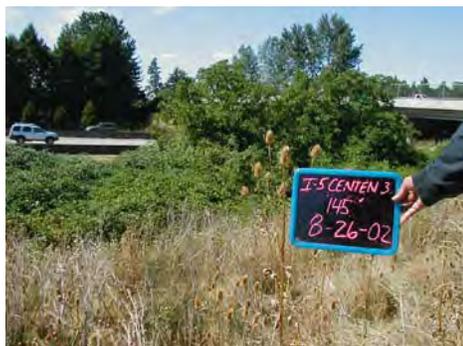
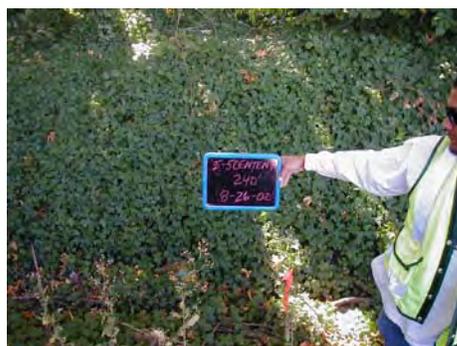
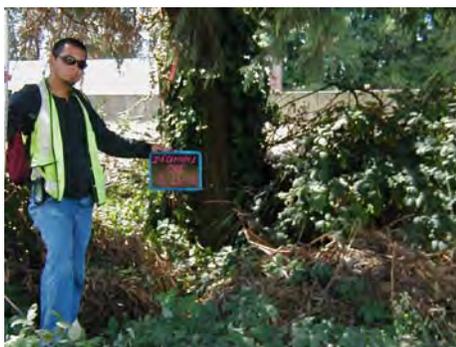
I-5 Centennial Channel starts west of Anderson Ln. One section is south of West Centennial and the other is north of West Centennial. Both sections flow to a piped system that flows to Eugene, west of Interstate 5.

It receives flow from stormwater runoff. The channel is approximately 0.29 miles long.

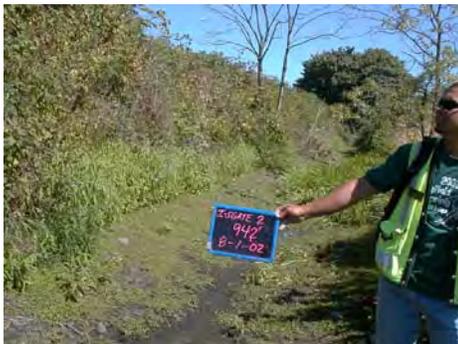
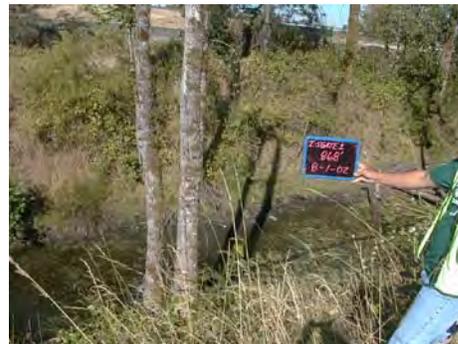
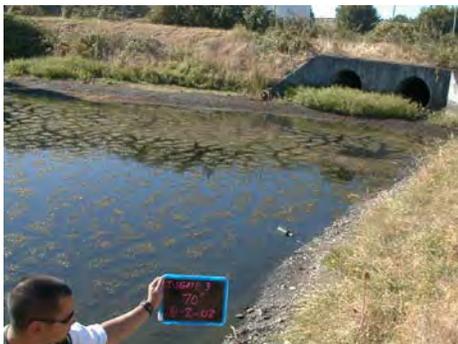
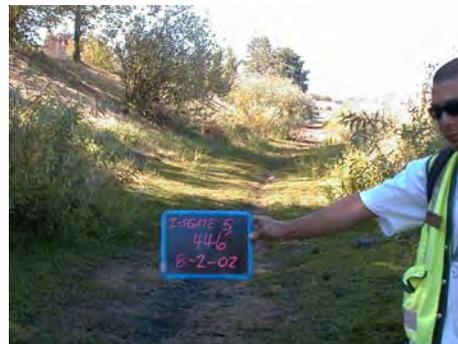
I-5 Gateway Channel is a tributary to the Q St Floodway. It starts northwest of the Gateway Mall and east of I-5. It flows south, and turns east to intersect with the Q St Floodway at I-105.

It receives flow from stormwater runoff, Channel 6, commercial and industrial stormwater runoff. This system is considered wetlands and is listed on the Local Wetlands Inventory. The channel is approximately 1.14 miles long.

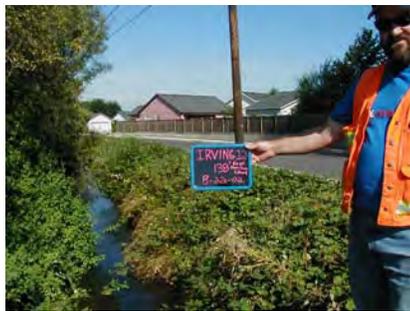
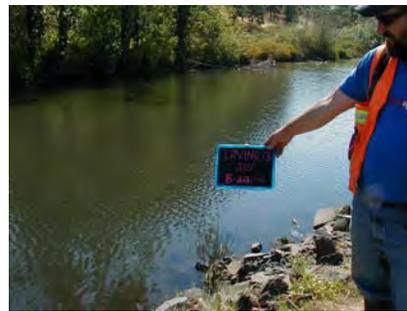
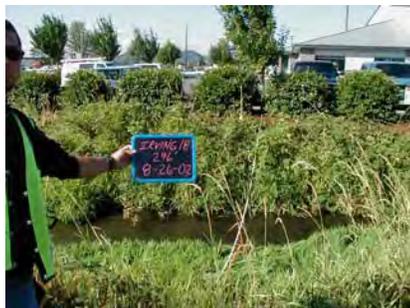
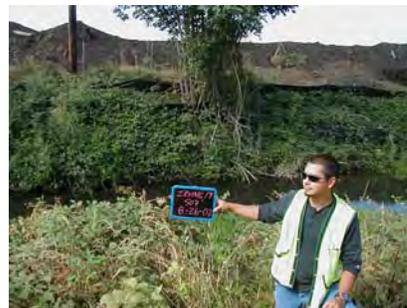
Irving Slough starts west of 42nd St just north of Weyerhaeuser Co. It flows northwest to V St where it splits to feed the Pierce Channel to the west and the rest of Irving Slough to the north. The channel becomes piped at 28th St south of Viewmount Ave.

It receives flow from stormwater runoff, Keizer Slough, industry, and flows through a wetland. This system is considered wetlands and is listed on the Local Wetlands Inventory. The channel is approximately 2 miles long.

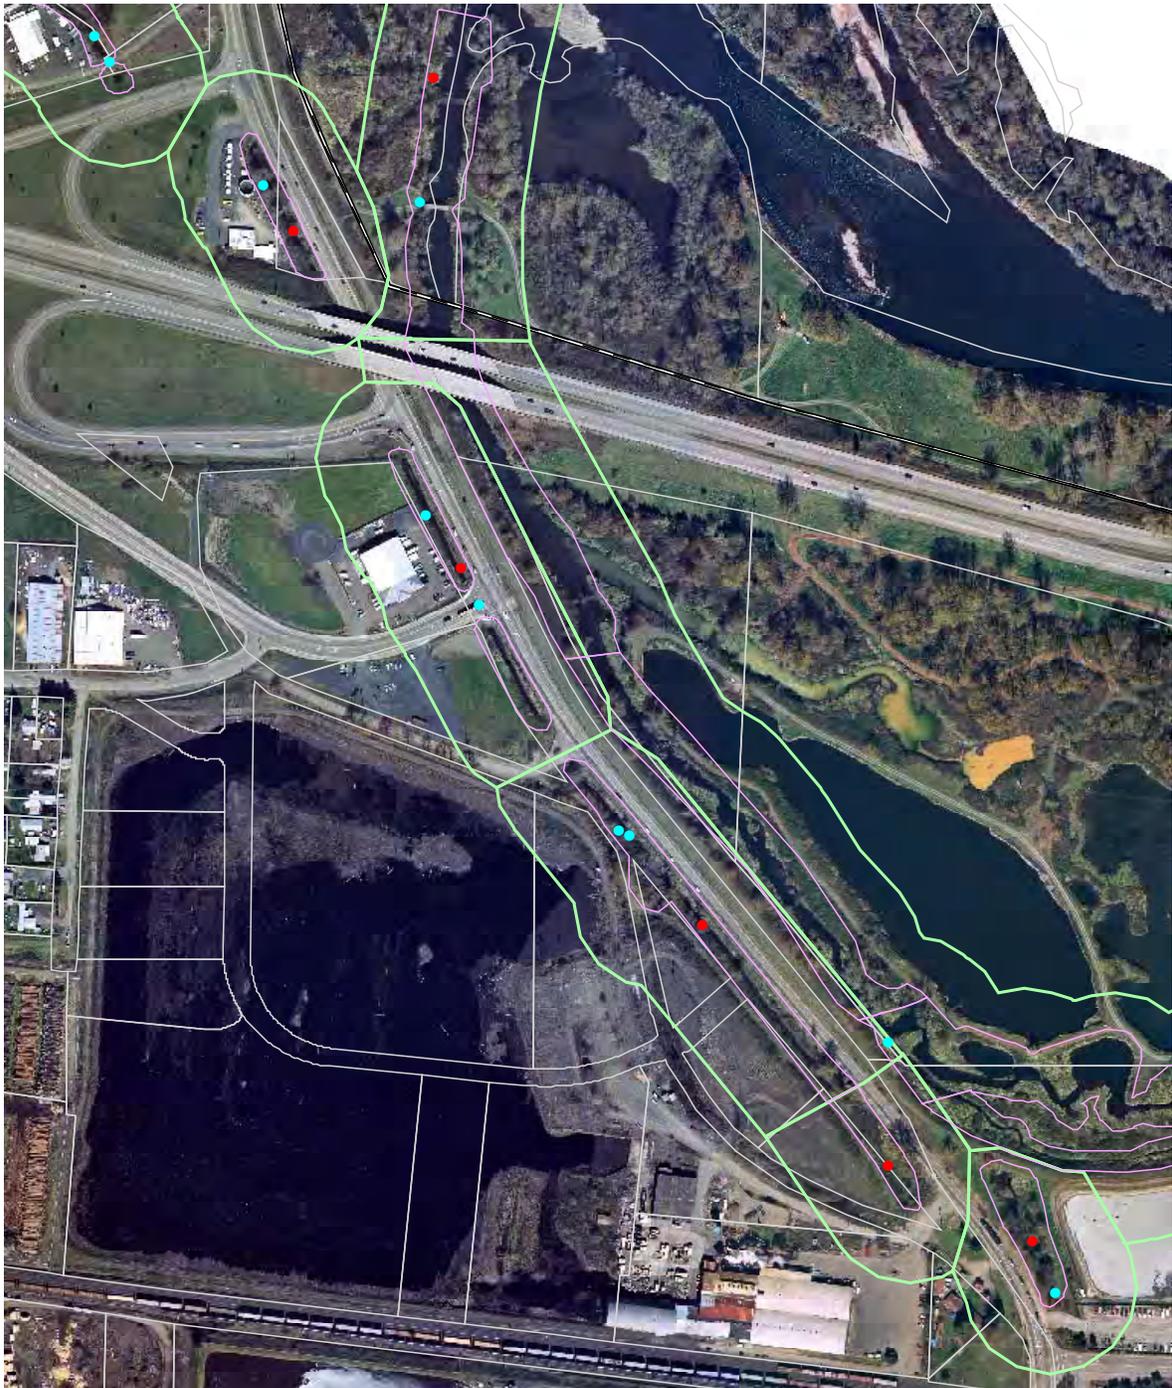
Irving Slough - Weyco. to Freeway

Waypoints	10ft_riparian_buffer
● Plot	200ft_landuse_buffer
● Seed Collection Site	tax lots
● In Channel Structure

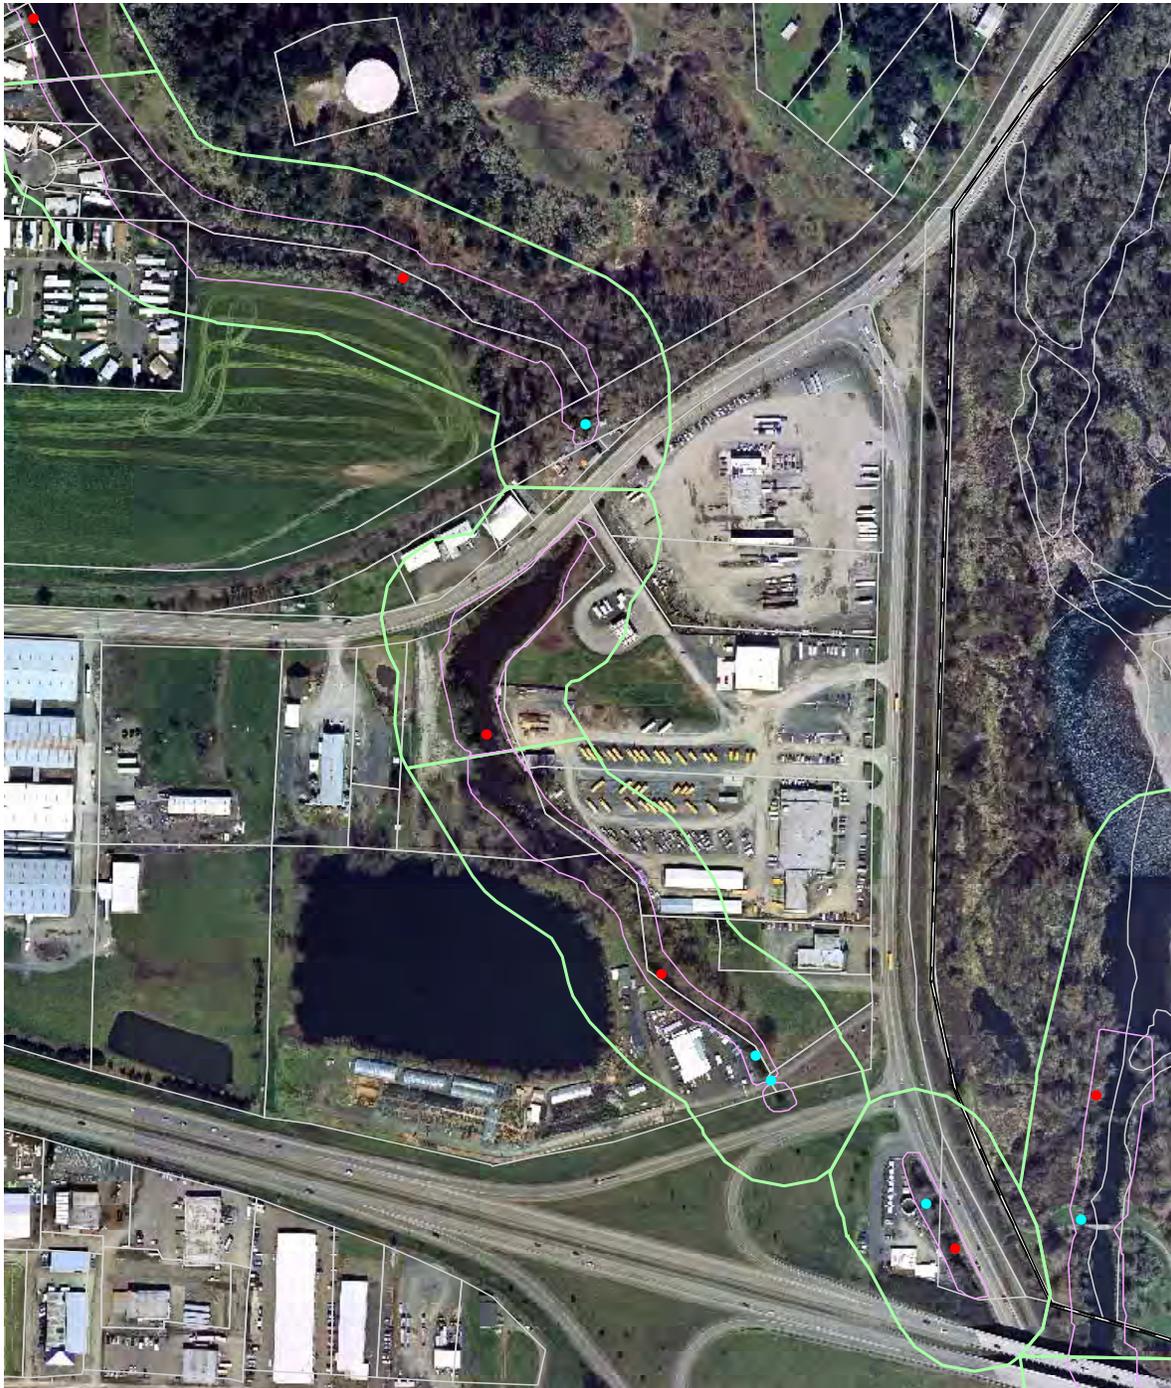
Irving Slough - Freeway to Marcola No scale

Waypoints	
●	Plot
●	In Channel Structure
	200ft Landuse Buffer
	10ft Riparian Buffer
	tax lots

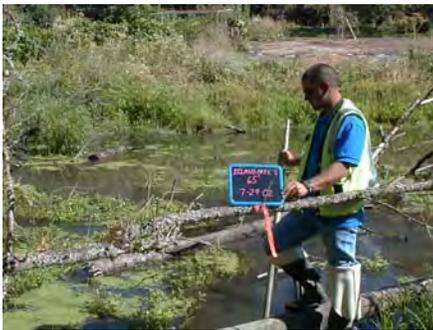
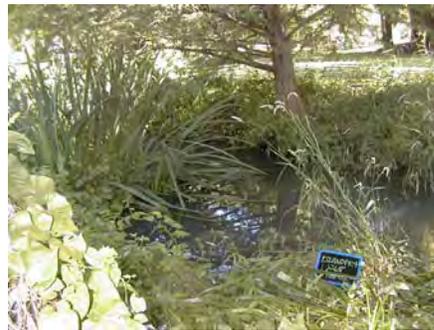
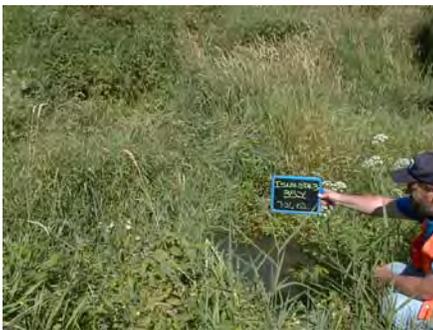
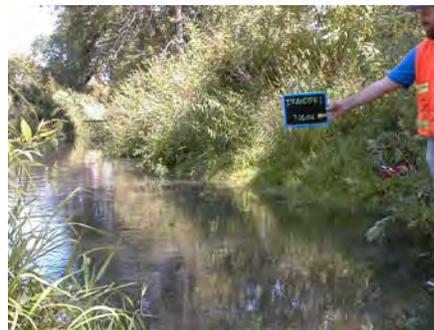
Island Park Slough is a tributary to the Willamette River. It starts south of South A St from the Mill Race. It flows northwest through Island Park to the Willamette River south of D St and Riverview.

It receives flow from the Mill Race and stormwater runoff. This system is considered wetlands and is listed on the Local Wetlands Inventory. The channel is approximately 0.46 miles long.

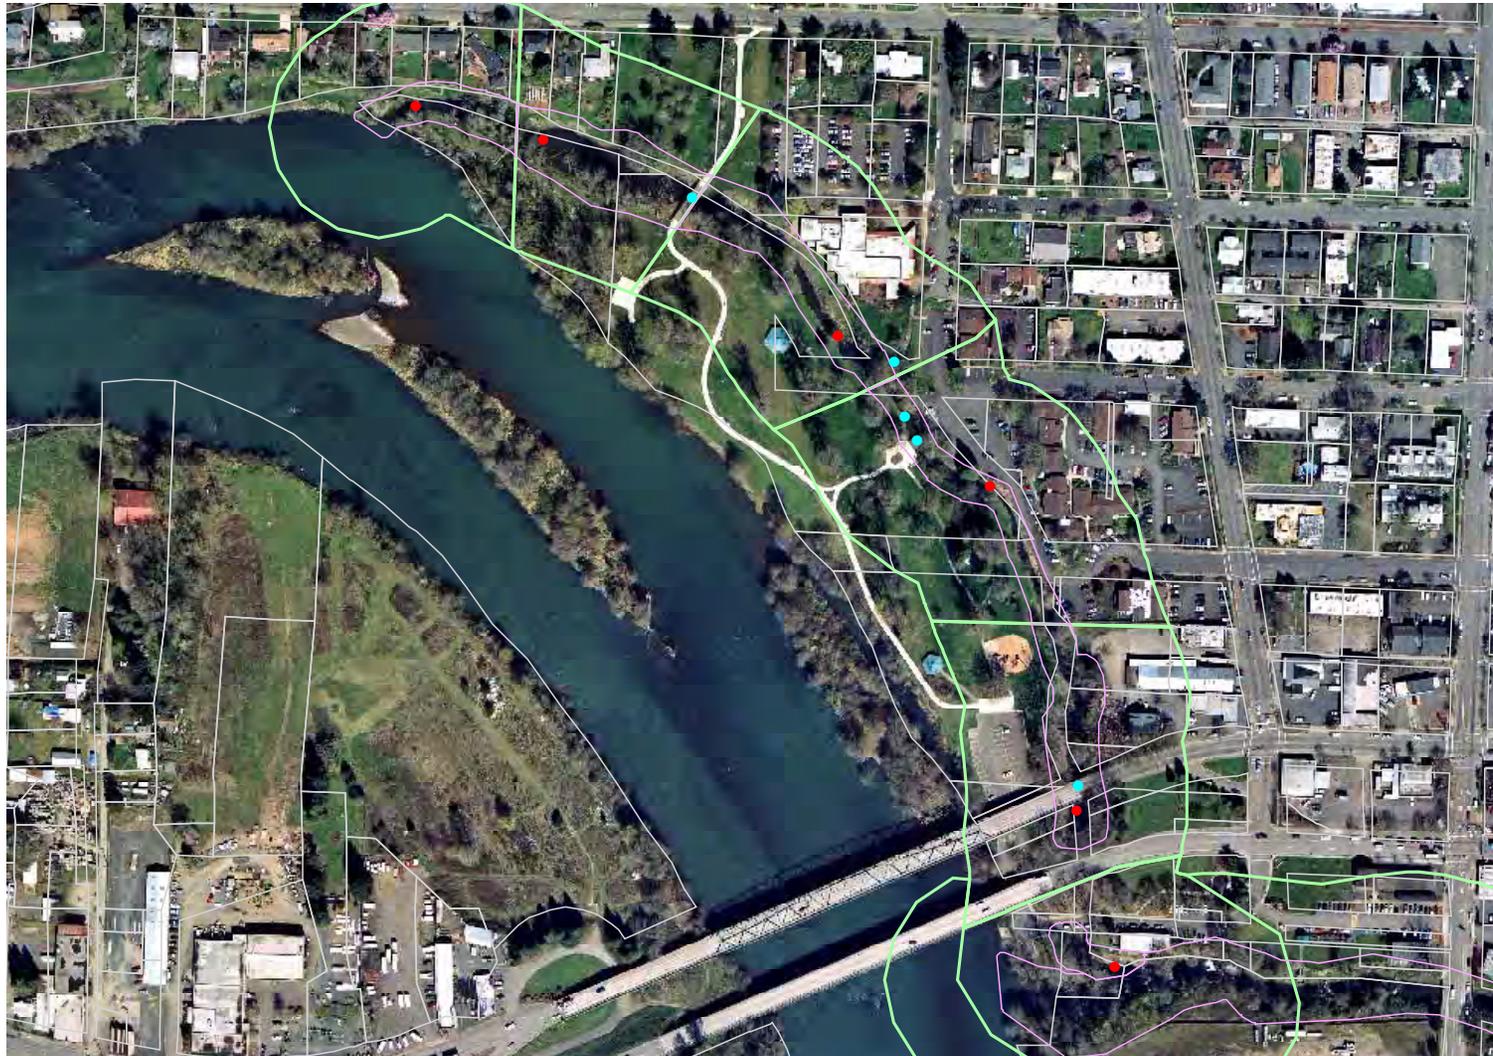
Island Park Slough

Waypoints	
●	Plot
●	Seed Collection Site
●	In Channel Structure
	10ft_riparian_buffer
	200ft_Janduse_buffer
	tax lots

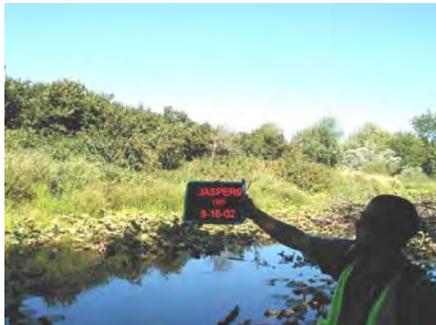
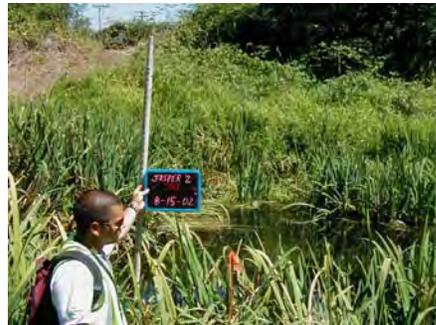
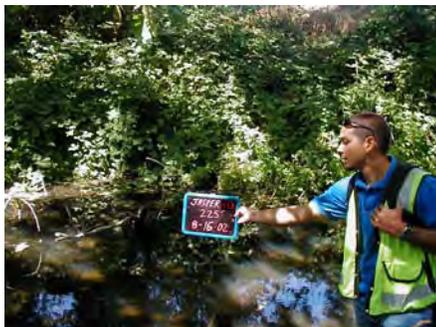
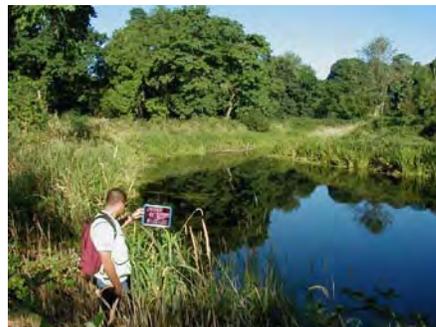
Jasper Slough is a tributary to the Mill Race. The original headwaters of this system have been filled in over the years by upstream landowners. The section accessed starts south of south 42nd St, and south of Jasper Road. It flows southwest then northwest to intersect with the Mill Race south of Jasper Rd at South 32nd St.

It receives flow from stormwater runoff and from a wetland overflow pipe. Sections of this system are wetlands and are listed on the Local Wetlands Inventory. The channel is approximately 1.12 miles long.

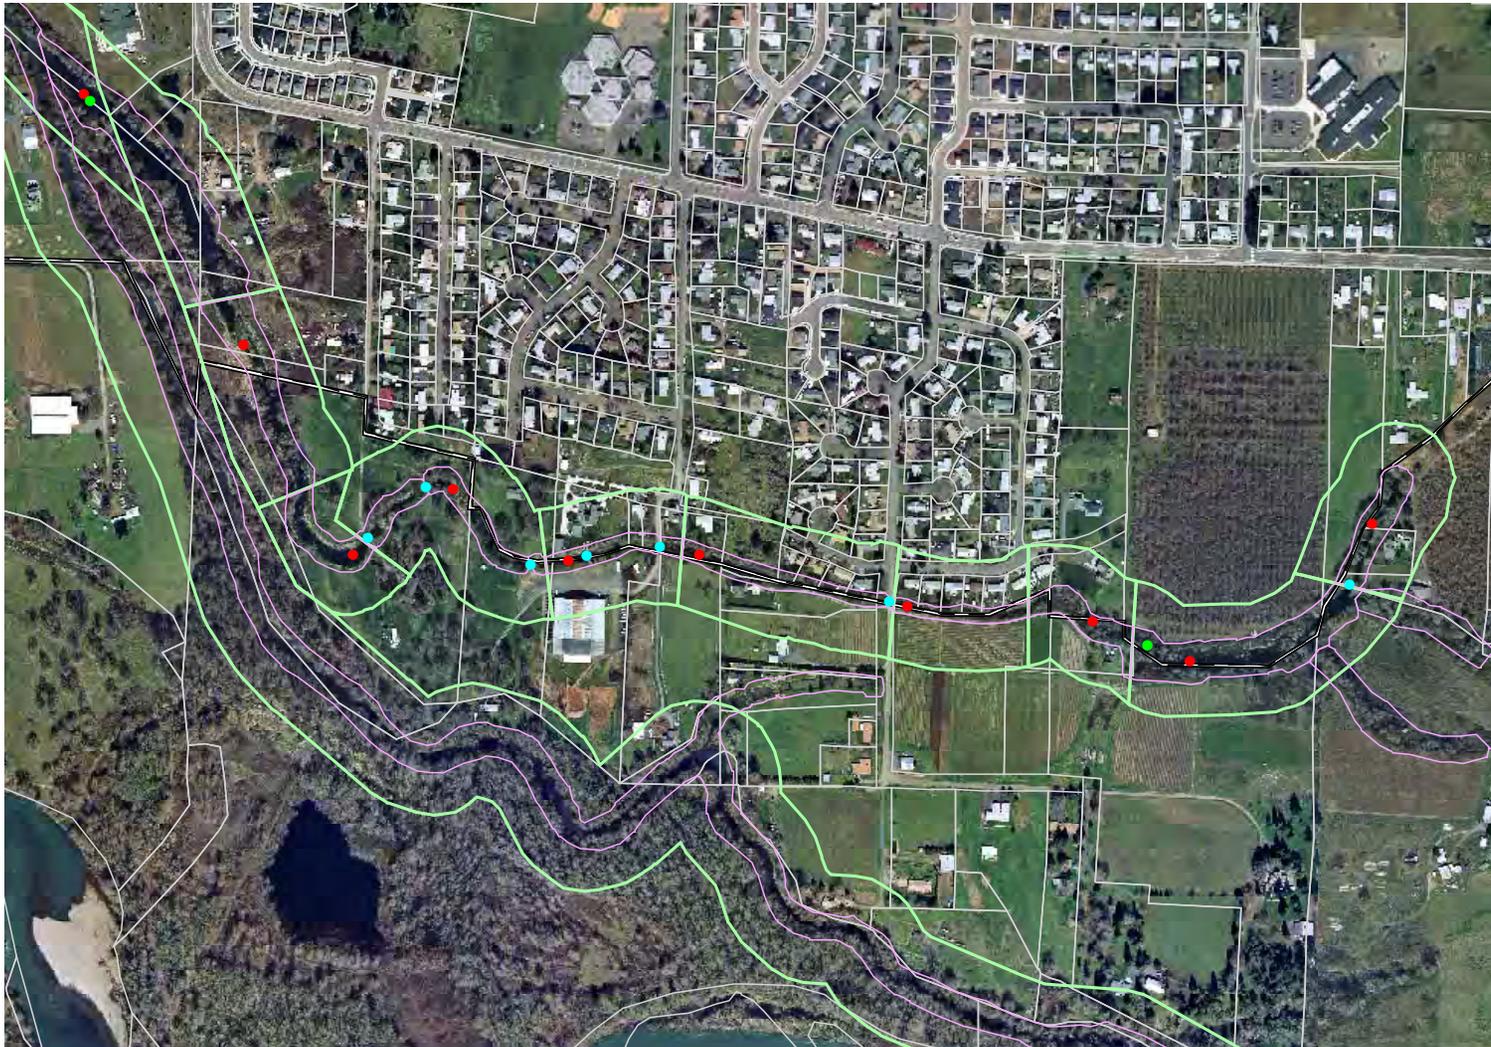
Jasper Slough

Waypoints	
● Plot	10ft_riparian_buffer
● Seed Collection Site	200ft_landuse_buffer
● In Channel Structure	tax lots

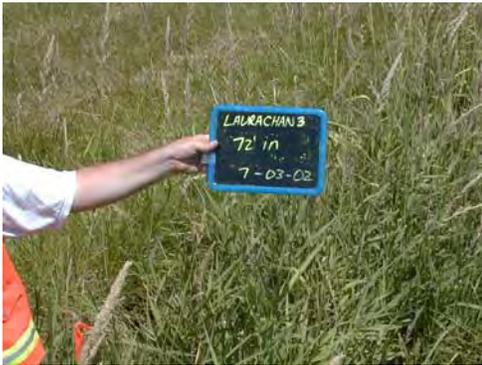
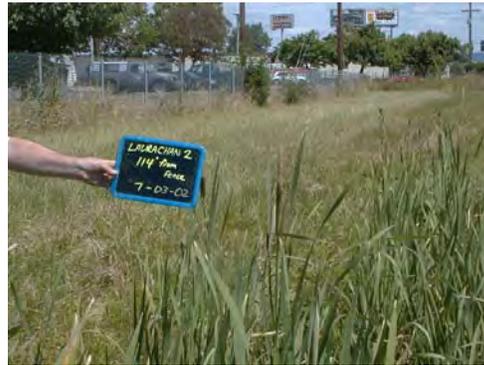
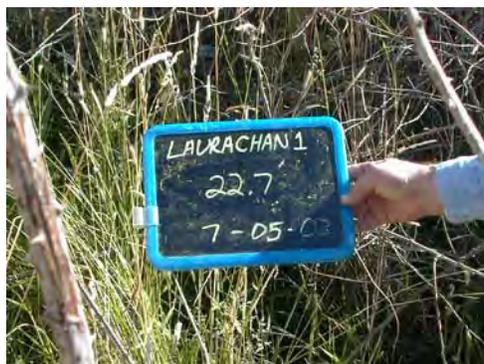
Laura Channel starts west of Laura St where Q St becomes an "on ramp" for I-105 westbound. It flows northwest to a piped system.

It receives flow from stormwater runoff and commercial runoff. The channel is approximately 0.10 miles long.
