Inventory and Channel Assessment Report For Springfield Waterways

Q St Floodway
Concrete Control Structure

August 2004

Environmental Services, Water Resources

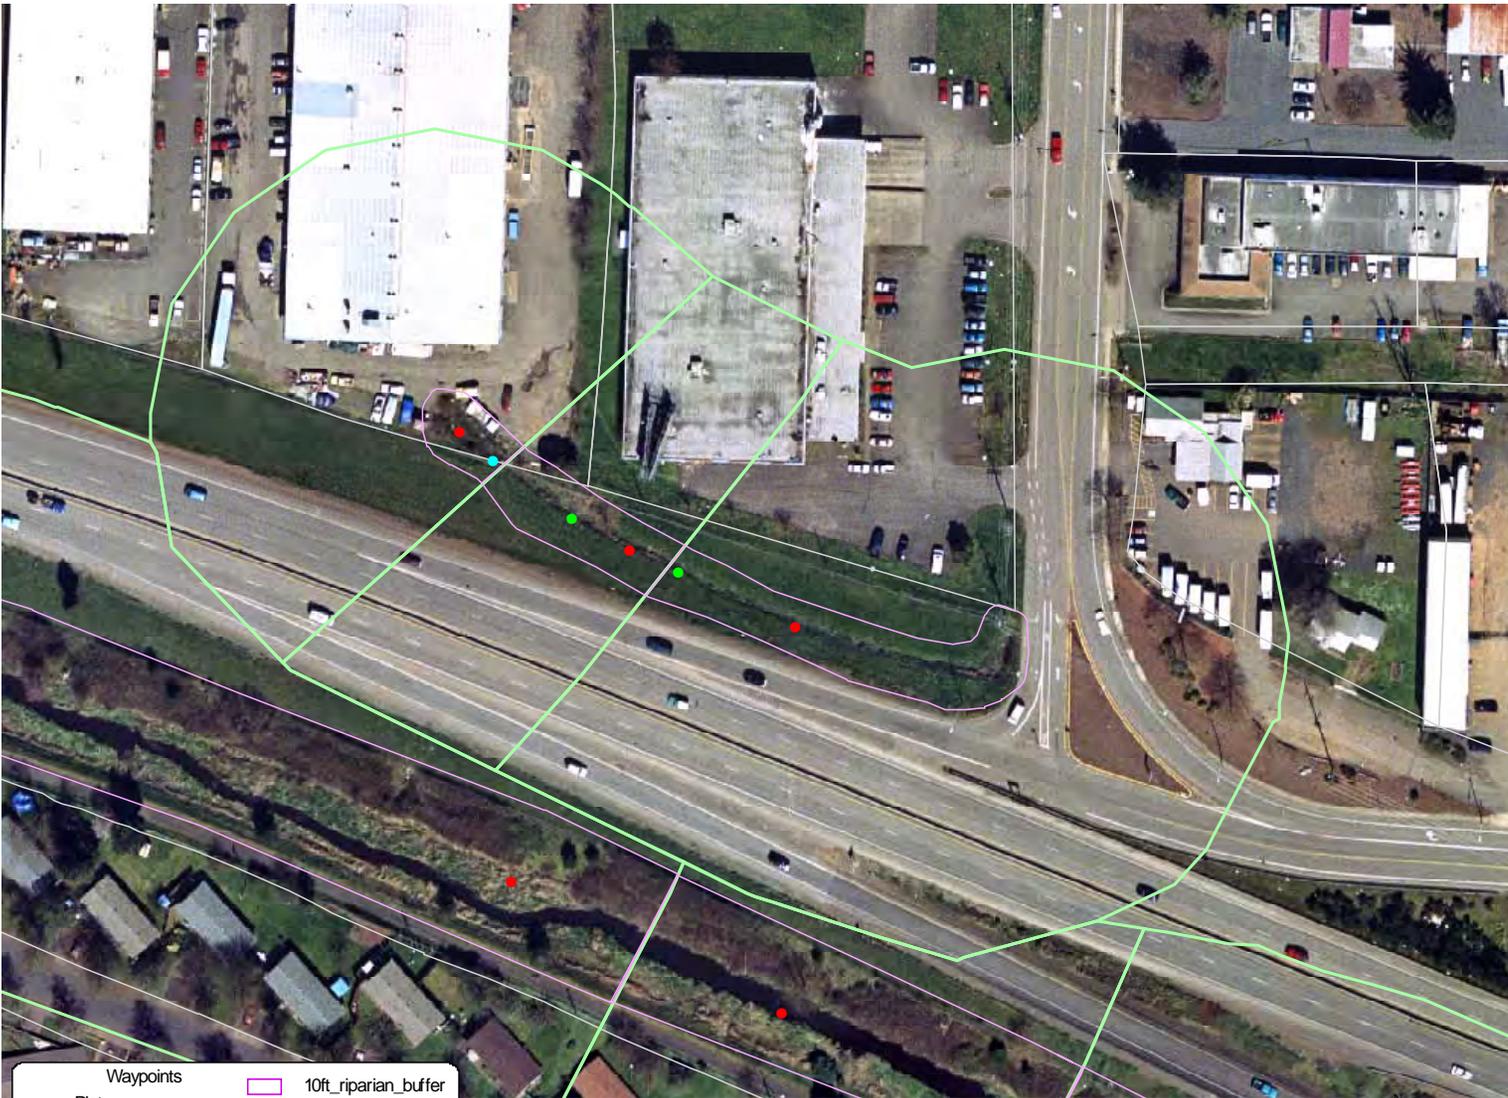
Laura Channel

Waypoints	
●	Plot
●	Seed Collection Site
●	In Channel Structure
	10ft_riparian_buffer
	200ft_landuse_buffer
	tax lots

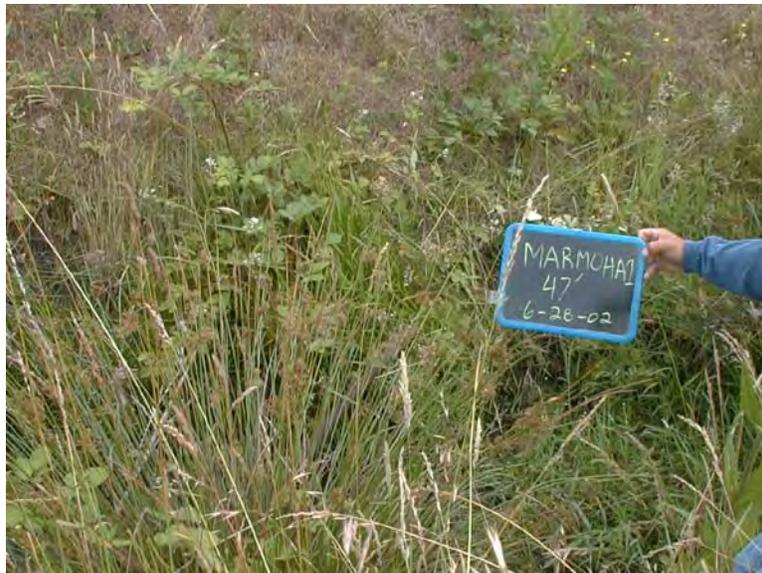
Marcola - Mohawk Channel starts on the southeast side of the intersection of Marcola Rd and Mohawk Rd. It flows southwest to a piped system.

It receives flow from stormwater runoff. The channel is approximately 0.10 miles long.

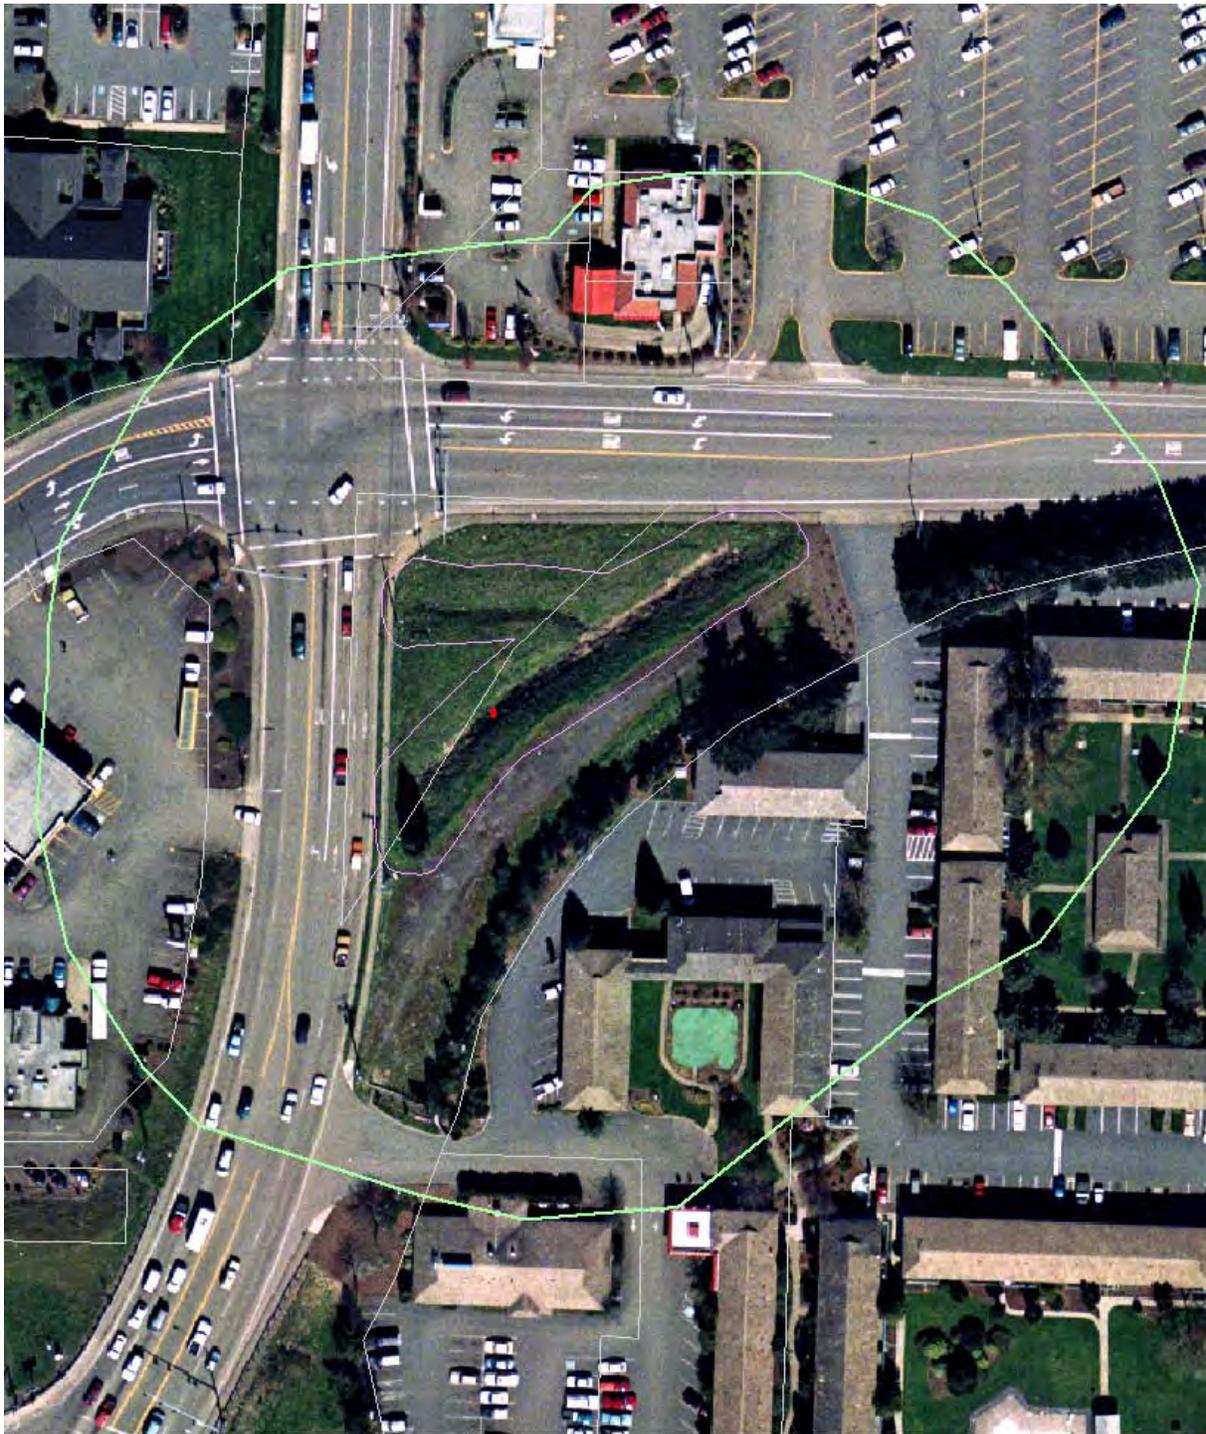
Marcola Mohawk Channel

Waypoints	
● Plot	10 ft riparian buffer
● Seed Collection Site	200 ft land use buffer
● In Channel Structure	tax lots

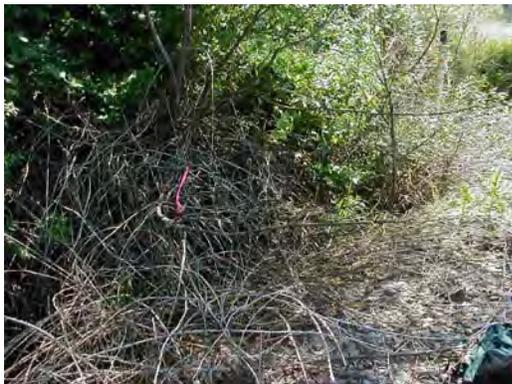
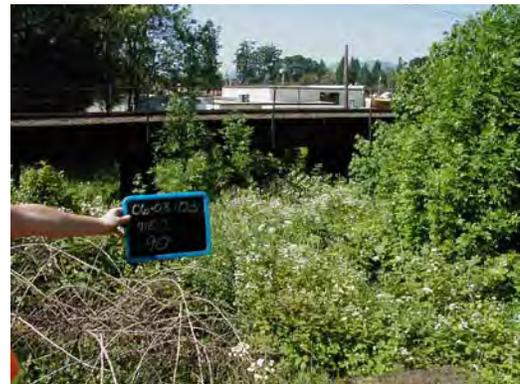
The Moon Mt. East System is a tributary to the Glenwood Slough. Springfield's jurisdiction starts on the north side of I-5 east of Henderson Lane behind the current Pape Cat facility. It flows northwest to a piped section south of 22nd Ave. The system daylights again on the south side of the railroad tracks that split Henderson Lane. It flows east along the tracks then crosses north under the tracks and then north to intersect with the Glenwood Slough.

It receives flow from stormwater runoff, industrial runoff and is fed by runoff from Eugene. The Springfield side of the channel is approximately 0.31 miles long.

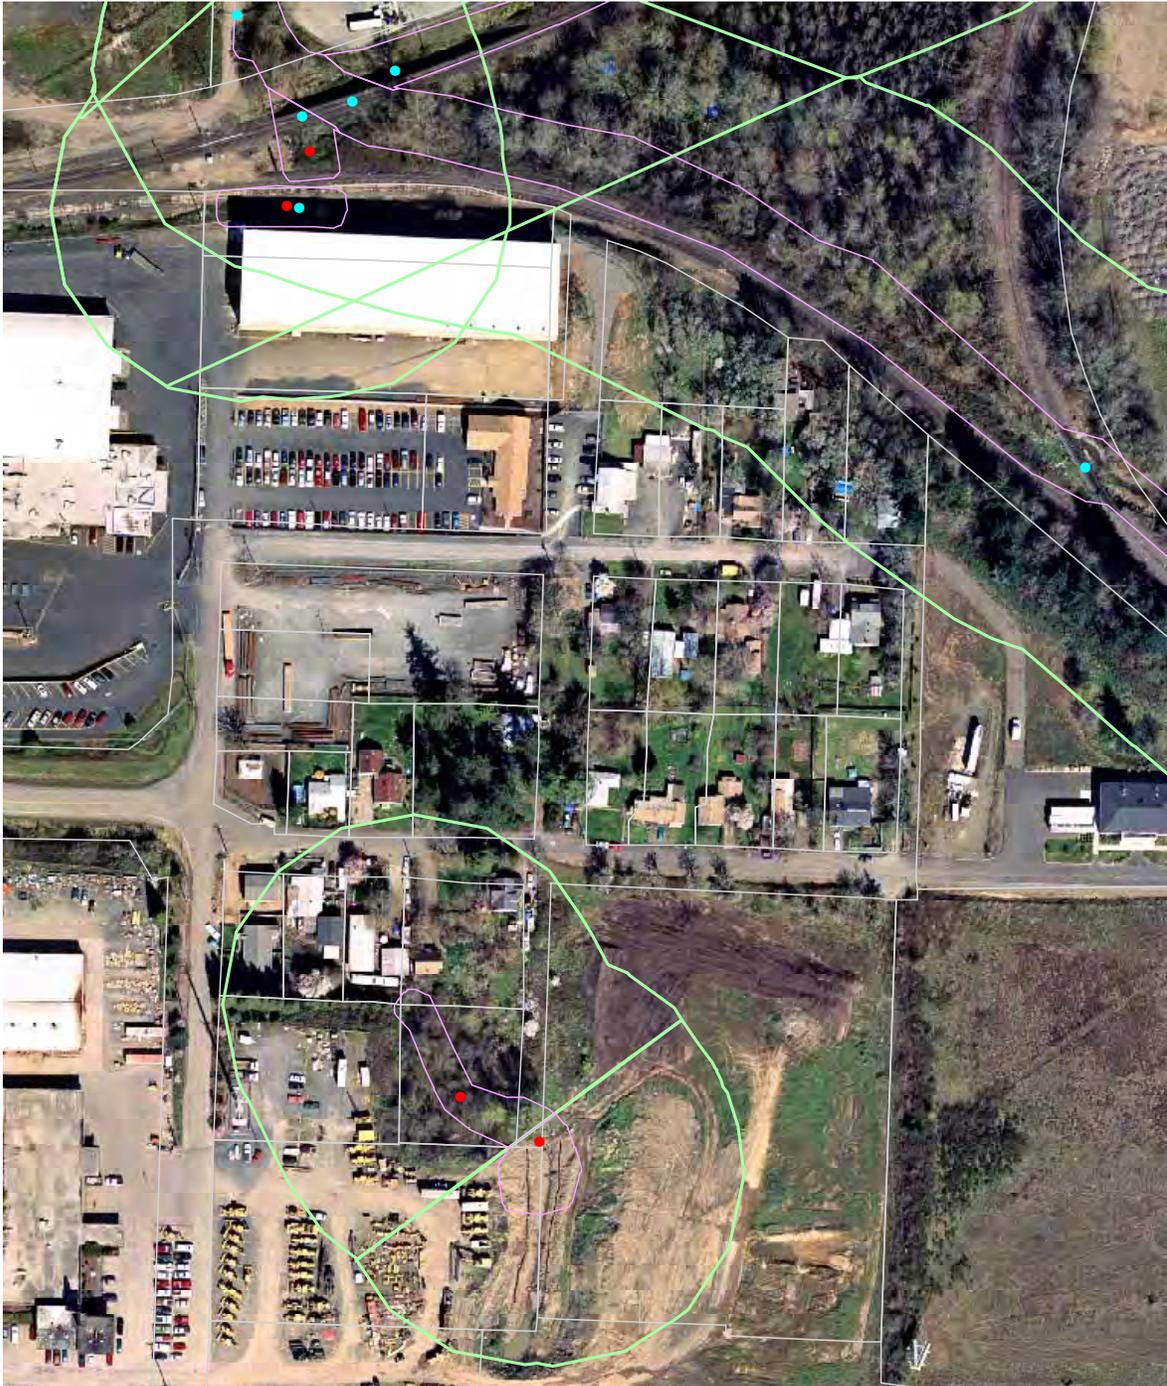
Moon Mt East System

Waypoints	
● Plot	10ft_riparian_buffer
● Seed Collection Site	200ft_landuse_buffer
● In Channel Structure	tax lots

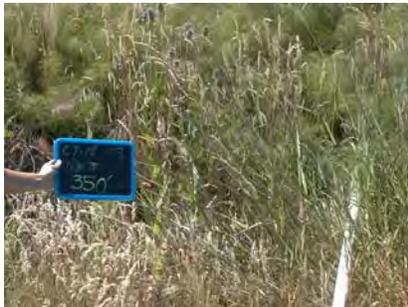
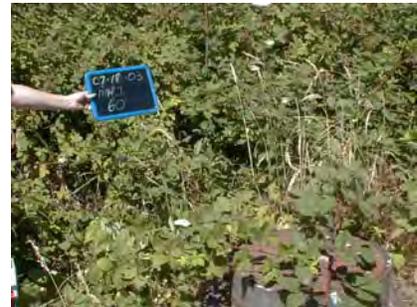
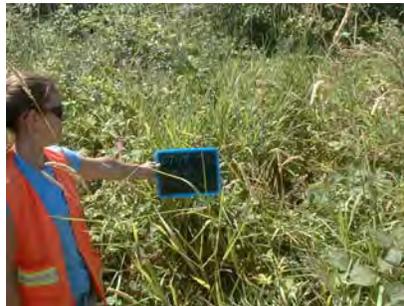
The Moon Mt. West System is a tributary to the Glenwood Slough. Springfield's jurisdiction starts on the east side of I-5 and the south side of the railroad tracks that are on the north side of Farwest Steel's property east of Henderson Lane in Glenwood. It flows east along side the railroad tracks, north under the tracks and then west and north to intersect with the Glenwood Slough.

It receives flow from stormwater runoff, industrial runoff and is fed by runoff from Eugene. The channel is approximately 0.30 miles long.

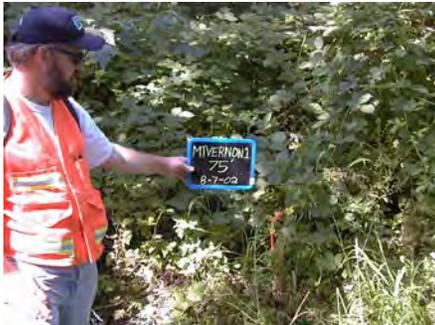
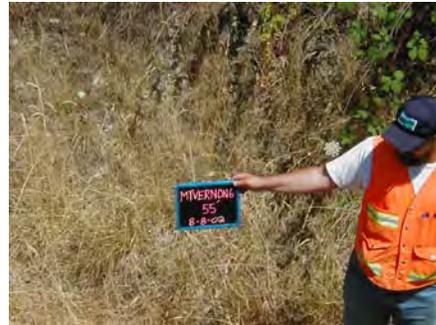
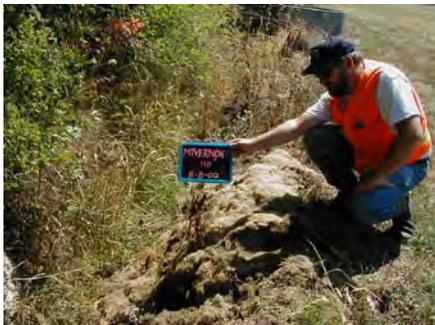
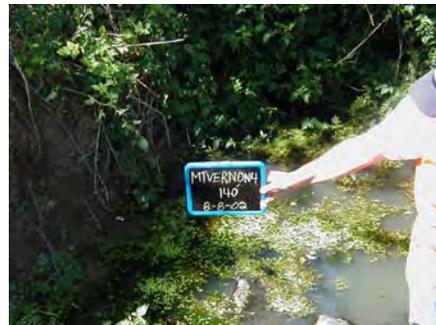
Mt. Vernon Channel starts east of South 59th St. and south of Mt. Vernon St. It flows north to Mt. Vernon St. then west to about South 57th Pl then south to wetlands.

It receives flow from stormwater runoff and flows through and to wetlands. Sections of this system are wetlands and are listed on the Local Wetlands Inventory. Not all of this system has been mapped. The mapped section of the channel is approximately 0.25 miles long. The area was under development at the time the assessment was performed.

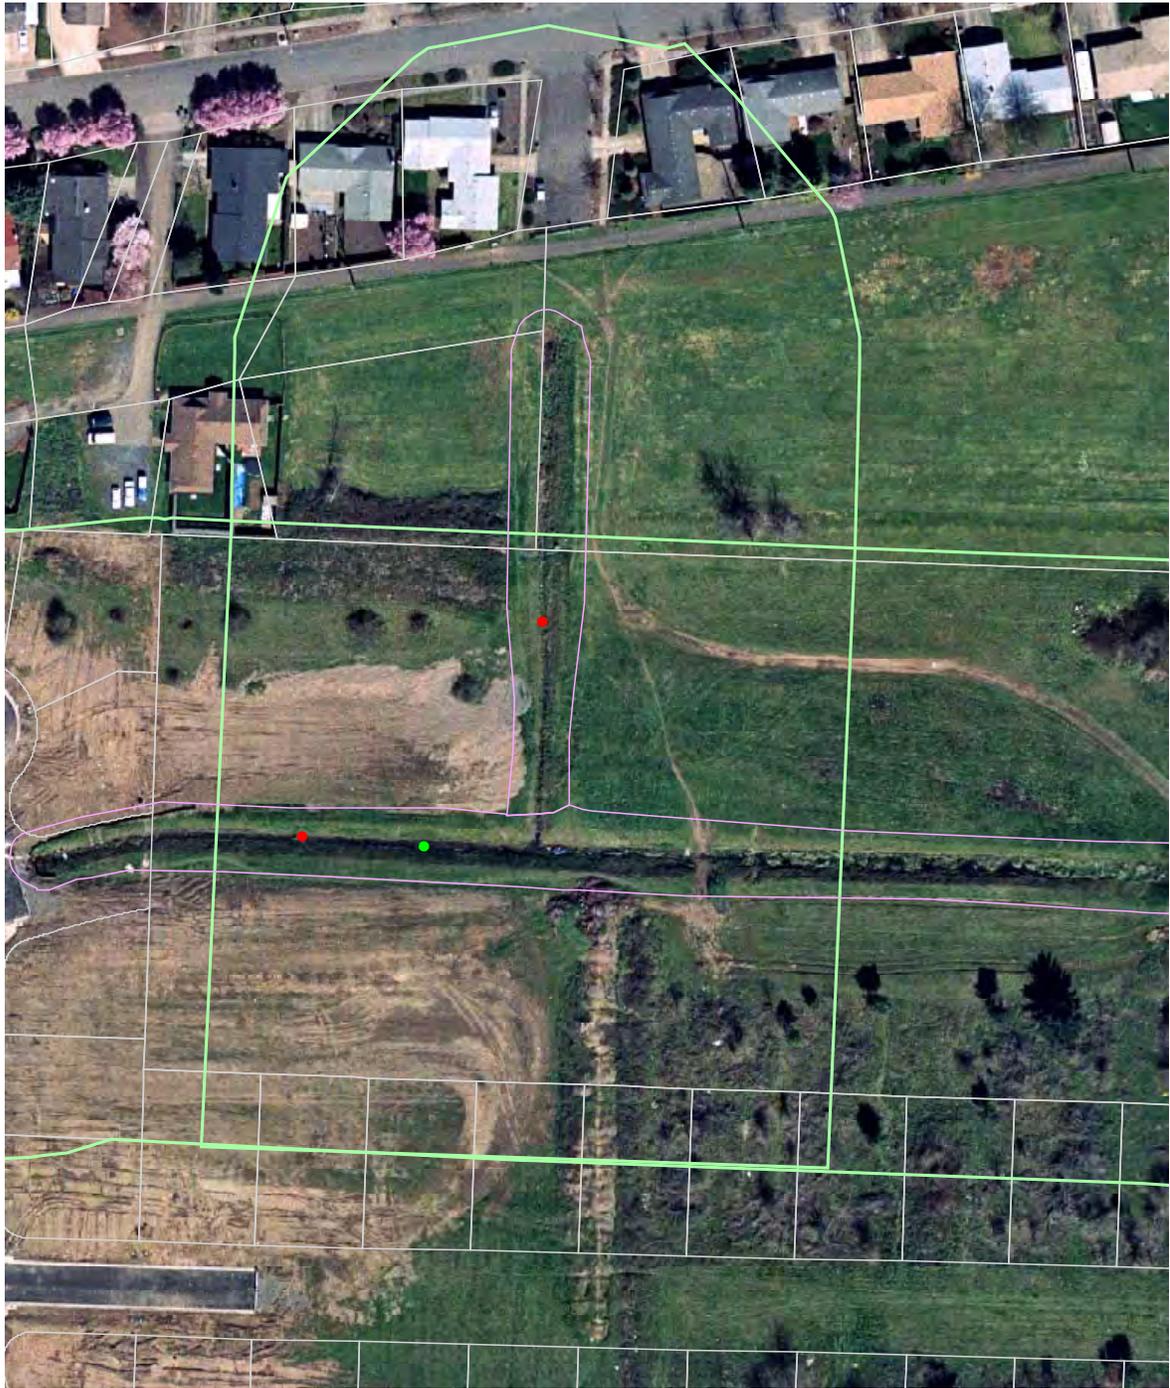
Northridge & 9th Channel No scale

Waypoints	
●	Plot
●	Seed Collection Site
●	In Channel Structure
	10ft_riparian_buffer
	200ft_landuse_buffer
	tax lots

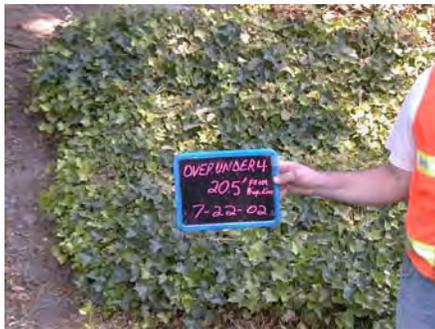
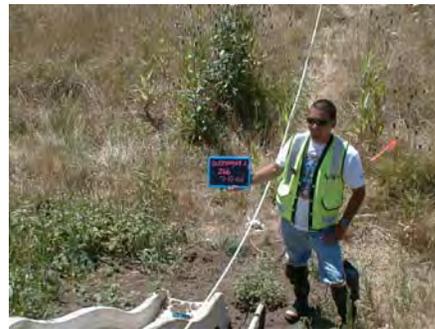
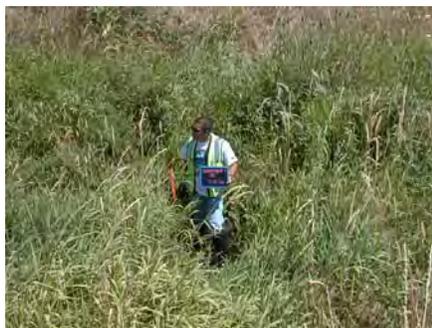
The Over/Under Channel is a tributary to the Q St Floodway. The section assessed starts west of 8th St and north of Centennial Blvd.

It receives flow from stormwater runoff and permitted, non-contact industrial discharge flows. The channel is approximately 0.53 miles long.

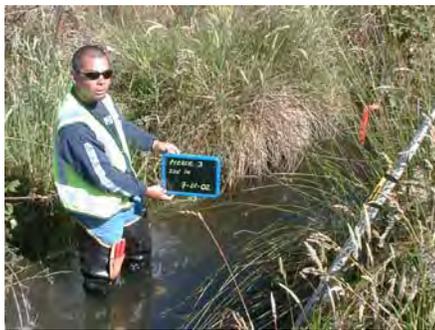
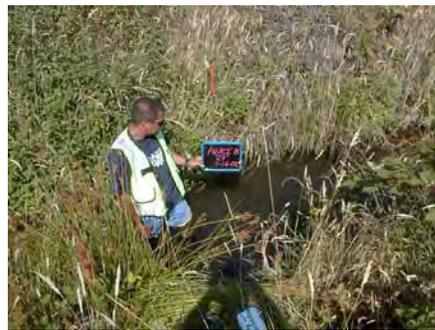
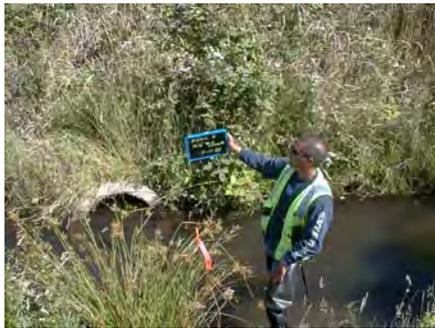
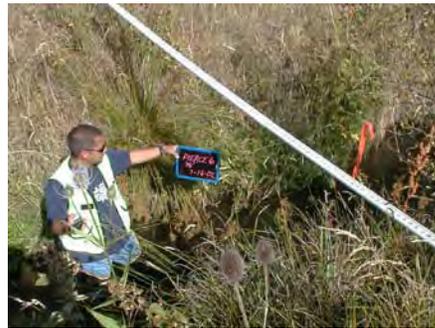
The Pierce Channel starts on the west side of 31st St. south of V St. It flows south then west to 23rd St, then south to Marcola Rd where it flows into a piped system.

It receives flow from stormwater runoff and is fed by Irving Slough. This system is considered wetlands and is listed on the Local Wetlands Inventory. The channel is approximately 0.71 miles long.

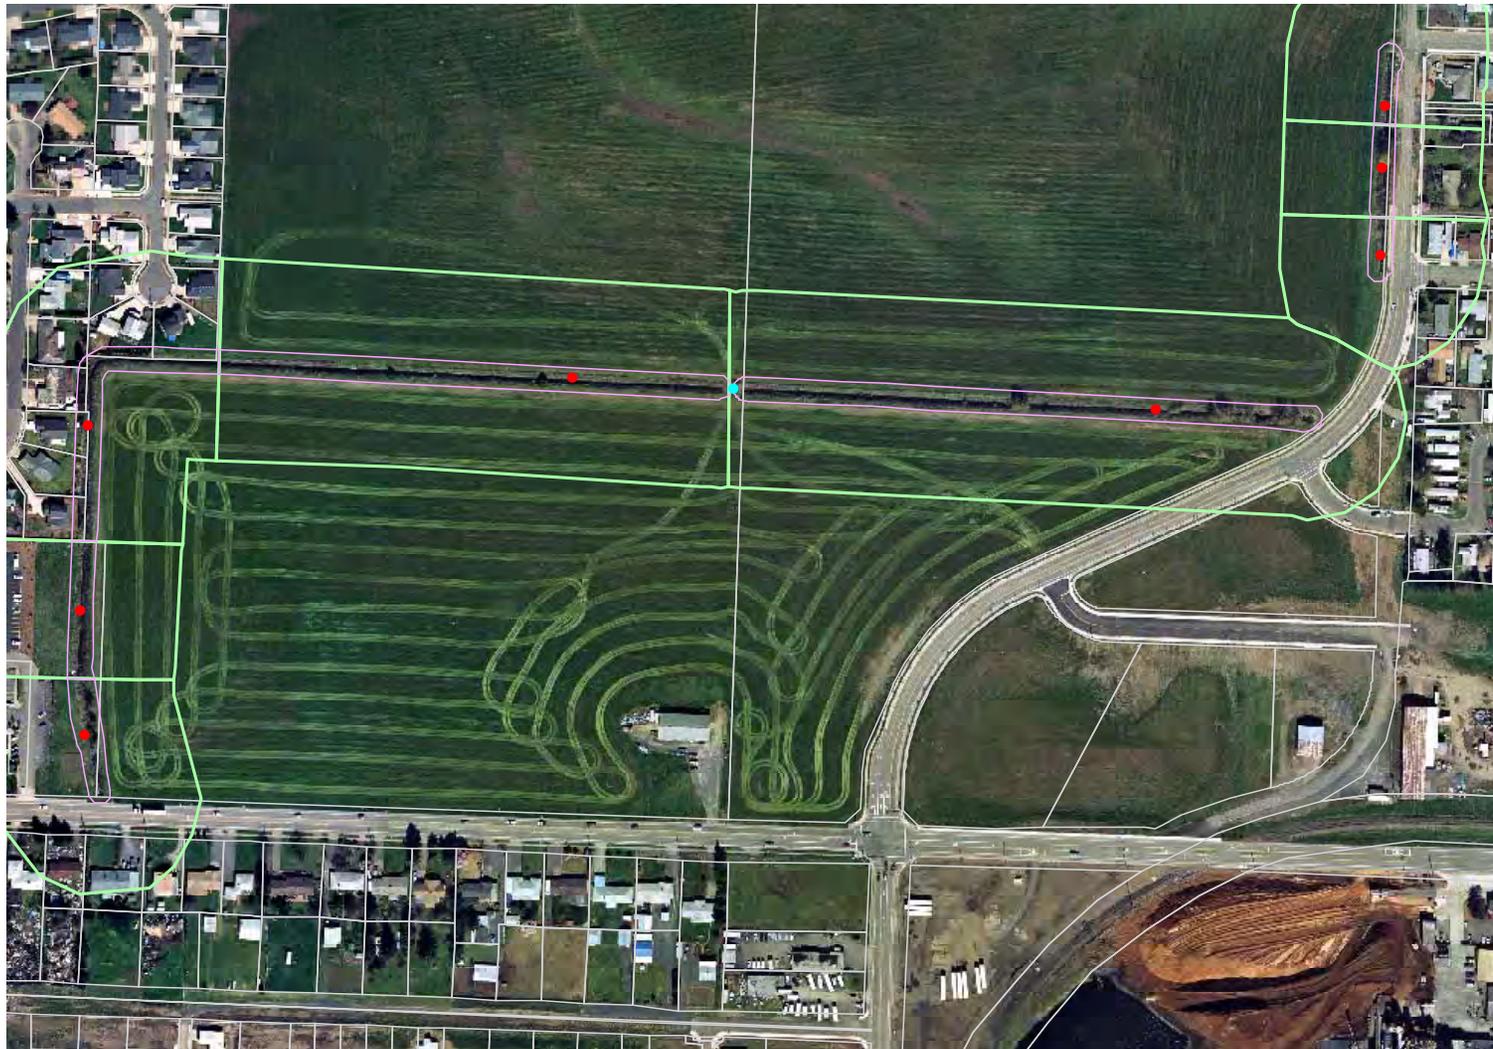
Pierce Channel

Waypoints	
● Plot	10ft_riparian_buffer
● Seed Collection Site	200ft_landuse_buffer
● In Channel Structure	tax lots

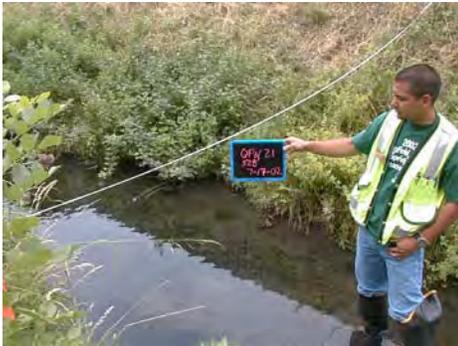
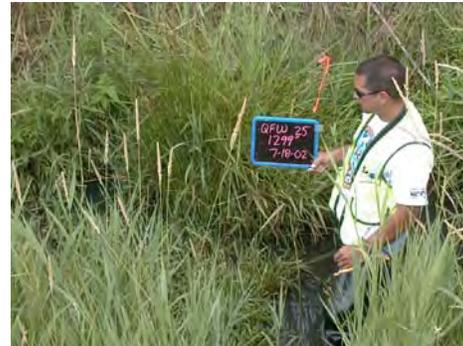
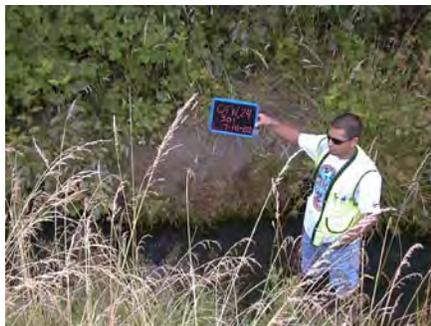
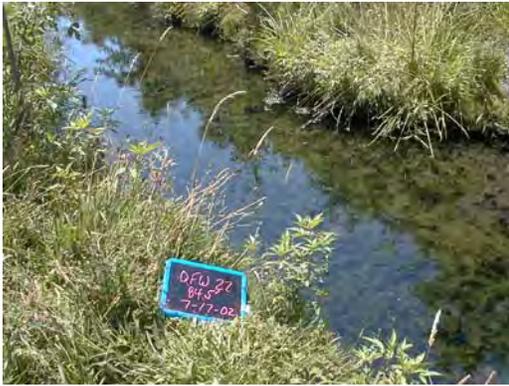
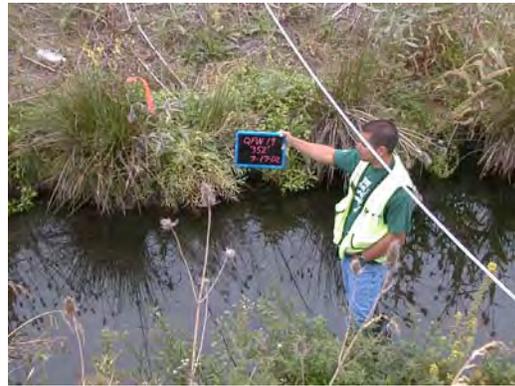
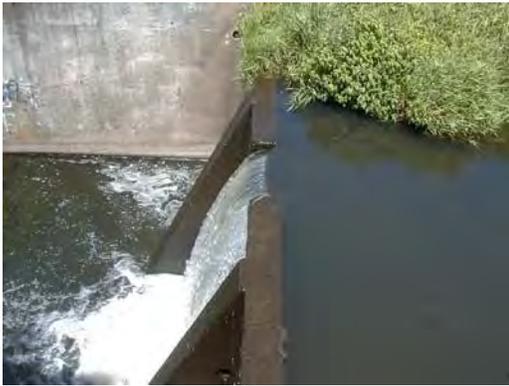
The Q St Floodway starts north of Main St at 30th St. It flows north then west to I-5 then into Eugene.

The system receives flow from residential and commercial stormwater runoff and industrial non-contact process water and stormwater runoff. Parts of this system are wetlands and are listed on the Local Wetlands Inventory (LWI). Springfield's jurisdiction of the channel is approximately 4.4 miles long. This system is listed as a Tributary on Springfield's Water Quality Limited Waterways (WQLW) by the City.

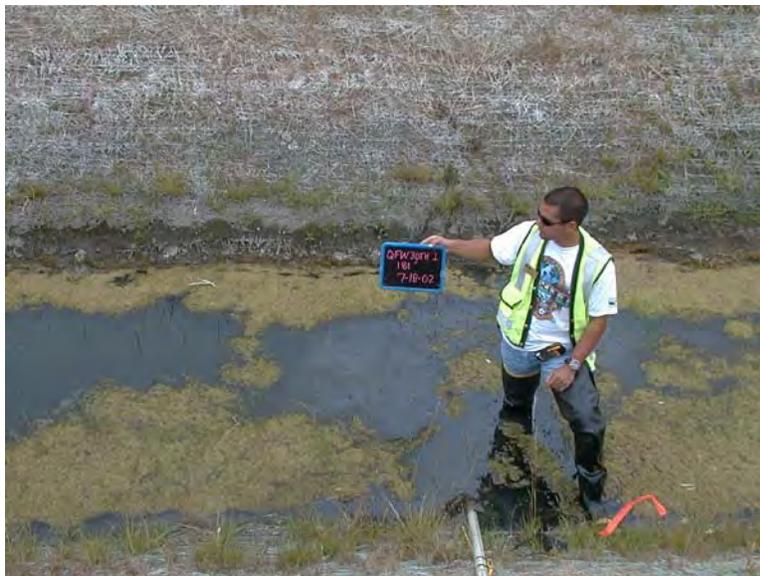
Q St Floodway – 30th St Channel is a tributary to the Q St Floodway. It starts east of 30th St north of Main St and at the end of 30th St. It flows west to intersect with the Q St Floodway at 30th St. This channel had just been reconstructed under city project P30176 at the time of the assessment.

It receives flow from stormwater runoff, industrial runoff and flows through a wetland. The channel is approximately 0.08 miles long

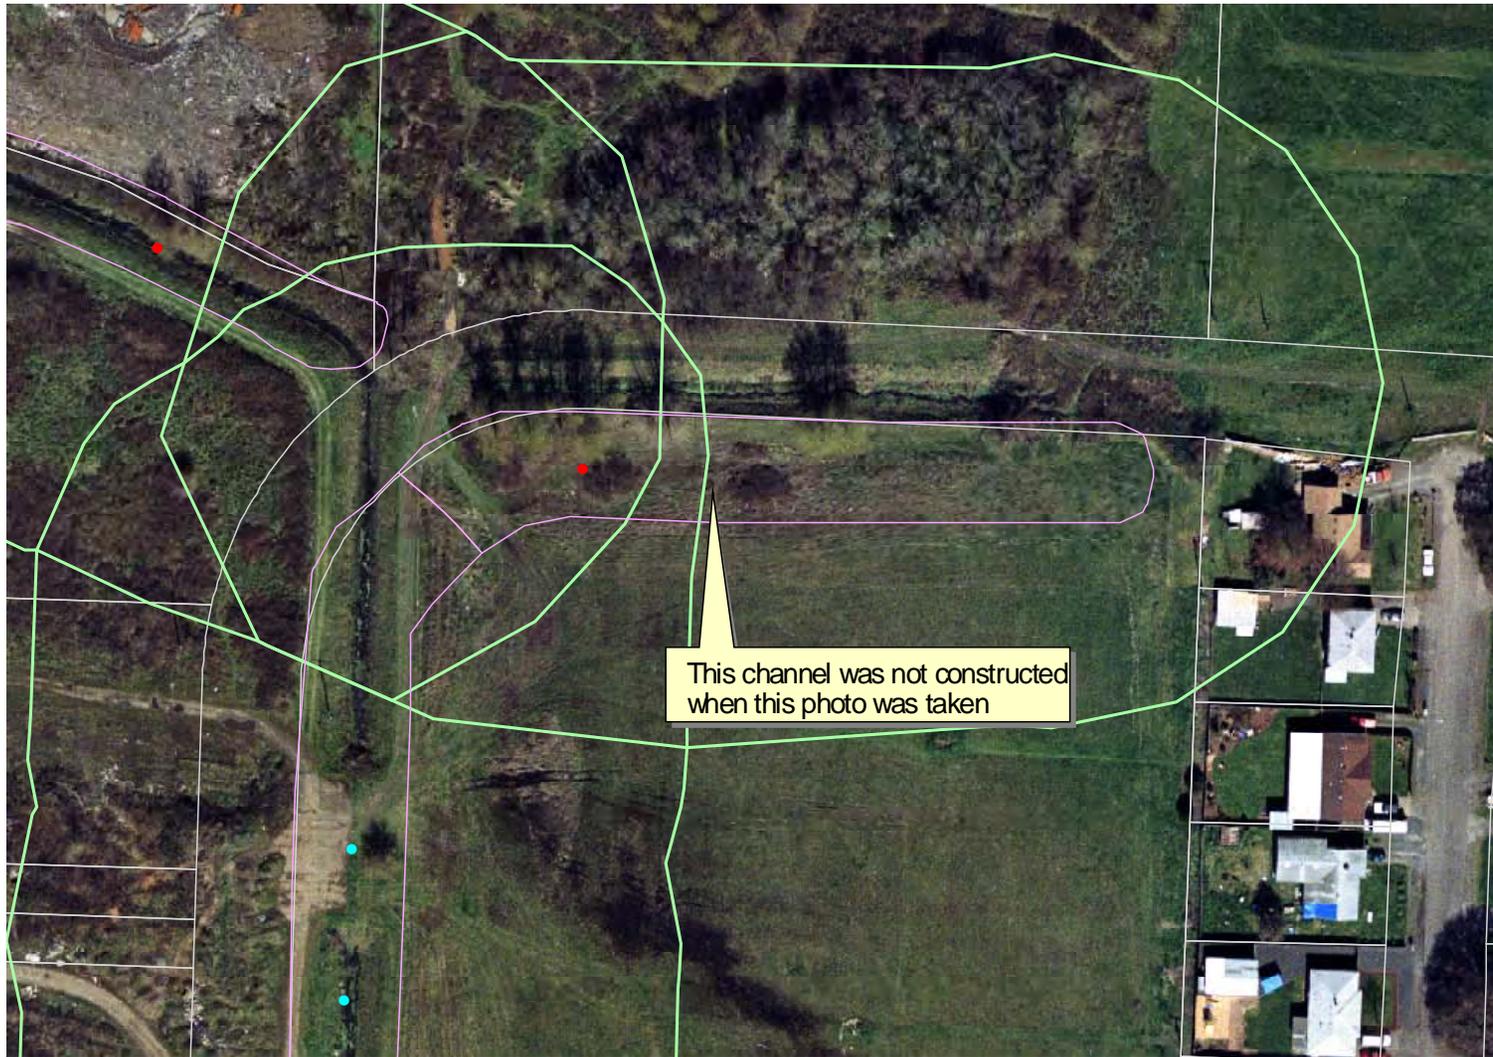
Q St Floodway - 30th St Channel

This channel was not constructed when this photo was taken

Waypoints	10ft_riparian_buffer
• Plot	200ft_landuse_buffer
• Seed Collection Site	tax lots
• In Channel Structure

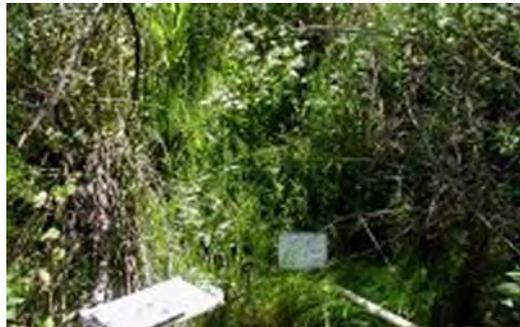
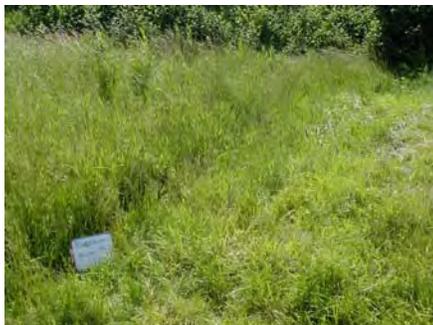
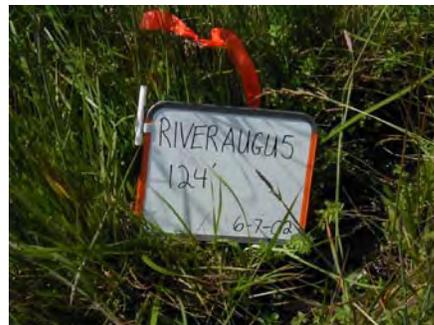
Riverview – Augusta Channel is a tributary to the Glenwood Slough. It starts on the east side of I-5 southwest of Judkins Rd behind the current Pepsi Cola facility. It flows northwest to intersect with the Glenwood Slough after going under the railroad tracks.

It receives flows from stormwater runoff from industrial and commercial sites, both from within Glenwood and from adjacent land in Eugene. It is also fed by an underground spring. The channel enters Eugene's jurisdiction under the I-5 Bridge before emptying to the Willamette River. It is approximately 0.42 miles long.

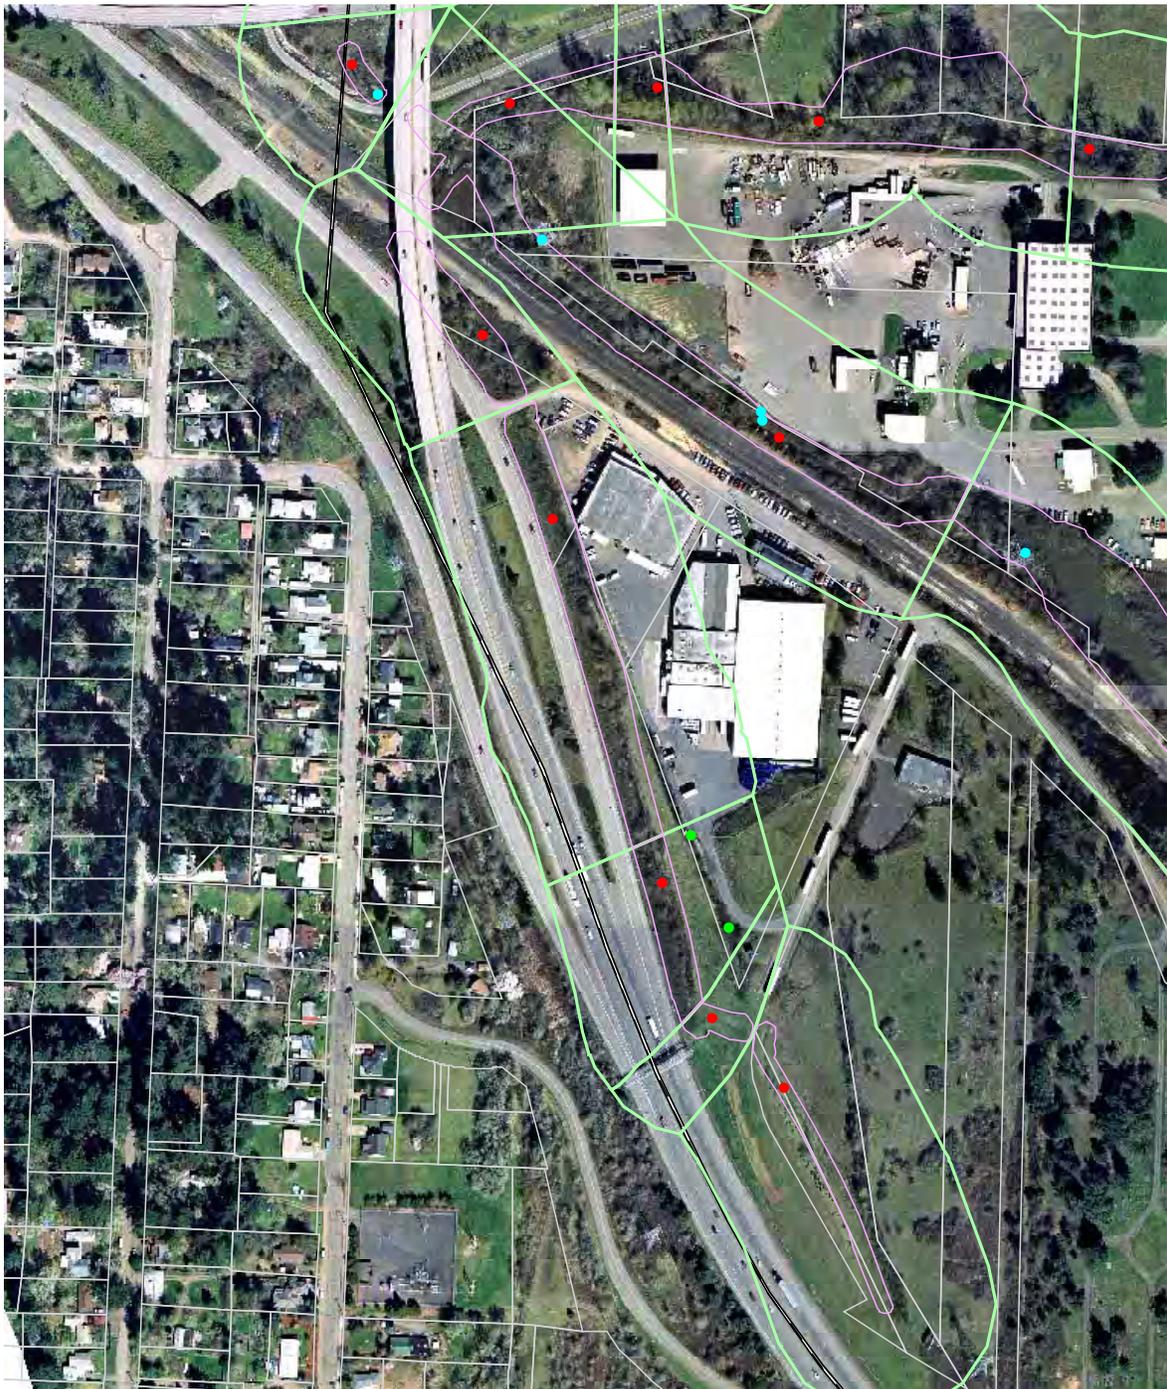
Riverview - Augusta Channel

Waypoints	10ft_riparian_buffer
• Plot	200ft_landuse_buffer
• Seed Collection Site	tax lots
• In Channel Structure

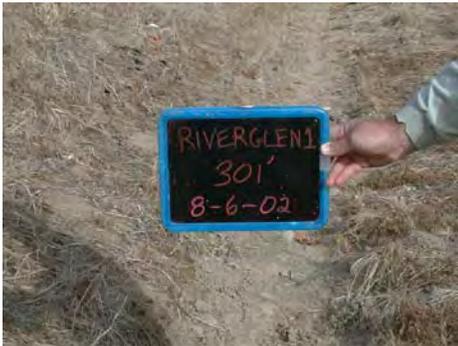
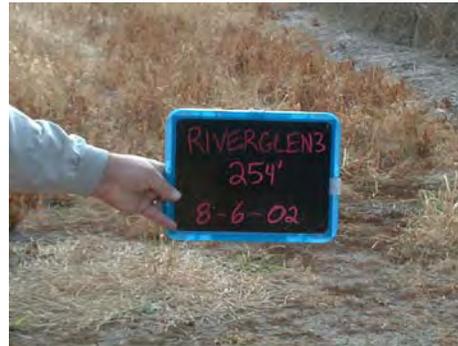
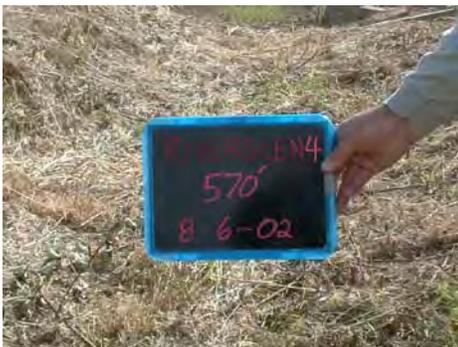
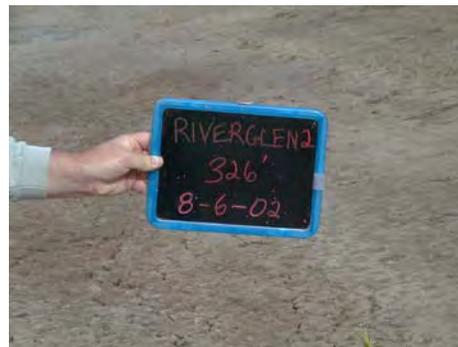
The River Glen Channel is a tributary to the McKenzie River. It starts west of Harvest Ln. north of Delrose Dr. It flows northwest to the river.

It receives flow from stormwater runoff. The channel is approximately 0.43 miles long.

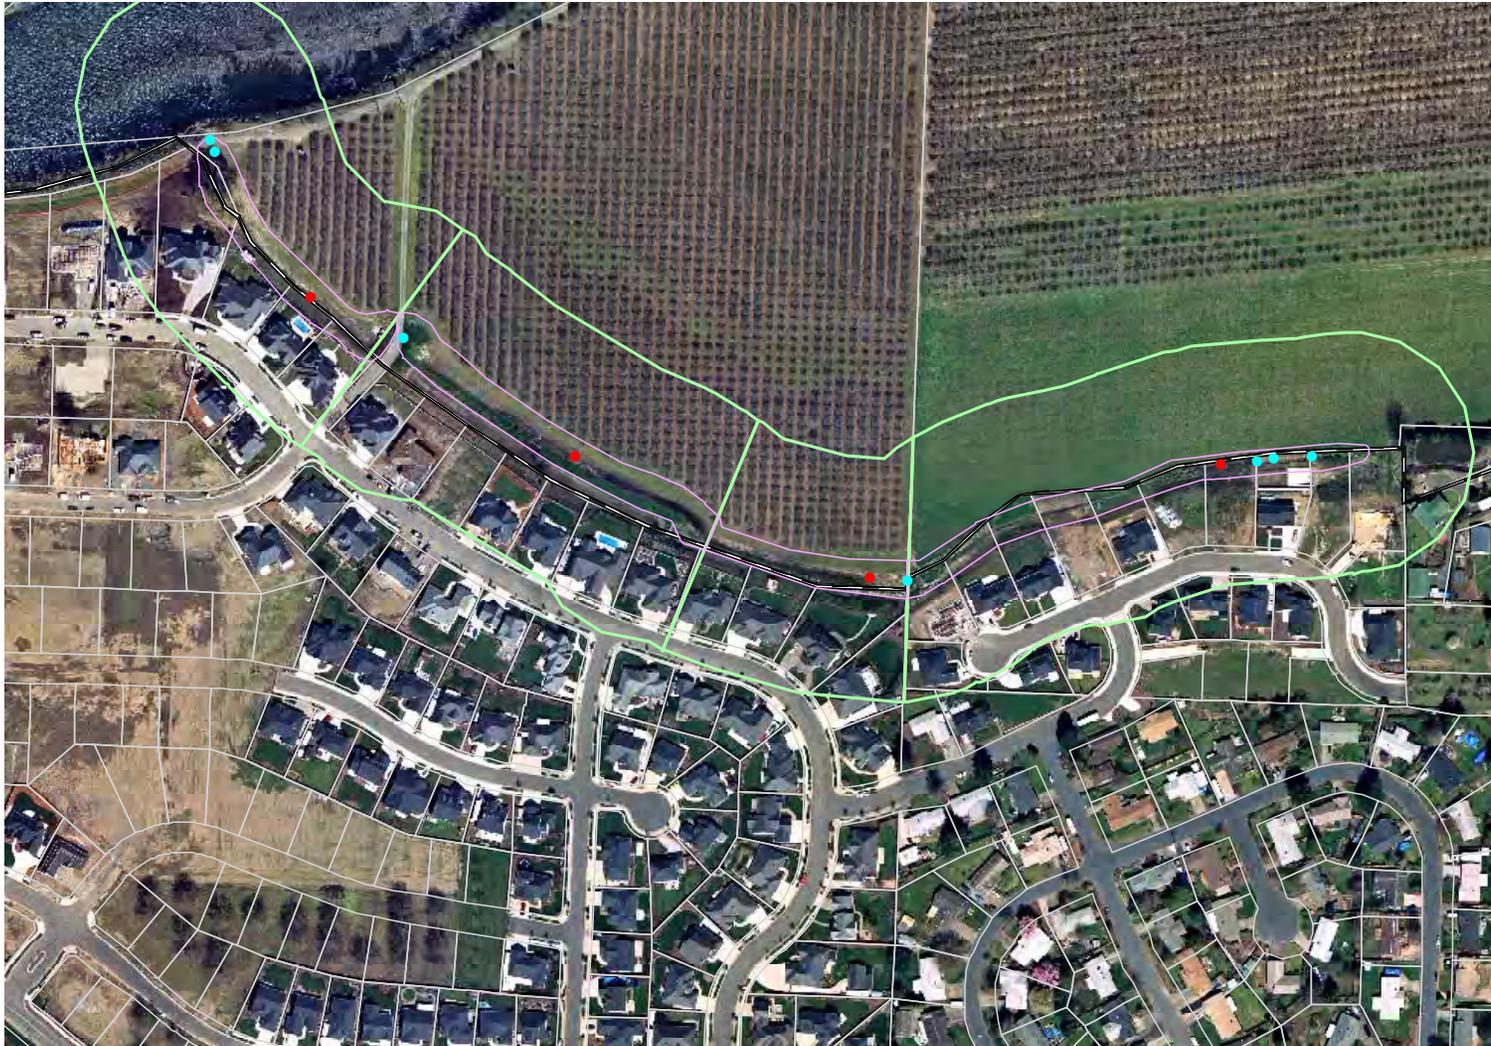
River Glen Channel

Waypoints		10ft_riparian_buffer
	Plot	200ft_landuse_buffer
	Seed Collection Site	tax lots
	In Channel Structure

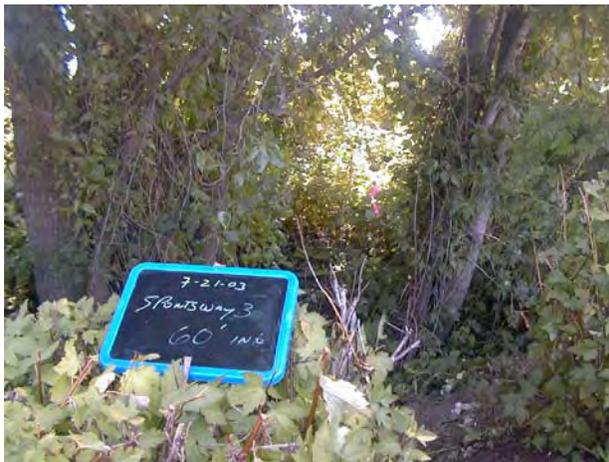
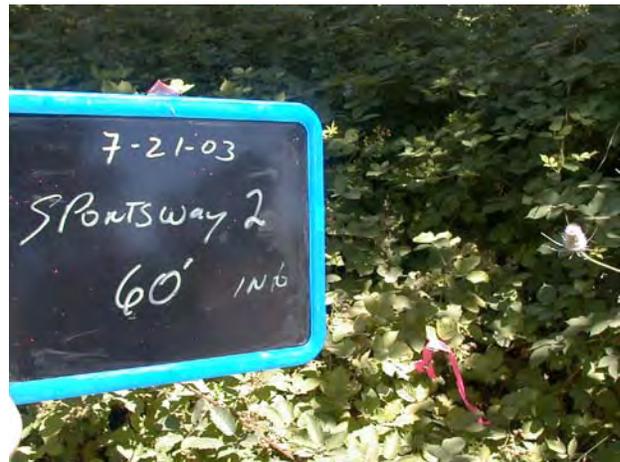
Sports Way Channel starts north of International Way and lies between International Way Court and Sports Way. It flows north to the Sports Way Soccer field parking lots and either absorbs into the ground or enters a piped system that has not been located. This system daylights again at the end of Sports Way and flows northwest into Maple Island Slough.

It receives flow from stormwater runoff. The channel is approximately 0.31 miles long.
