Local Wetlands Inventory and Riparian Corridor Assessment for the Glenwood Area of Springfield, Oregon

Pacific Habitat Services, Inc.
Wilsonville, Oregon

February 10, 2010

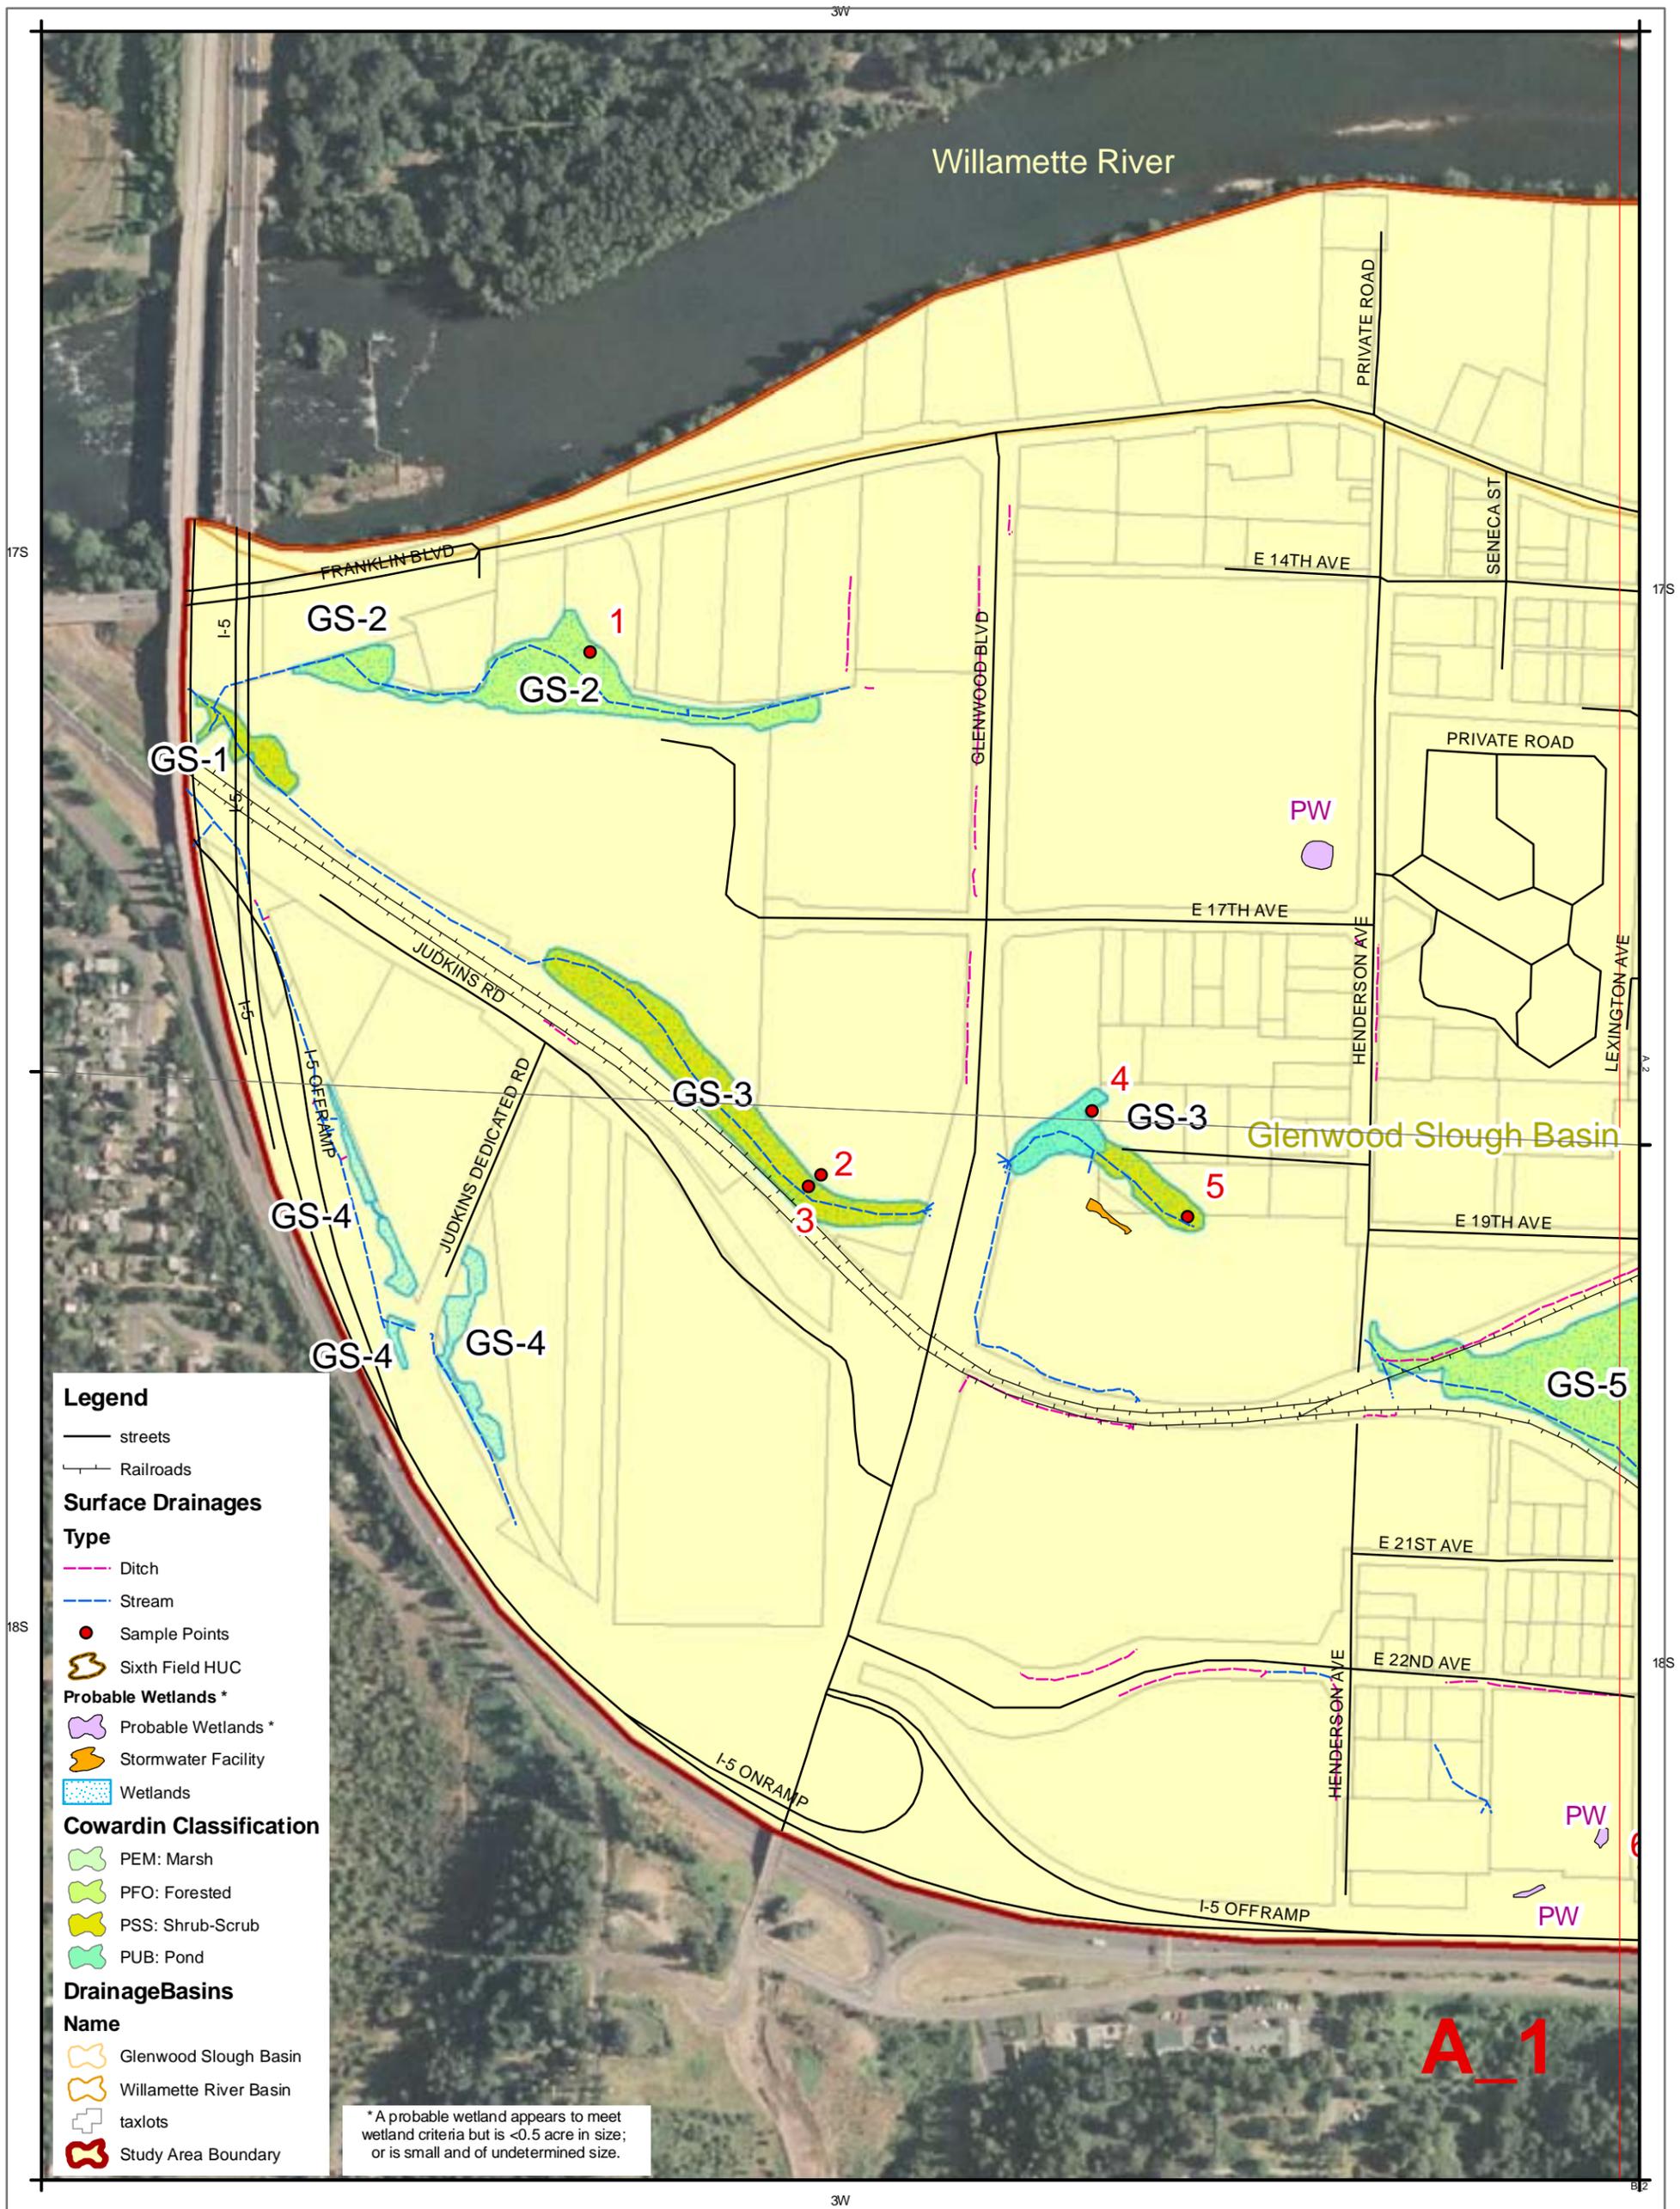
Glenwood LWI Map (A-1)

Sheet 2 - Glenwood Area of Springfield Local Wetlands Inventory

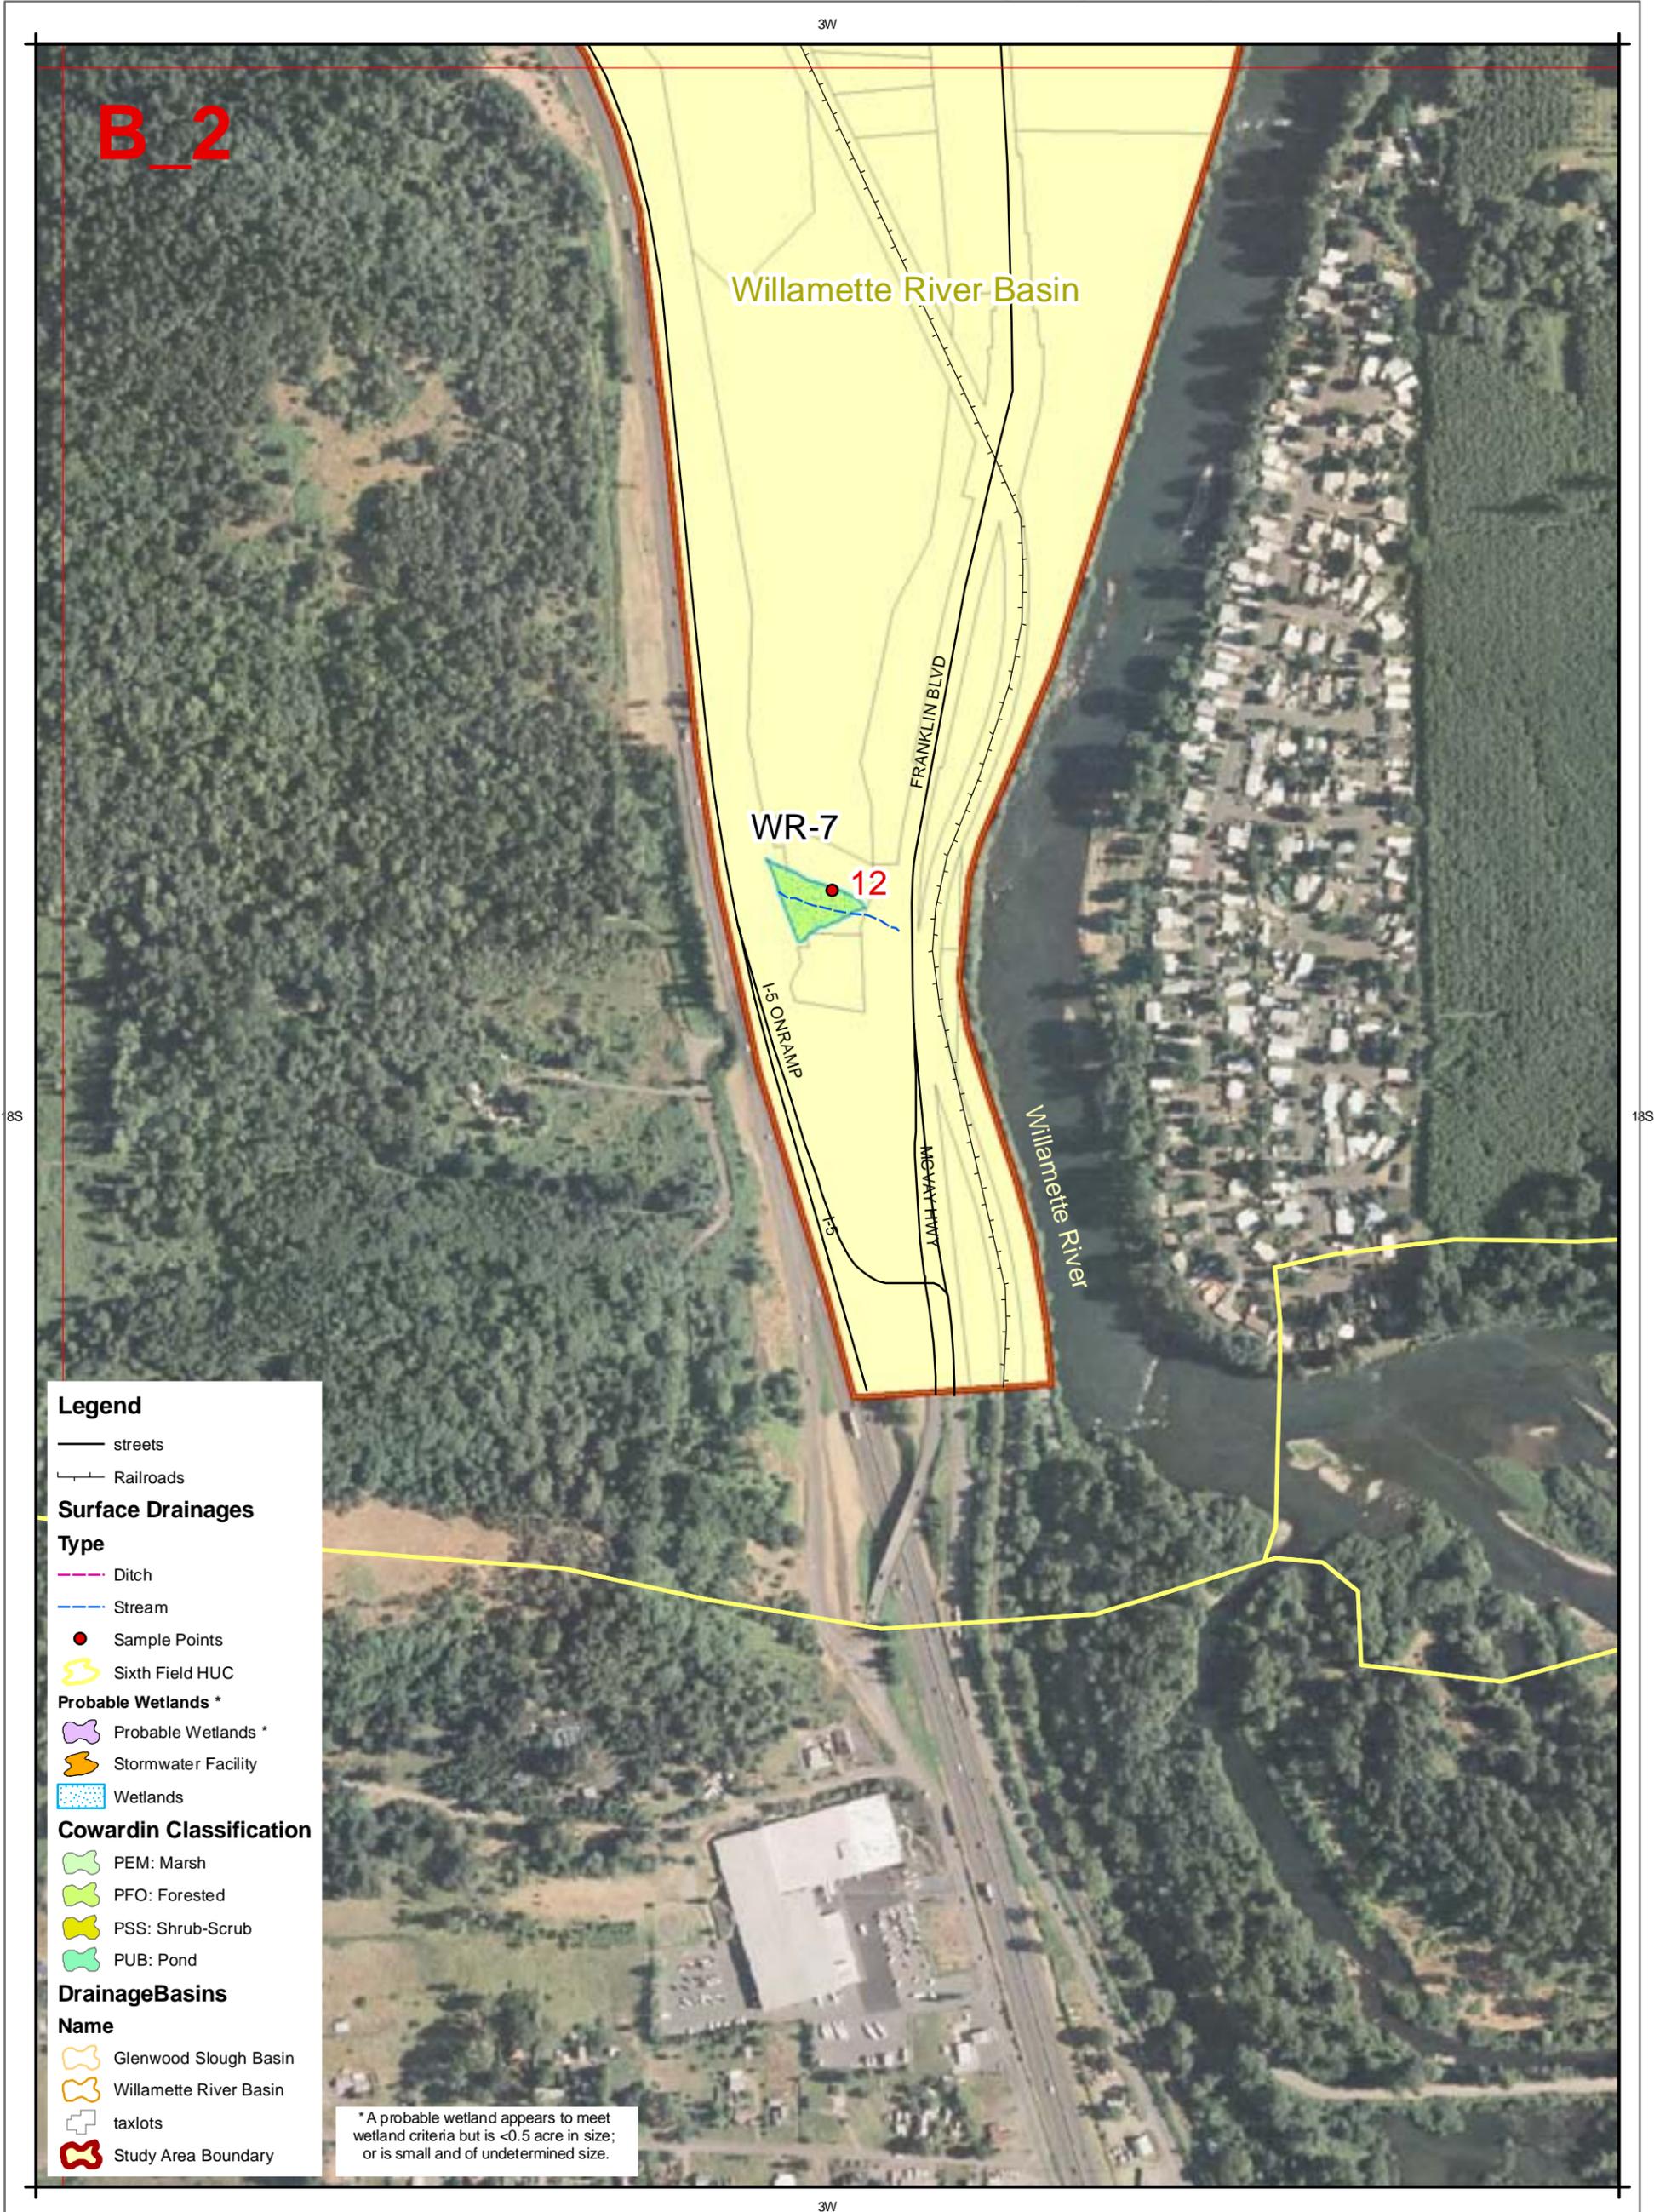
Glenwood LWI Map (B-2)

Sheet 4 - Glenwood Area of Springfield Local Wetlands Inventory

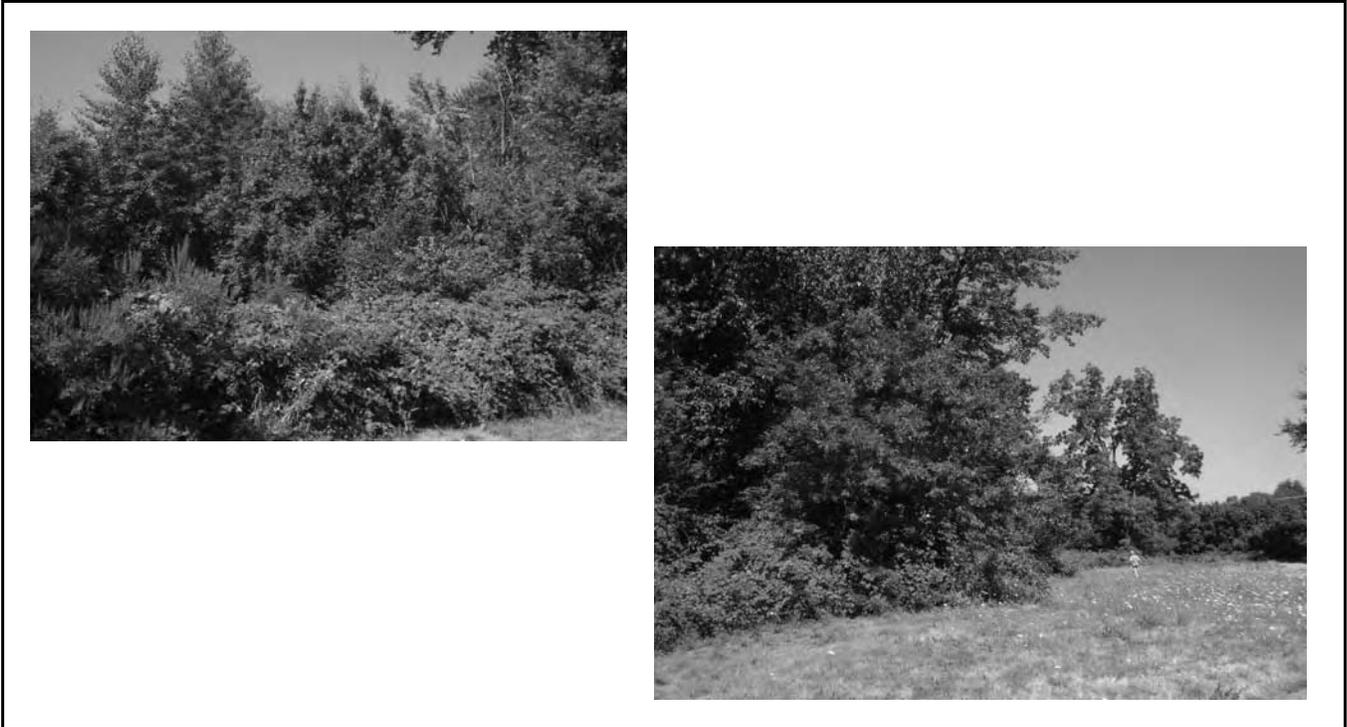
Typical Cross Section:

Comments: Drainage through wetland GS-2. The eastern portions of the drainage appear to be intermittent as no hydrology was identified during the July 2009 site visit. The western portion, just west of I-5 is perennial as flowing water was observed during an October 2009 site visit.

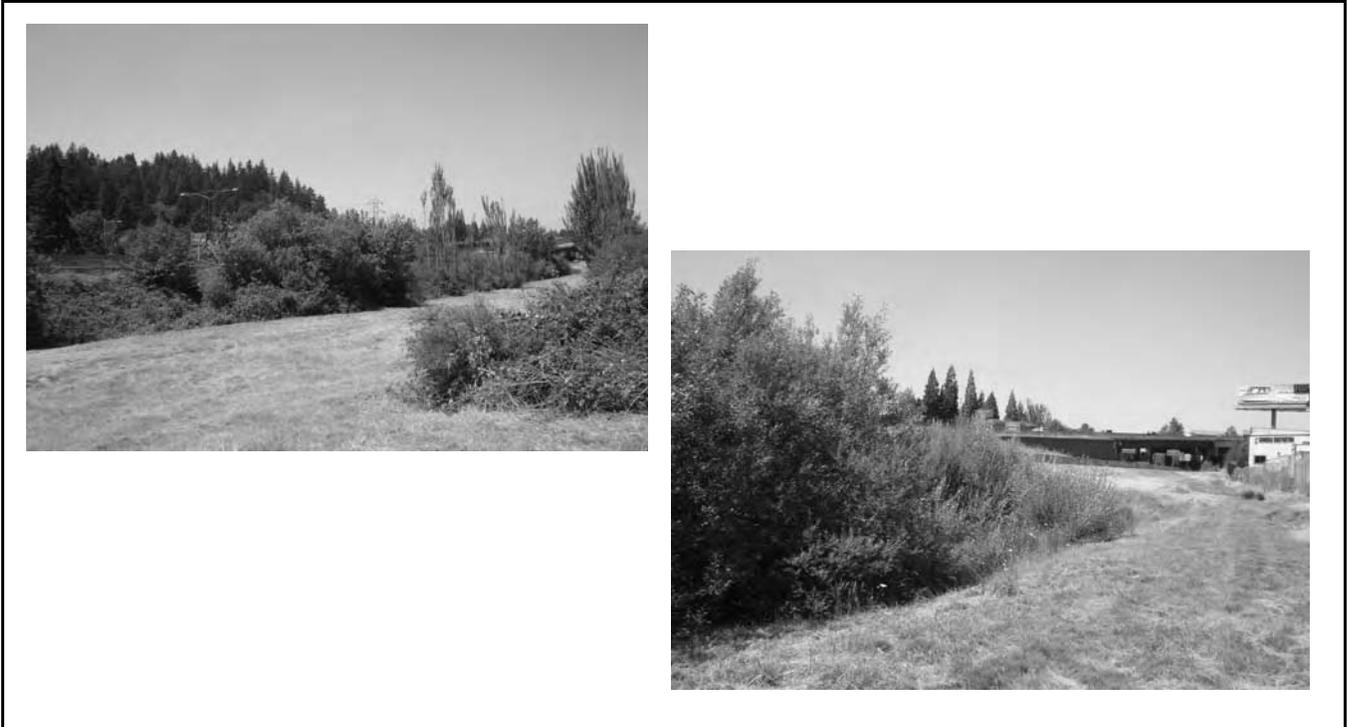
Typical Cross Section:

Comments: R-GS-2 is bordered to the west by I-5. The northern portion is culverted for approximately 462 feet before it daylights under the I-5 bridge before continuing north to the Willamette River. There is an unnamed perennial drainage that begins on the west side of I-5 and is culverted under the freeway where it converges with the culverted portion of R-GS-2. Oregon Department of Fish and Wildlife representative, Jeff Ziller, said this drainage has Cutthroat trout. The left & right bank are similar but the average slope of the left bank is 20% and the impervious surface is >25%.

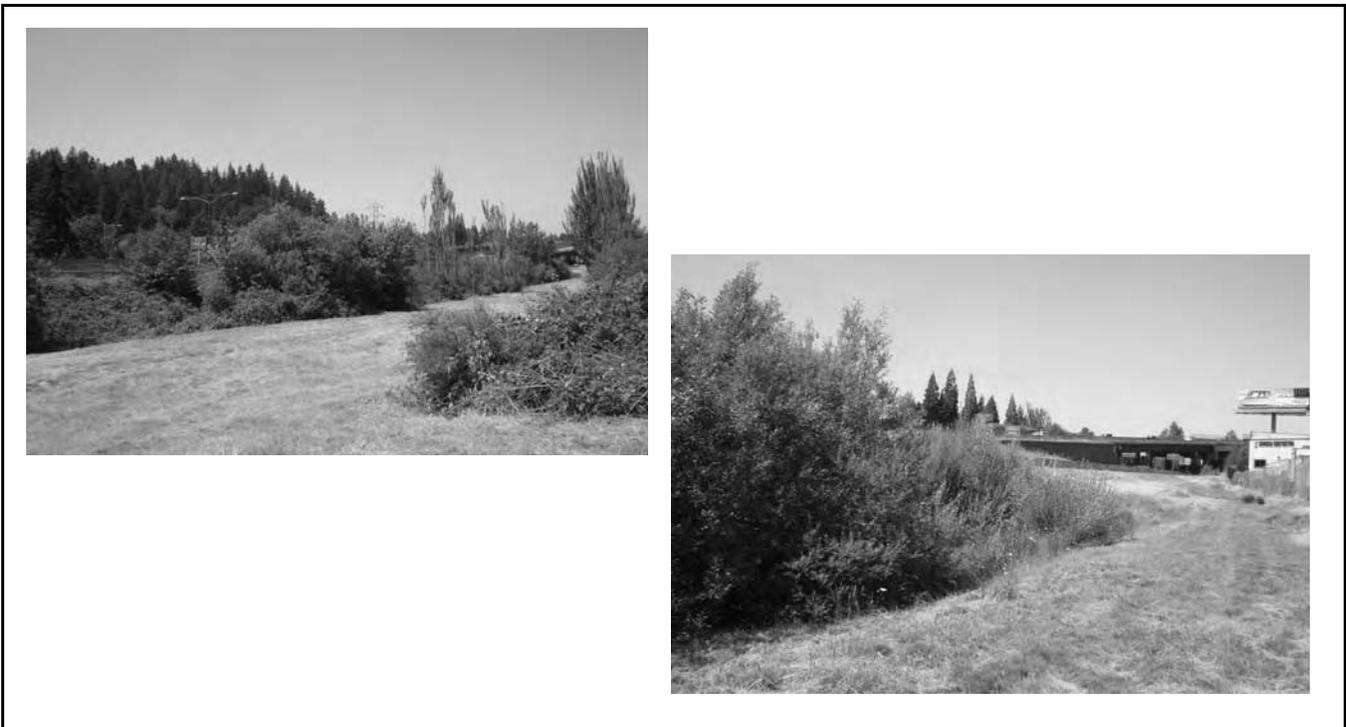
Typical Cross Section:

Comments: R-GS-2 is bordered to the west by I-5. The northern portion is culverted for approximately 462 feet before it daylights under the I-5 bridge before continuing north to the Willamette River. There is an unnamed perennial drainage that begins on the west side of I-5 and is culverted under the freeway where it converges with the culverted portion of R-GS-2. Oregon Department of Fish and Wildlife representative, Jeff Ziller, said this drainage has Cutthroat trout. The left & right bank are similar but the average slope of the right bank is 10% and the impervious surface is between 10-25%.

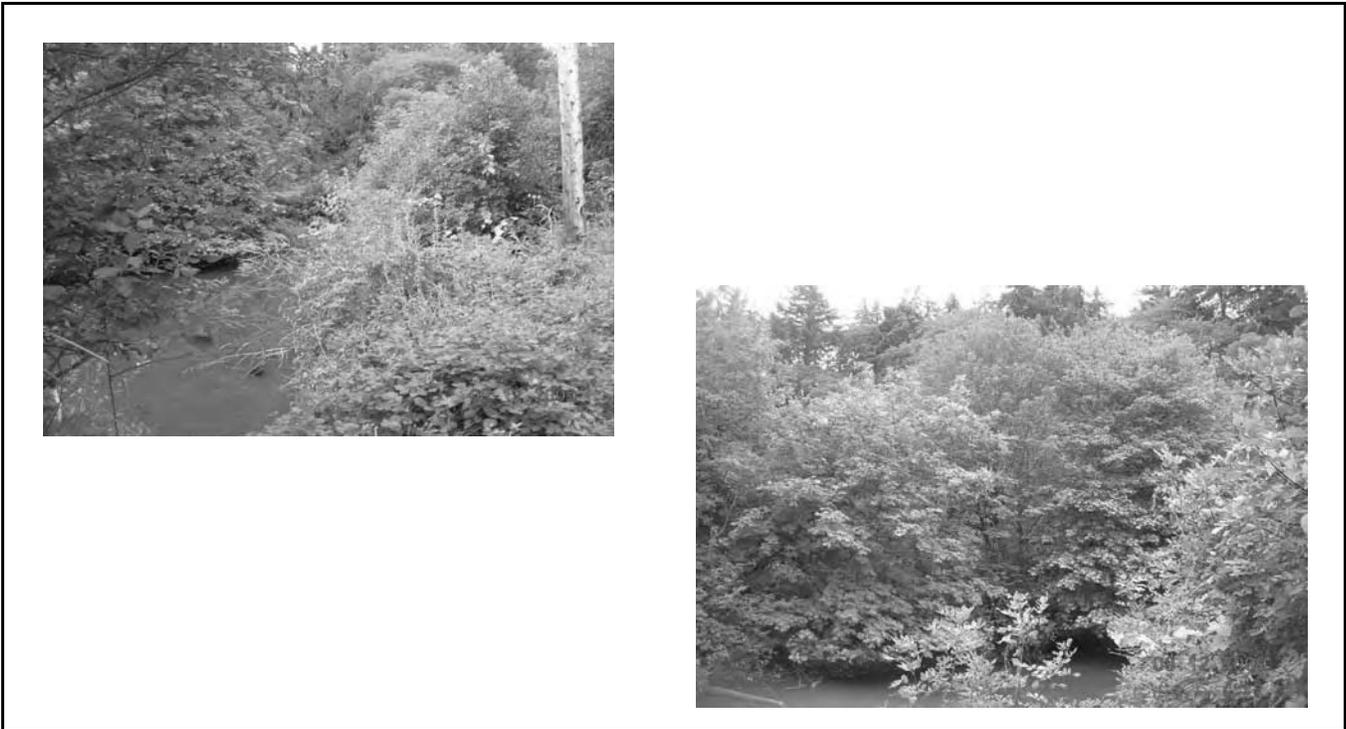
Typical Cross Section:

Comments: Riparian reach constricted on the right be development. Well-developed tree canopy on left. The eastern and western portions of the drainage were accessed during the site visit; however, there was no access to the central portion. The left and right banks are similar with the exceptio of the left bank extent of impervious surface in the riparian area is <10%, there is not large woody debris, and the degree of development of human caused disturbance is <25%.

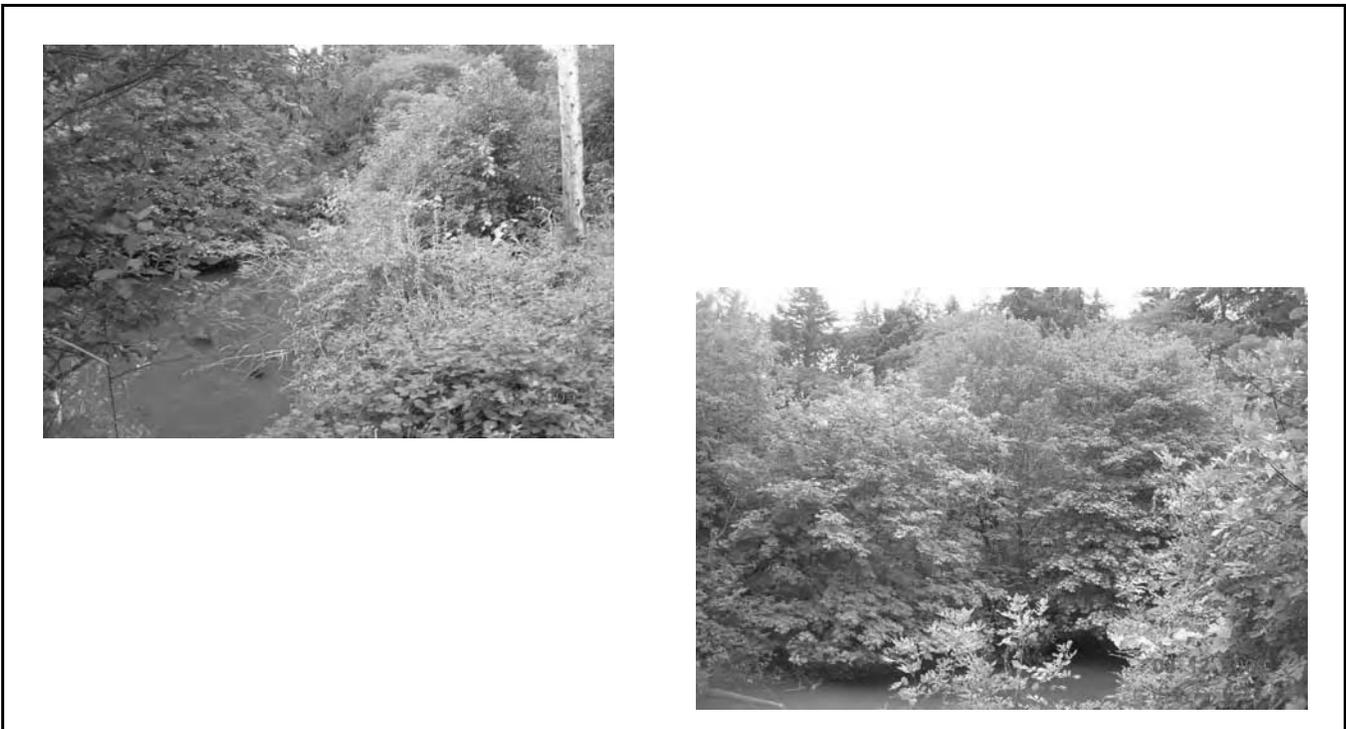
Typical Cross Section:

Comments: Riparian reach constricted on the right be development. Well-developed tree canopy on left. The eastern and western portions of the drainage were accessed during the site visit; however, there was no access to the central portion. The left and right banks are similar with the exceptio
of the right bank extent of impervious surface in the riparian area is 10-25%, there is large woody debris,
and the degree of development of human caused disturbance is 25-75%.

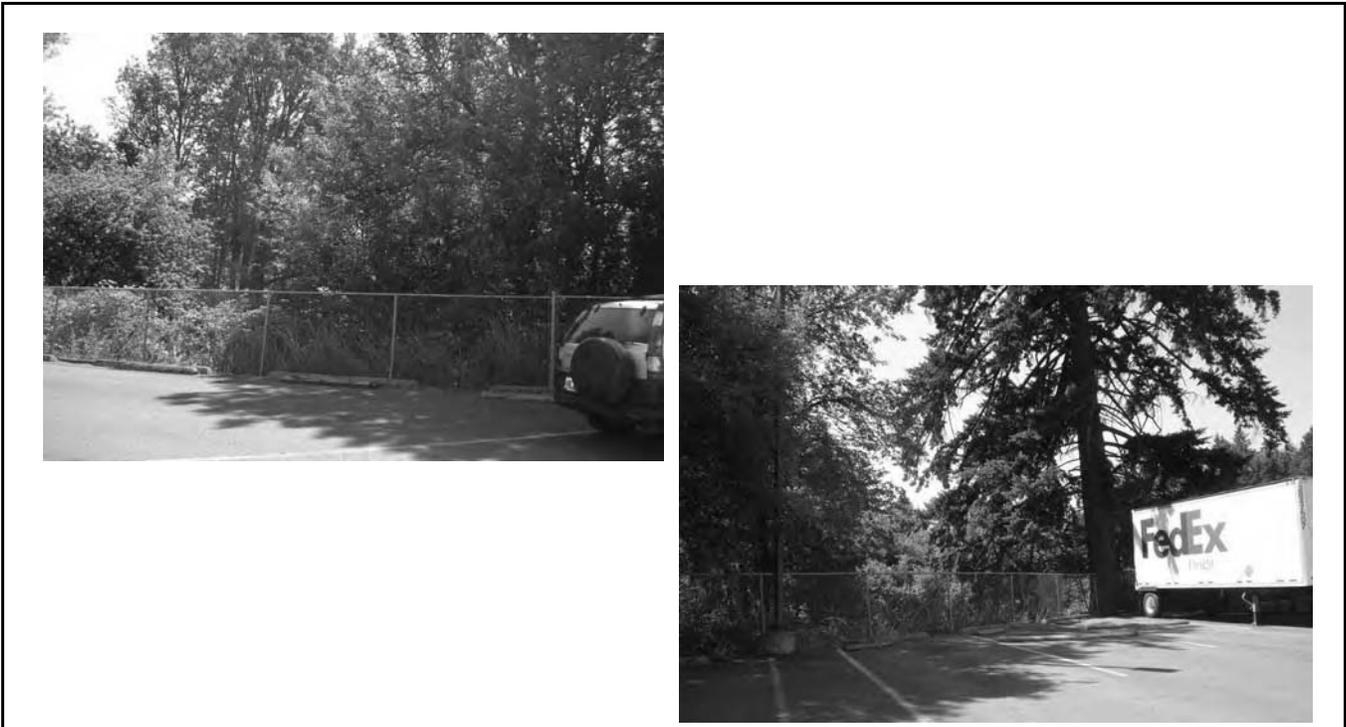
Typical Cross Section:

Comments: Pond behind the Fed-Ex building to the north. There are steep slopes along the south side. The left and right banks are similar with the exception of the extent of impervious surface with the riparian area on the left bank is <10%.

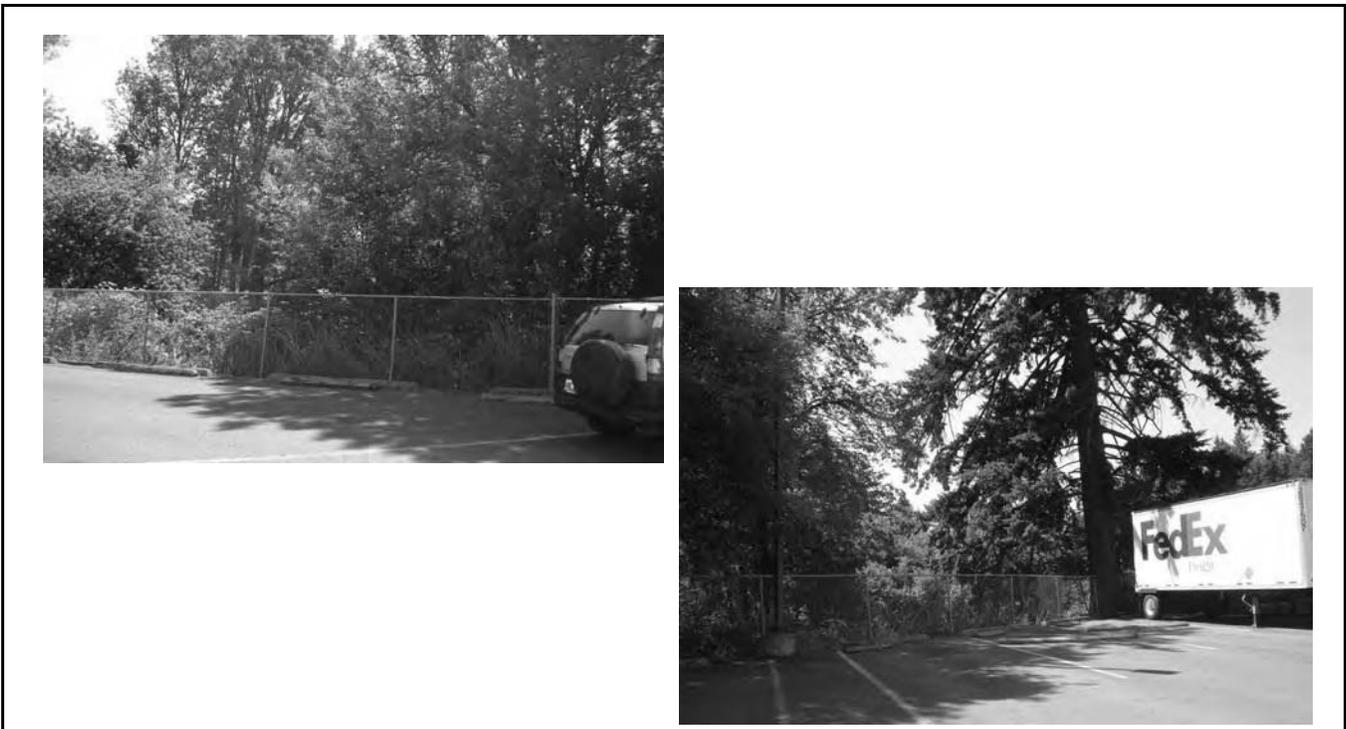
Typical Cross Section:

Comments: Pond behind the Fed-Ex building to the north. There are steep slopes along the south side. The left and right banks are similar with the exception of the extent of impervious surface with the riparian area on the right bank is 10-25%.

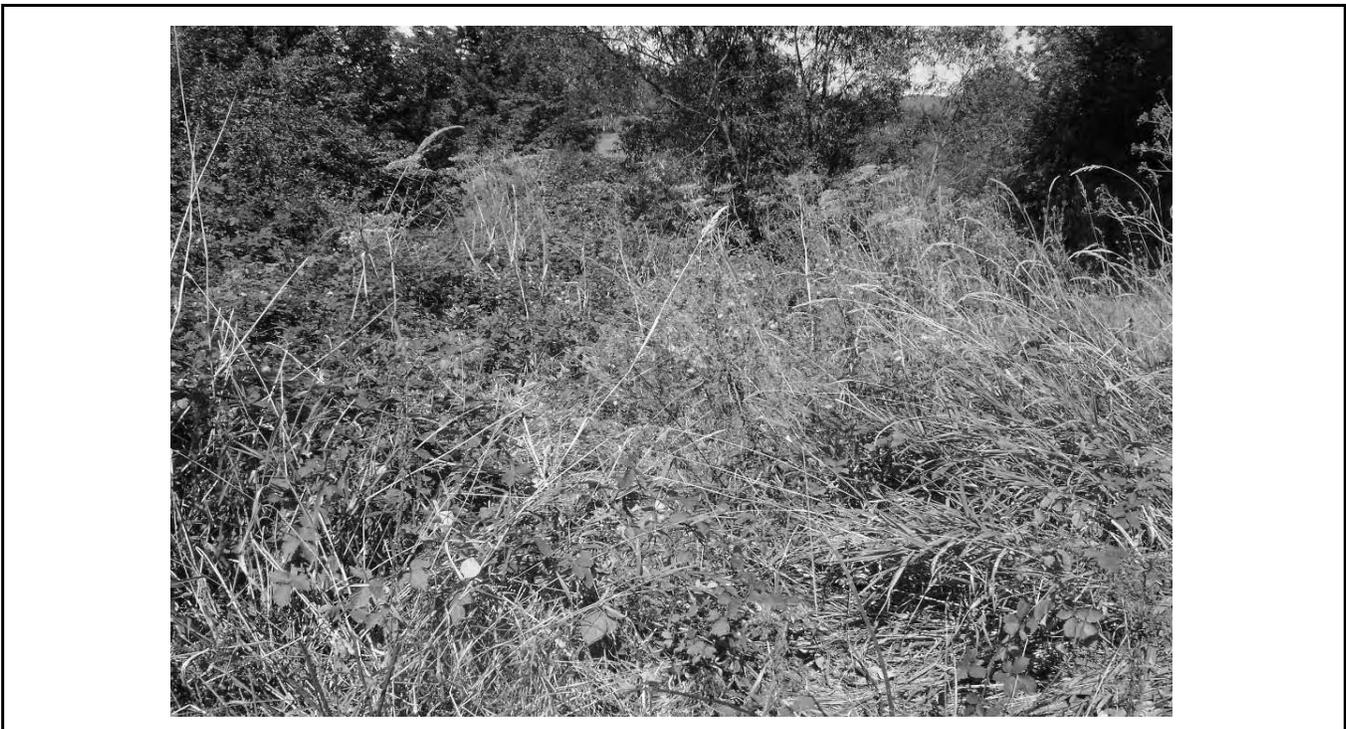
Typical Cross Section:

Comments: The western fill slope of R-GS-5 abuts Glenwood Boulevard. It is 2-6 feet wide and had 2 inches of flowing water at the time of the 9/15/09 site visit. R-GS-5 flows north where it converges with R-GS-4 and flows under Glenwood Boulevard into R-GS-3. The left and right bank are similar with the exception of the left bank average slope is 20%, the extent of impervious surface within the riparian area is 10-25%, the degree of development or human caused disturbance is >75%, and there are two vegetation layers present.

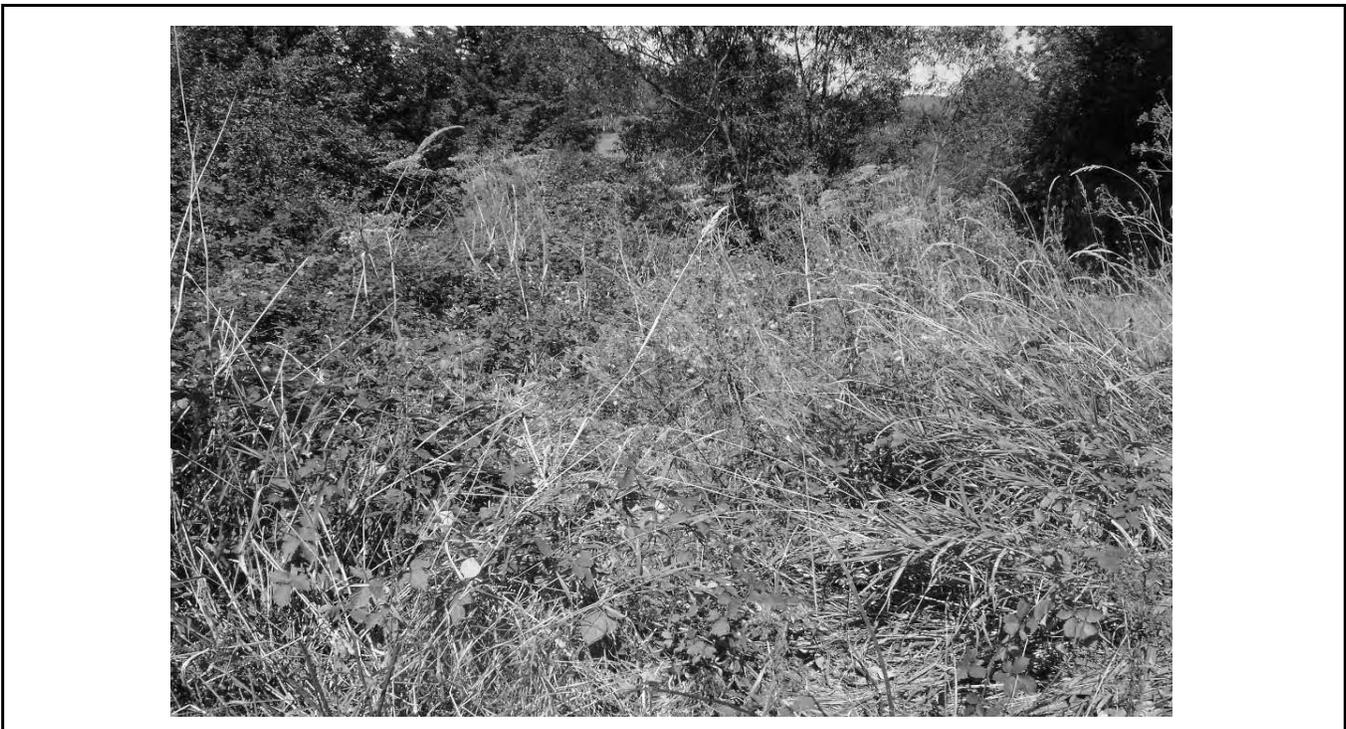
Typical Cross Section:

Comments: The western fill slope of R-GS-5 abuts Glenwood Boulevard. It is 2-6 feet wide and had 2 inches of flowing water at the time of the 9/15/09 site visit. R-GS-5 flows north where it converges with R-GS-4 and flows under Glenwood Boulevard into R-GS-3. The left and right bank are similar with the exception of the right bank average slope is 10%, the extent of impervious surface within the riparian area is <10%, the degree of development or human caused disturbance is 25-75%, and there are more than two vegetation layers present.

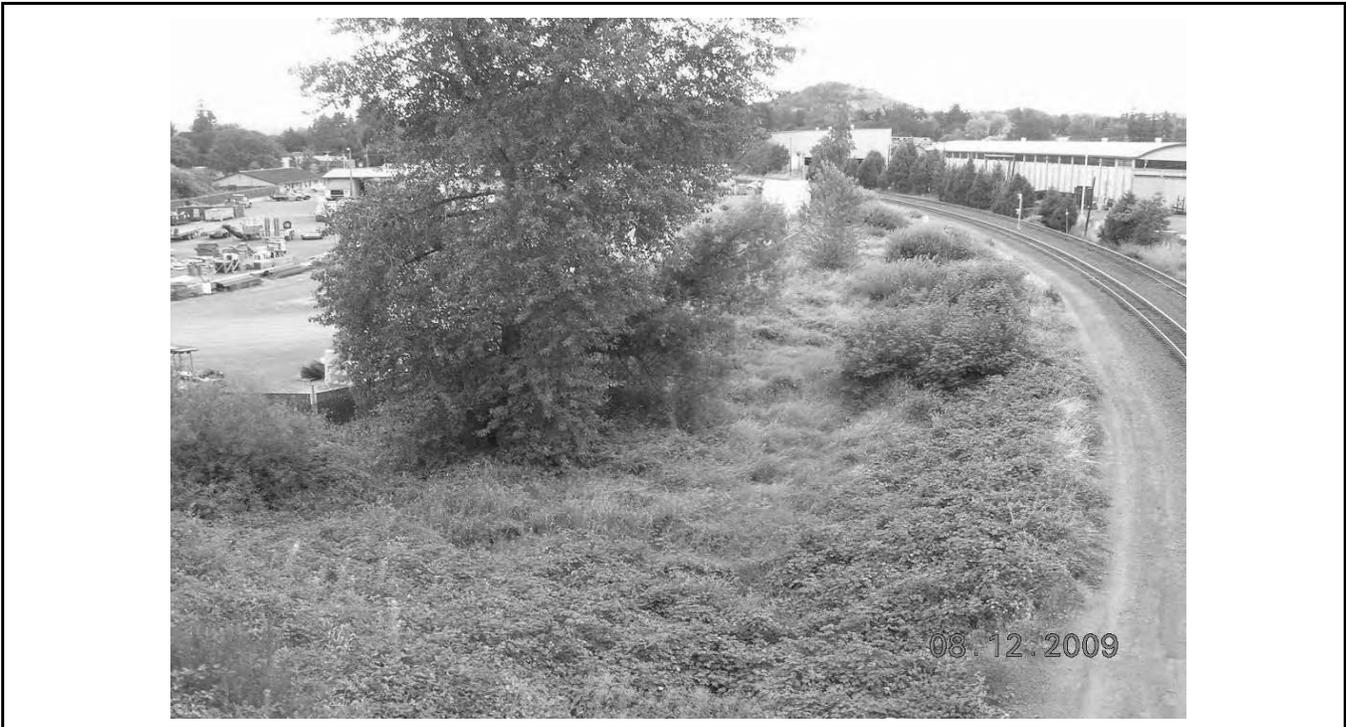
Typical Cross Section:

Comments: R-GS-6 is located between the railroad tracks and the ODOT maintenance yard.
R-GS-6 is a channelized manmade feature that flows northwest and converges with GS-5.

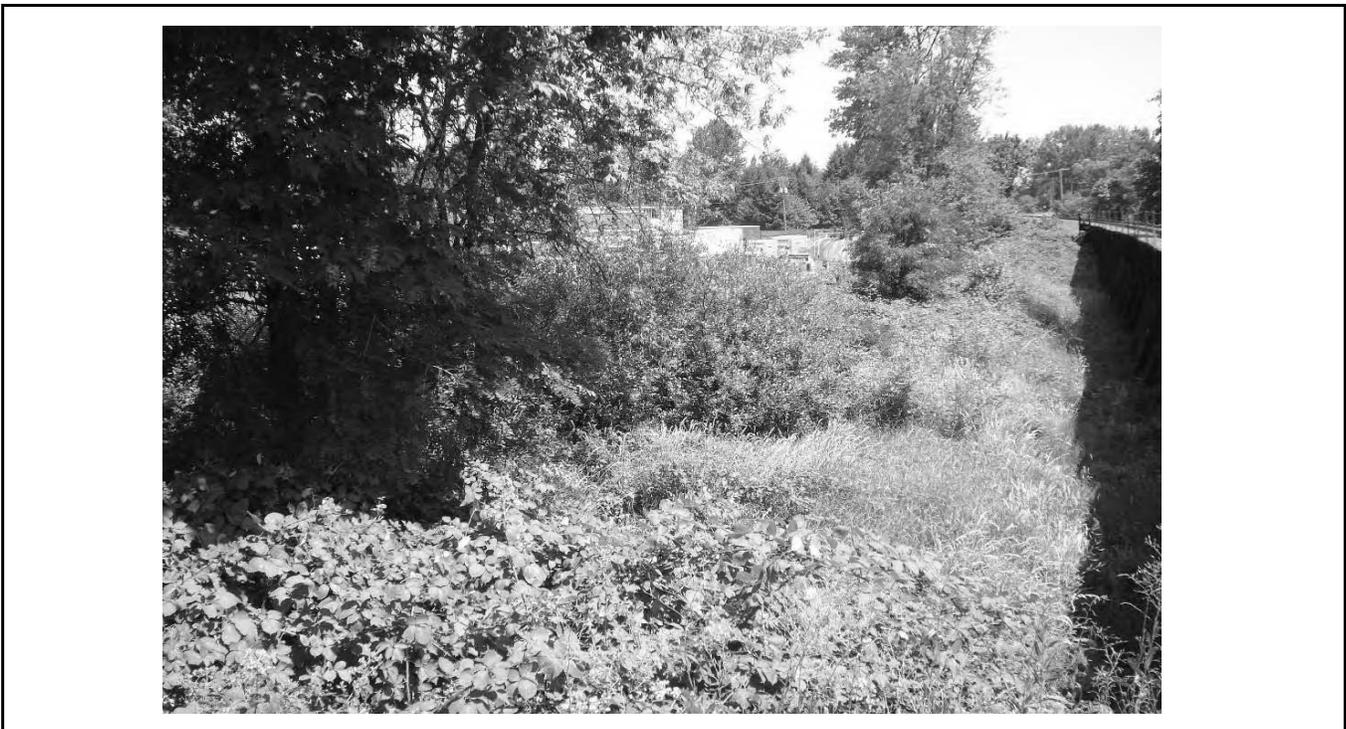
Typical Cross Section:

Comments: Railroad is located on left side; development is located to the right. Wetted width is approximately 4-6 feet; average water depth was two inches at the time of the October 2009 site visit. The left and right bank of the riparian area are similar with the exception of the left bank between 10-20%.

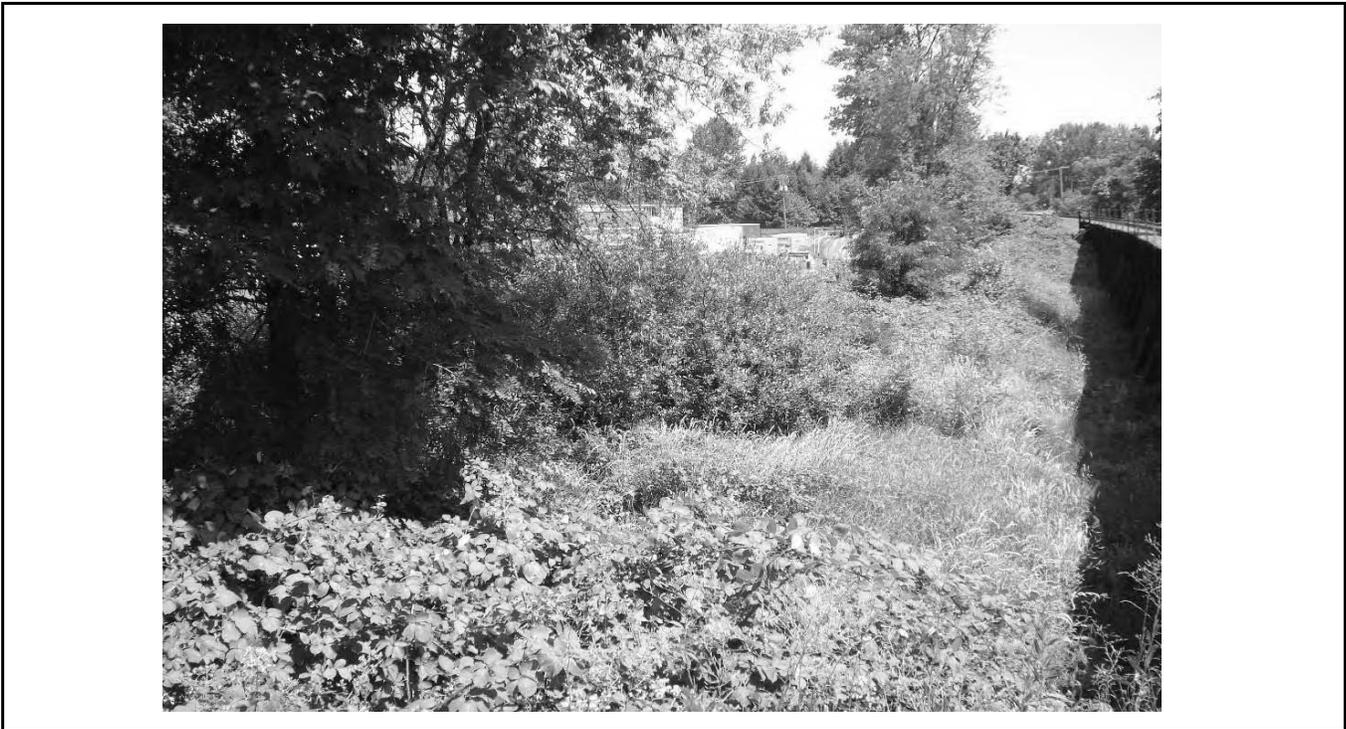
Typical Cross Section:

Comments: Railroad is located on left side; development is located to the right. Wetted width is approximately 4-6 feet; average water depth was two inches at the time of the October 2009 site visit. The left and right bank of the riparian area are similar with the exception of the right bank at 10%.

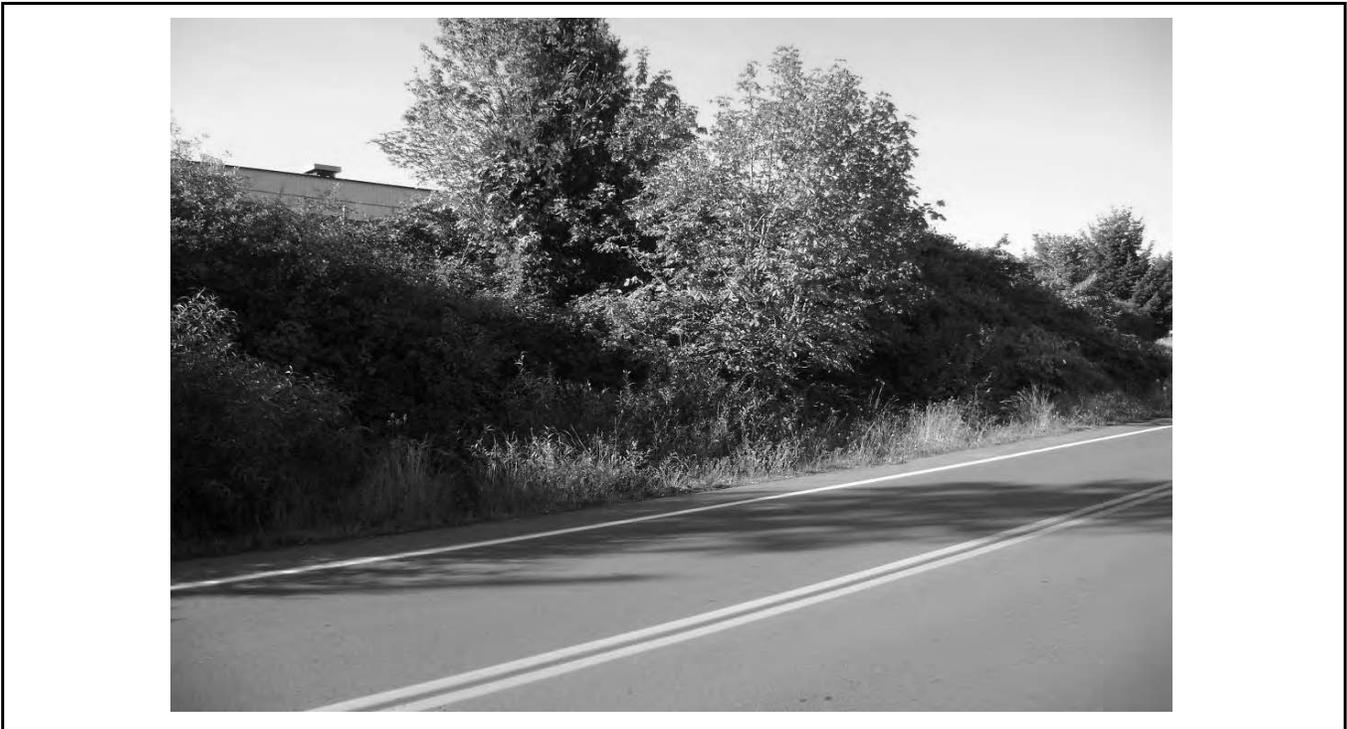
Typical Cross Section:

Comments: The riparian area appears to be a roadside ditch; however, it has perennial flow, therefore it was evaluated as a stream. R-GS-8 is approximately 3 feet wide and the water flows north into a culvert under East Ave. It is assumed the culvert daylights north into either R-GS-6 or R-GS-7.

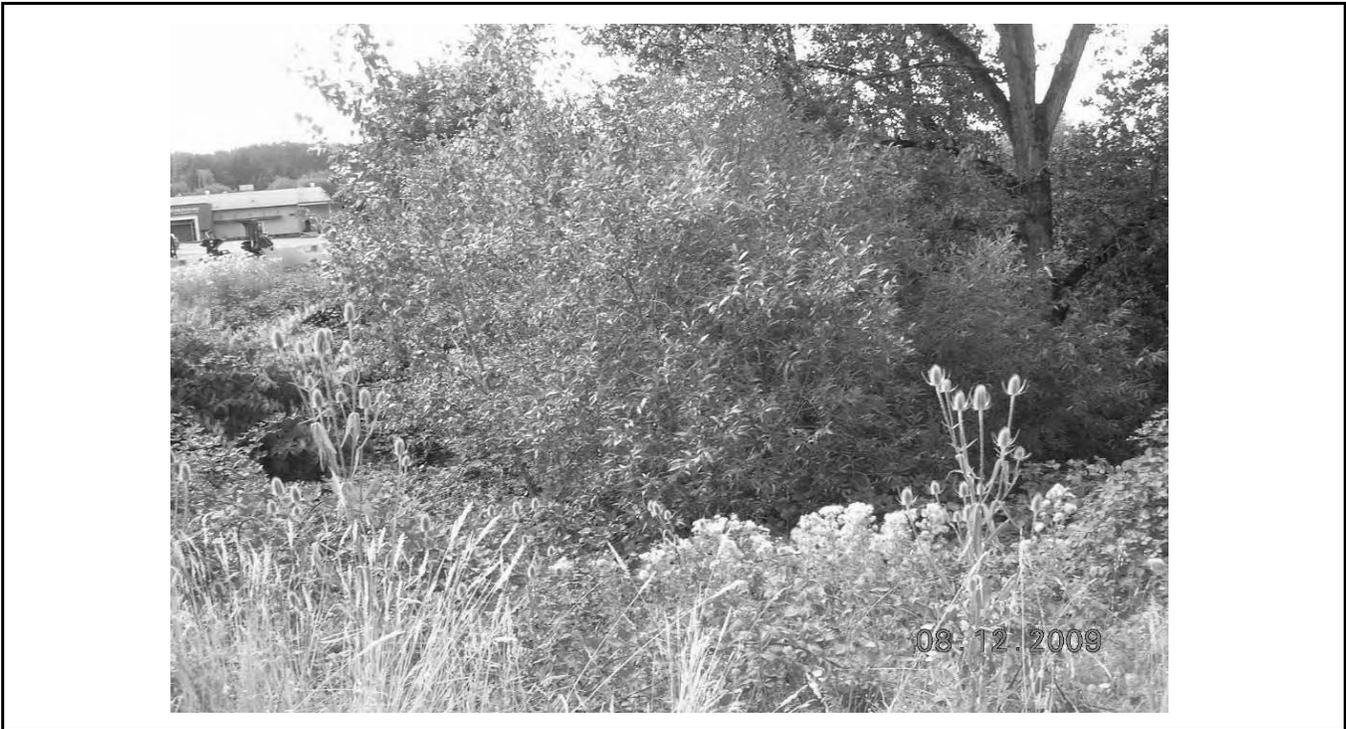
Typical Cross Section:

Comments: PHS was able to observe the drainage from the southern and western portions.
There are very steep slopes down to the drainage. It drains north towards E. 22nd Avenue.
PHS could not see the bottom of the drainage due to a steep bank and Salix sp. thicket.
