Local Wetlands Inventory and Riparian Corridor Assessment for the Glenwood Area of Springfield, Oregon

Pacific Habitat Services, Inc.
Wilsonville, Oregon

February 10, 2010

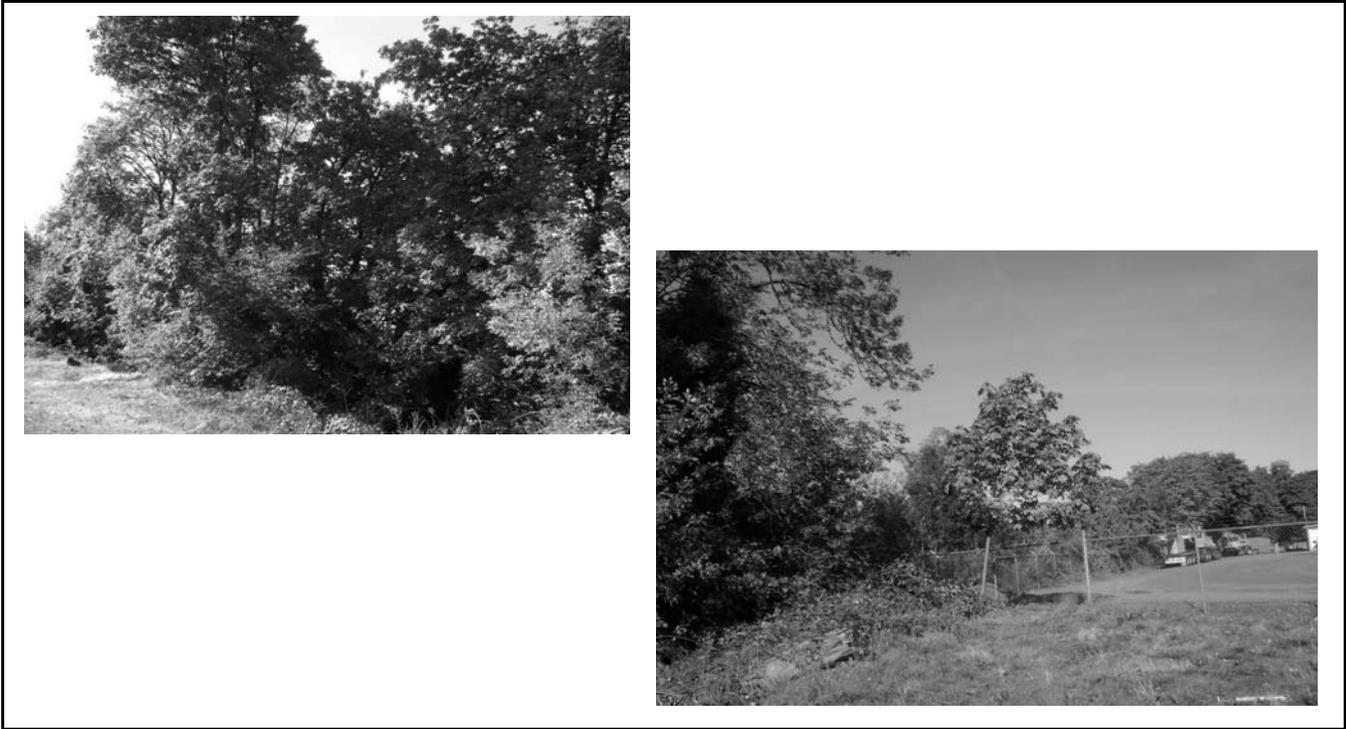
Typical Cross Section:

Comments: Developed portion along the south bank of the Willamette River. No access to upper beach. Assessment taken at downstream (west) end just north of Franklin Boulevard.

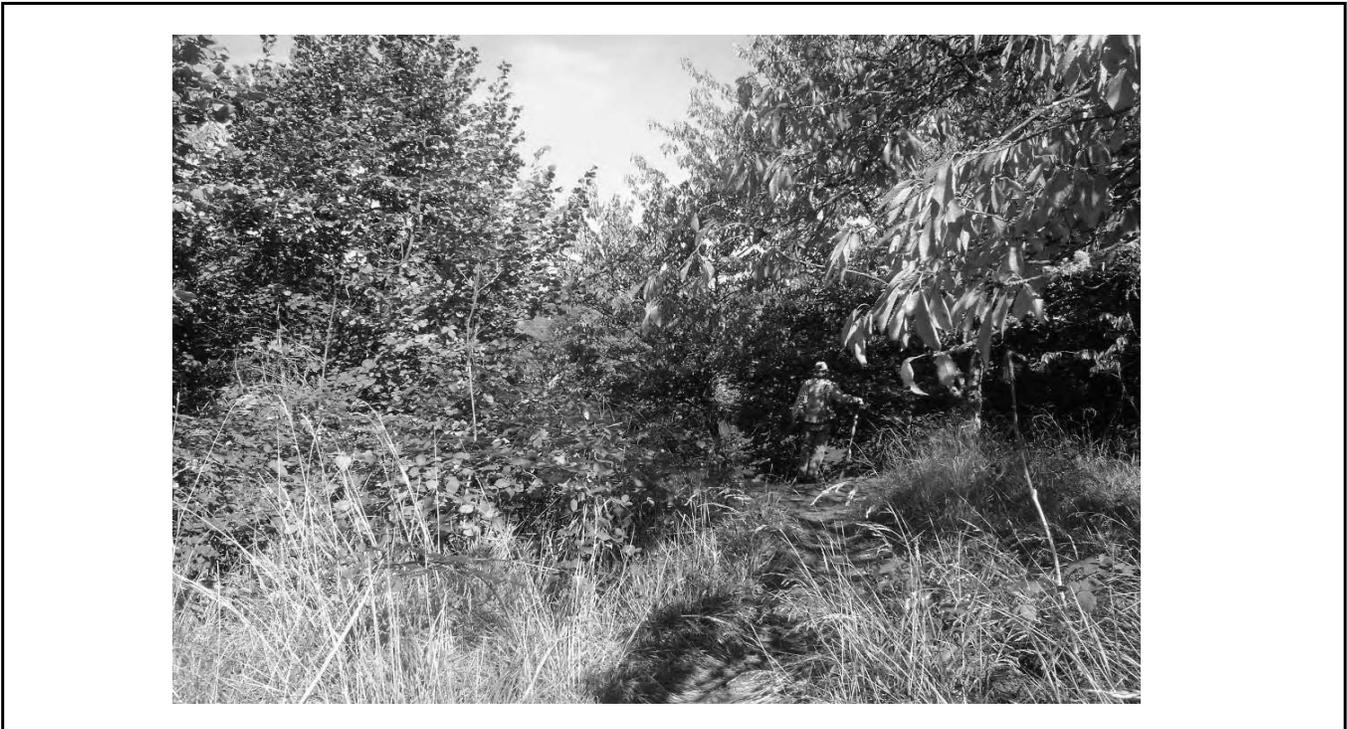
Typical Cross Section:

Comments: This section of the Willamette River riparian area is one of the few residential lots that remains forested. The vegetation is predominately native. The house/structure on site is set back from the river and has a relatively wide riparian corridor.

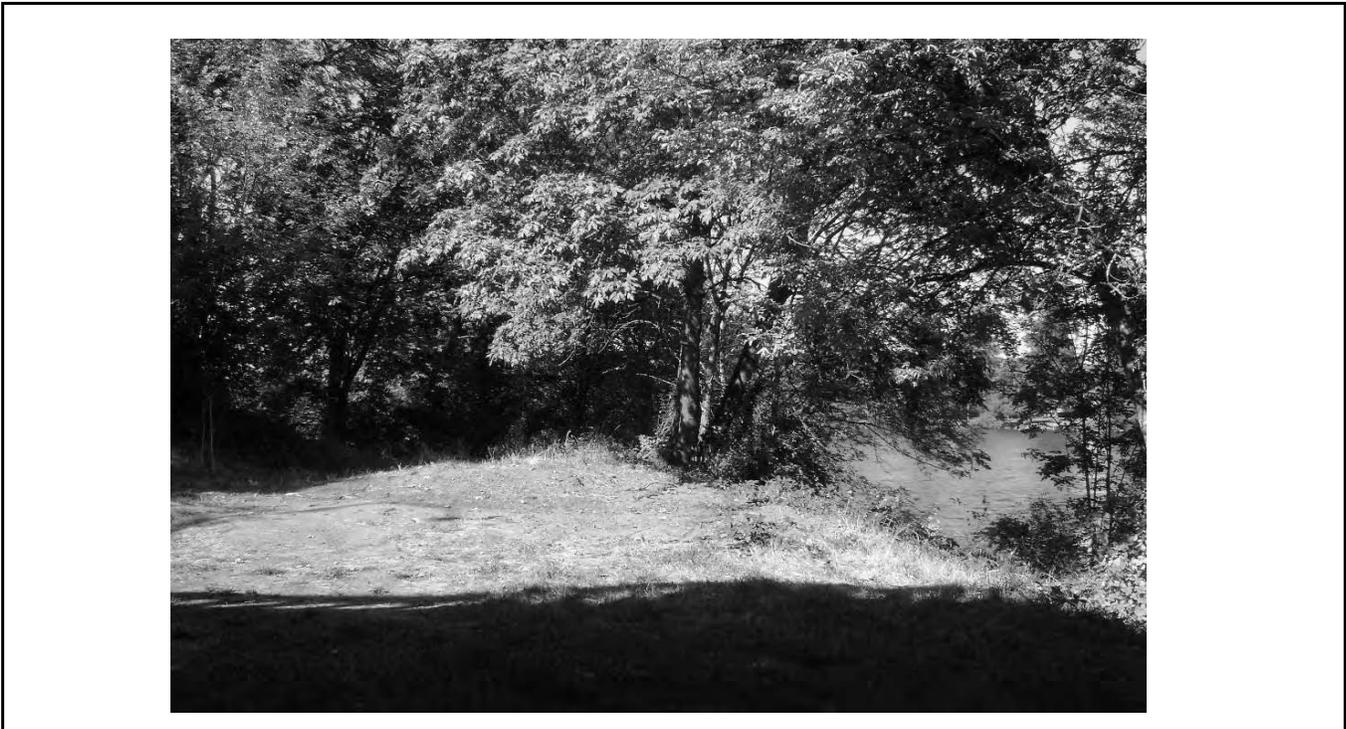
Typical Cross Section:

Comments: Area under Franklin Bridge, just west of Willamette River. There is a narrow fringe of trees and shrubs along this section of the Willamette; however, just beyond the dominant vegetation the area consists of mowed grass and forbs.

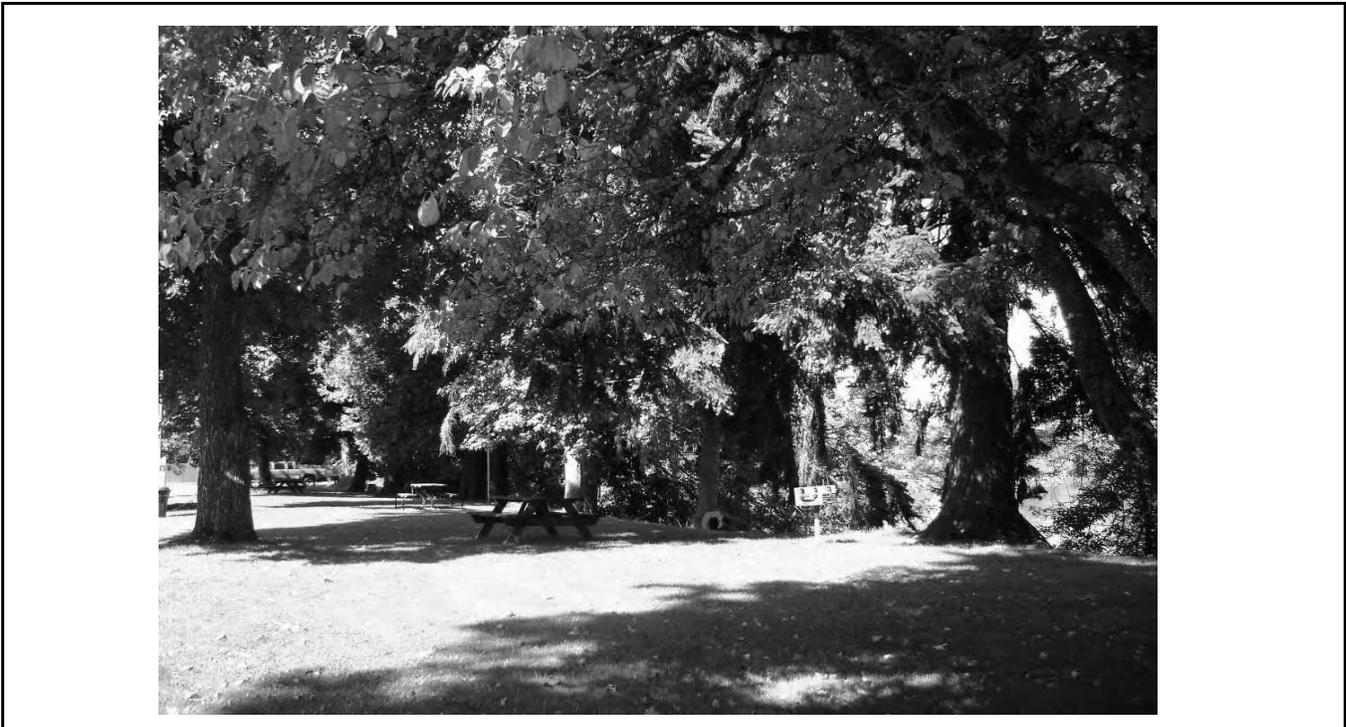
Typical Cross Section:

Comments: In Shamrock Village, there is a narrow strip of vegetation east of the mobile park road and river. Mature trees with grass and picnic tables make up this section of riparian corridor.

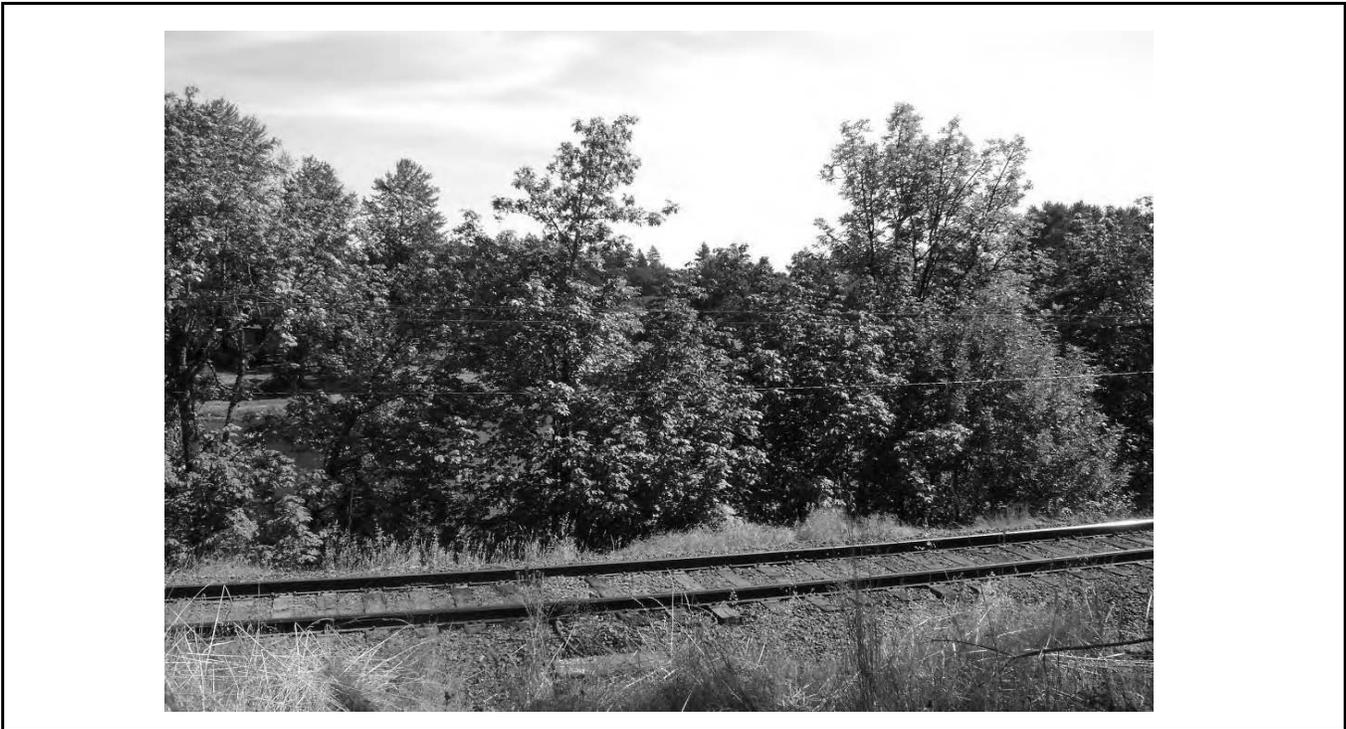
Typical Cross Section:

Comments: The southern portion of this section of riparian area is forested with an unimproved road within the corridor. The left bank of the river is steep. The north and central portion of the corridor is undeveloped and has a narrow fringe of trees and vegetation along the river with bare, disturbed ground beyond. Since there was no access to the northern portion, observations were identified from aerial photographs.

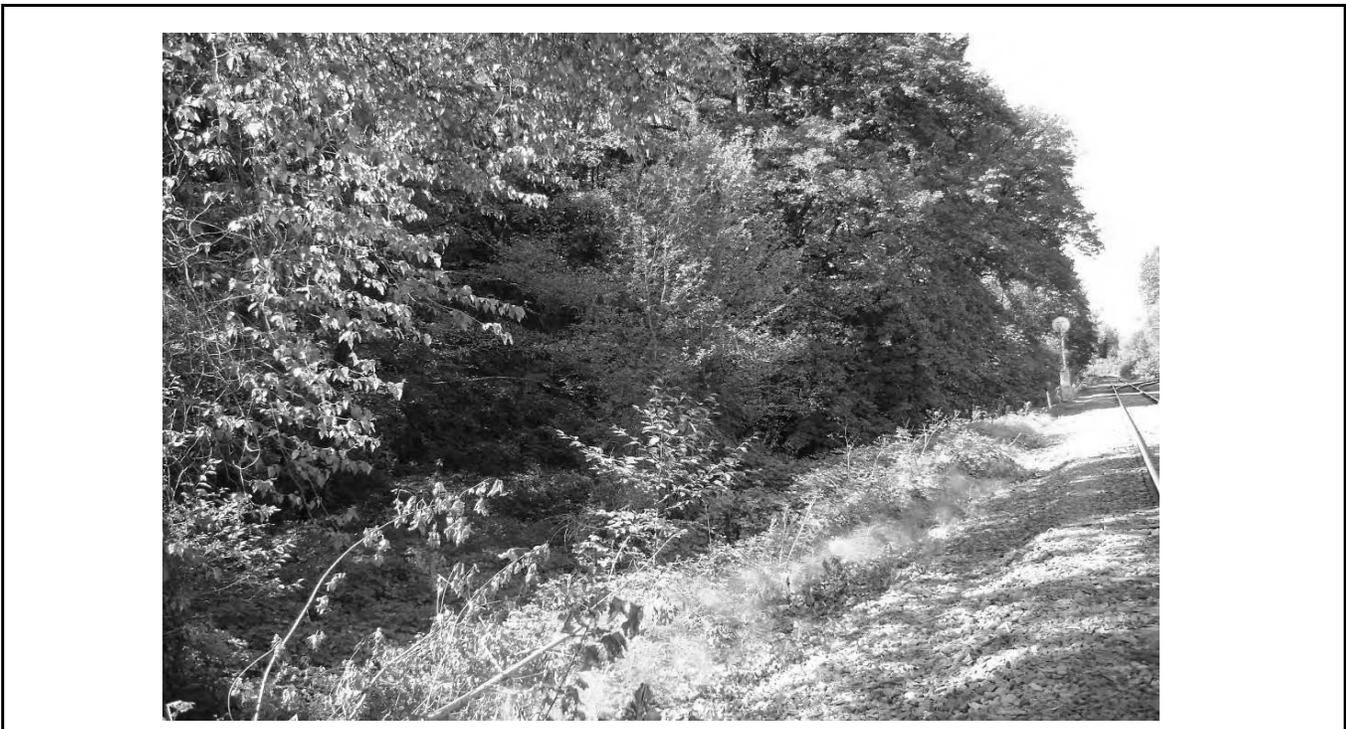
Typical Cross Section:

Comments: The stream flows through Wetland WR-7. The stream begins upslope, east of I-5. The stream is culverted under Franklin Boulevard and outfalls east into the Willamette River.
